TÜV SÜD Auto Partner GmbH
Gutenbergstraße 13
70771 Leinfelden-Echterdingen

# Expertise

Protocol number: 48582333
Order No. / Reference: 27157075
Inspection date: 3 Nov 2026

| Manufacturer: Mercedes-Benz | Model: C 200 4Matic 9G-TRONIC |

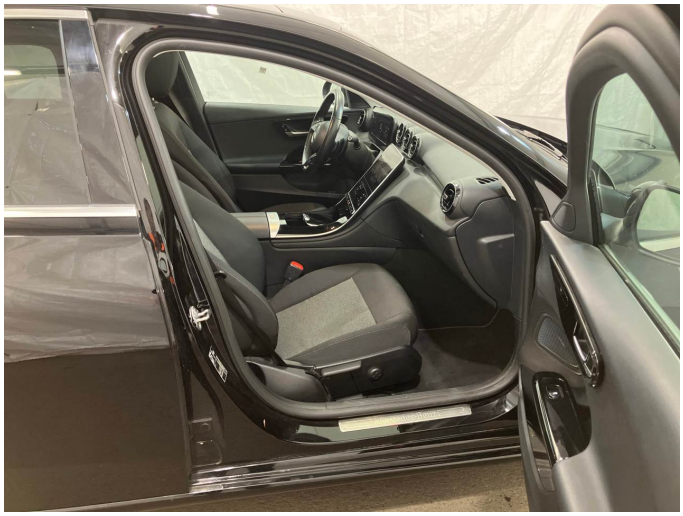
**Figure 5:** Interior - front

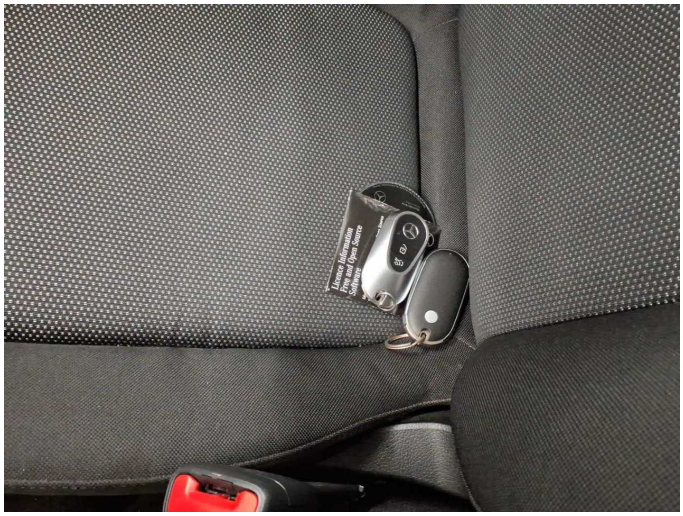
**Figure 12:** Documents

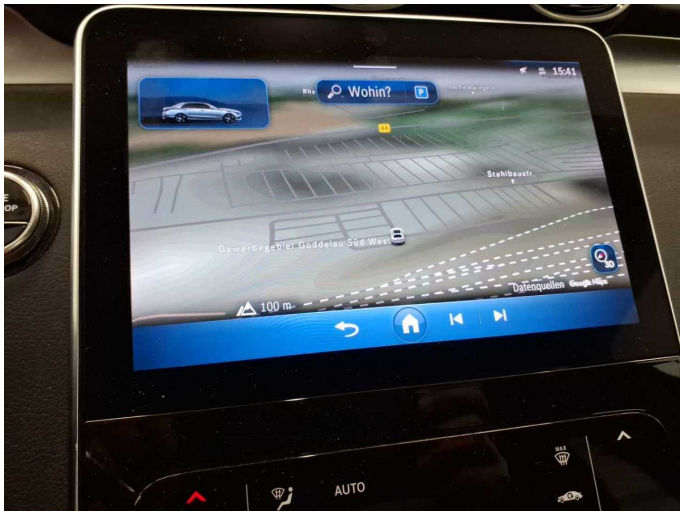
**Figure 16:** Navigation

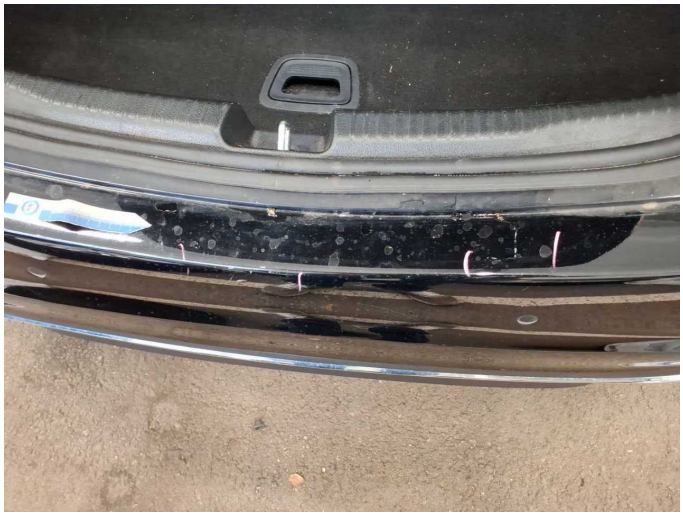
| No. | Component group | Description |
|---|---|---|
| 5 | Boot lid / rear door | Boot lid - Scratch(es) - Paint |

**Damage 5:** Boot lid / rear door: Boot lid - Scratch(es) - Paint

**Damage 6:** Rear bumper: Rear bumper - Scratched - Paint

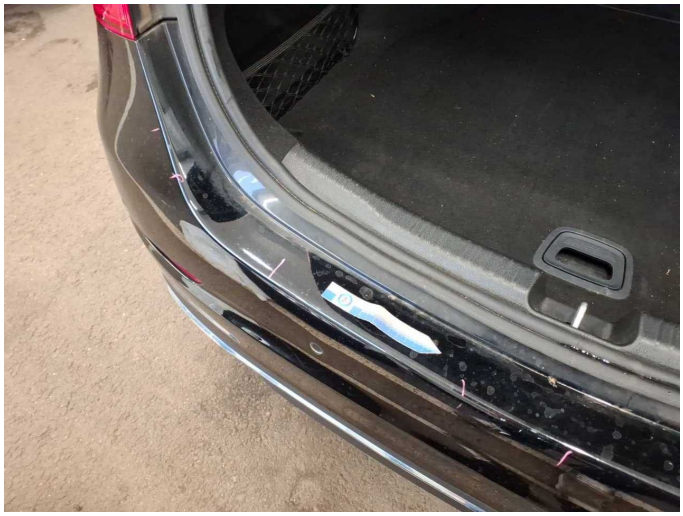
| No. | Component group | Description |
|---|---|---|
| 6 | Rear bumper | Rear bumper - Scratched - Paint |

**Damage 6:** Rear bumper: Rear bumper - Scratched - Paint

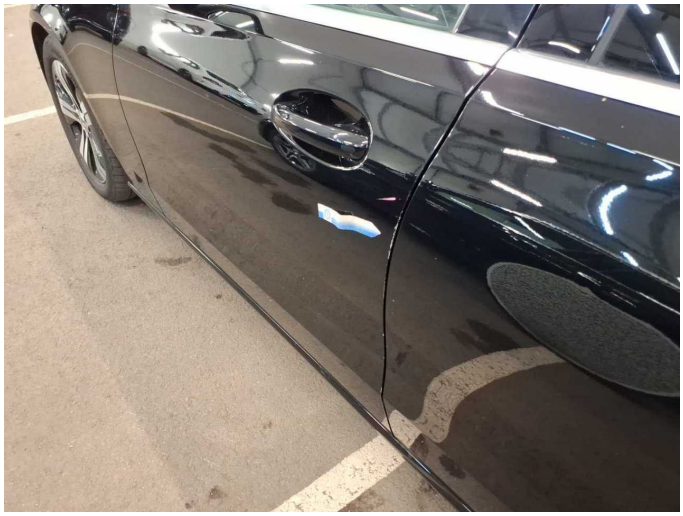
| No. | Component group | Description |
|---|---|---|
| 7 | Door - front left side | Door edge - Scratch(es) - Paint |

**Damage 7:** Door - front left side: Door edge - Scratch(es) - Paint

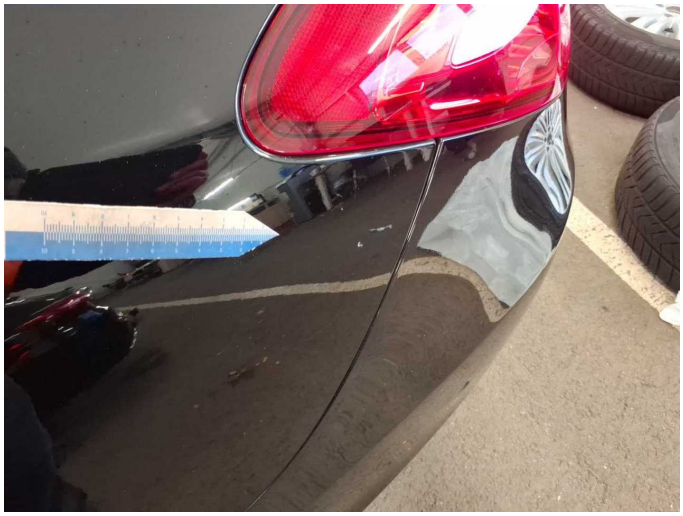
| No. | Component group | Description |
|---|---|---|
| 9 | Side panel - rear left side | Side panel - Dent / paintcoat damage - Repair and paint |

**Damage 8:** Front bumper: Front bumper (& Lackschaden) - Deformed - Paint

**Damage 9:** Side panel - rear left side: Side panel - Dent / paintcoat damage - Repair and paint

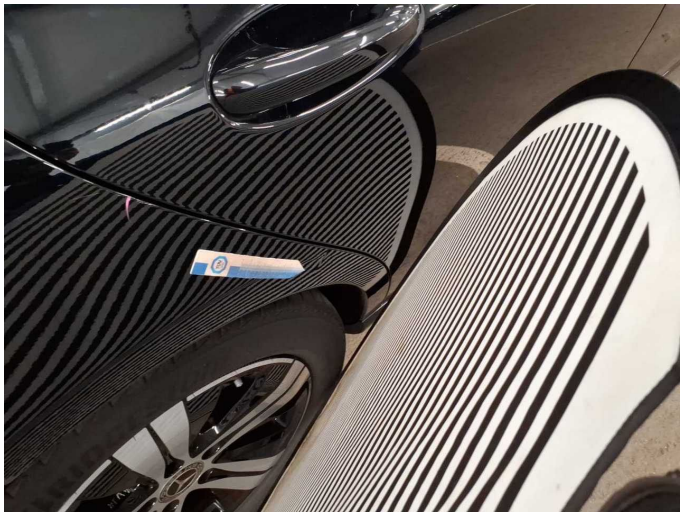
**Damage 9:** Side panel - rear left side: Side panel - Dent / paintcoat damage - Repair and paint

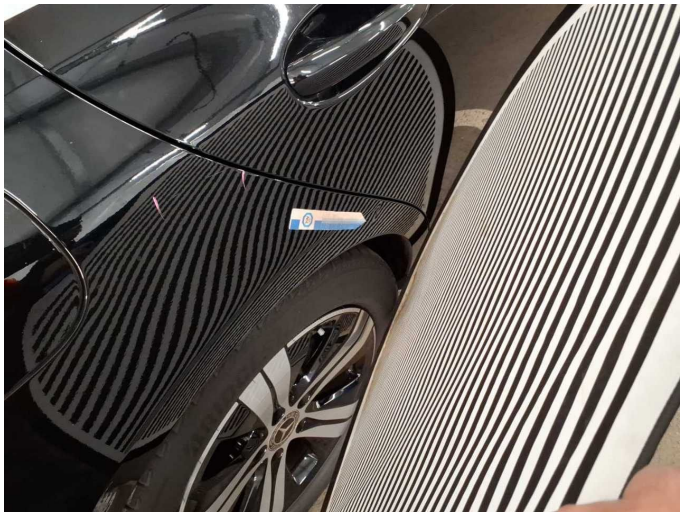
| No. | Component group | Description |
|---|---|---|
| 10 | Side panel - rear right side | Side panel (Kniestück) - Dent / paintcoat damage - Repair and paint |

**Damage 10:** Side panel - rear right side: Side panel (Kniestück) - Dent / paintcoat damage - Repair and paint

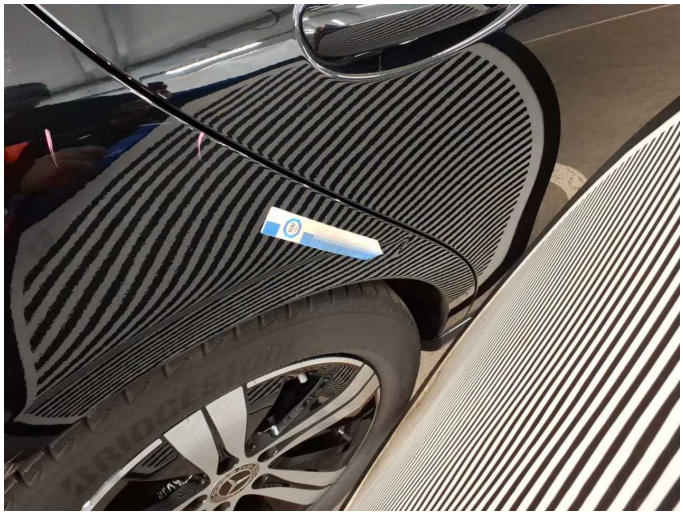
**Damage 10:** Side panel - rear right side: Side panel (Kniestück) - Dent / paintcoat damage - Repair and paint

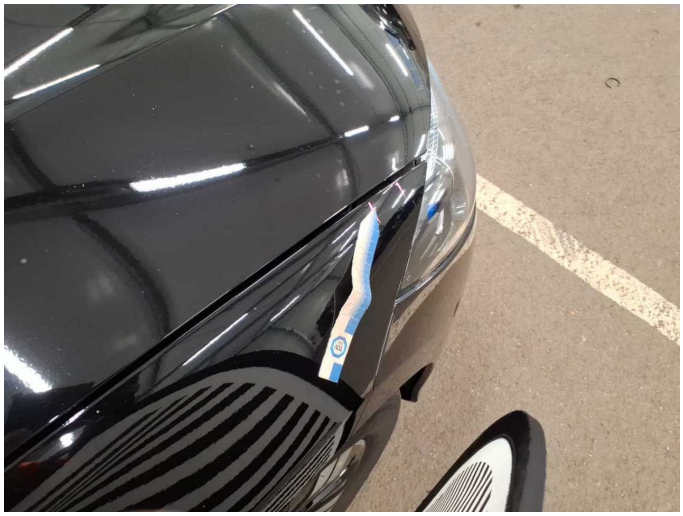
| No. | Component group | Description |
|---|---|---|
| 1 | Bonnet | Bonnet - Stone chips - No deduction |

**Wear and tear 1:** Bonnet: Bonnet - Stone chips - No deduction
