Expertise

Protocol number: 48368455
Order No. / Reference: 27161888
Inspection date: 28 Oct 2026

Manufacturer: Volvo	Model: XC60 T6 AWD Recharge Core
VIN: LYVUZH1V9RB746088

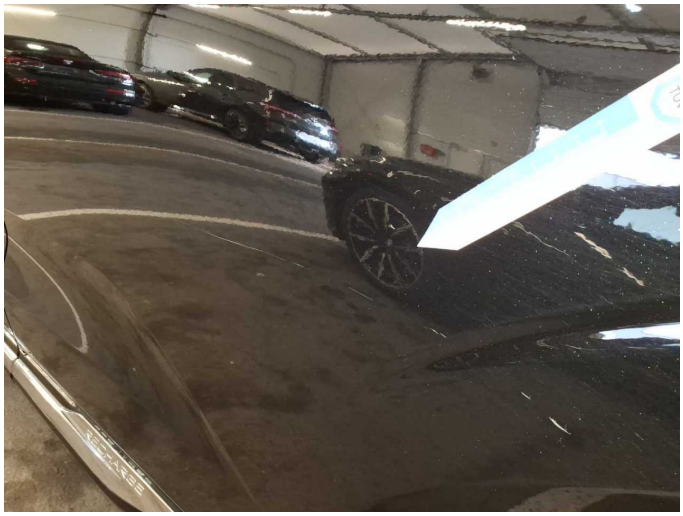
Damage 2: Door - rear left side: Door - Scratch(es) - Paint

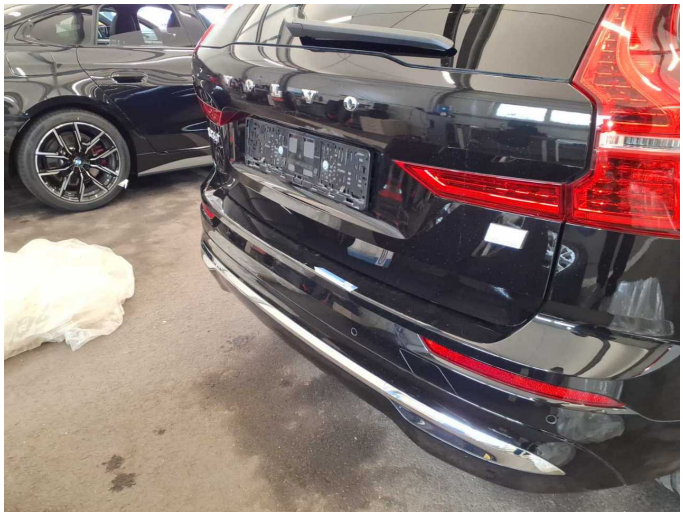
Damage 3: Side panel - rear right side: Side panel - Dent / paintcoat damage - Repair and paint
