Expertise

Protocol number: 48087445
Order No. / Reference: 27135817
Inspection date: 13 Oct 2026

Manufacturer: Mercedes-Benz	Model: GLC-Coupe 300 e 4Matic 9G-TRONIC AMG Line
VIN: W1N2533531F977197

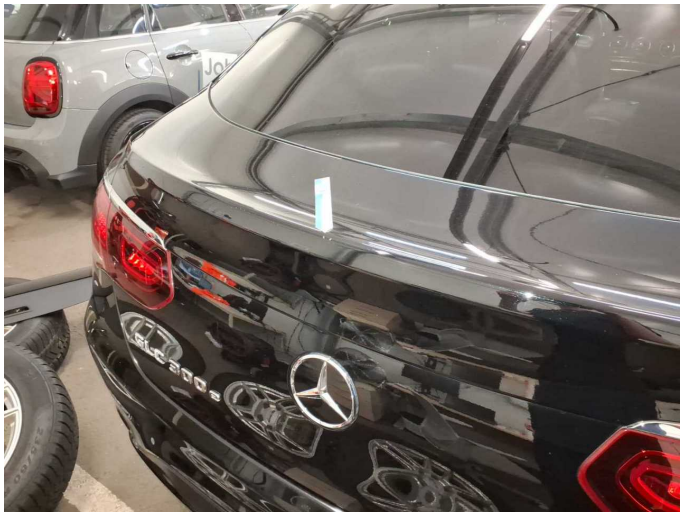
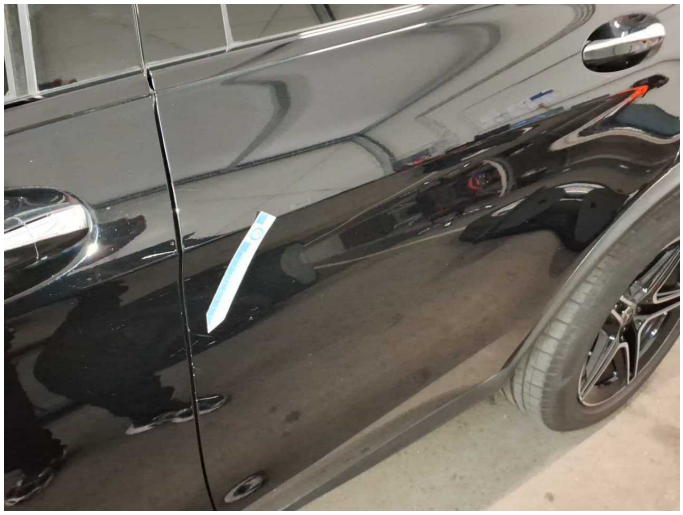
Damage 1: Boot lid / rear door: Boot lid - Scratch(es) - Smart repair

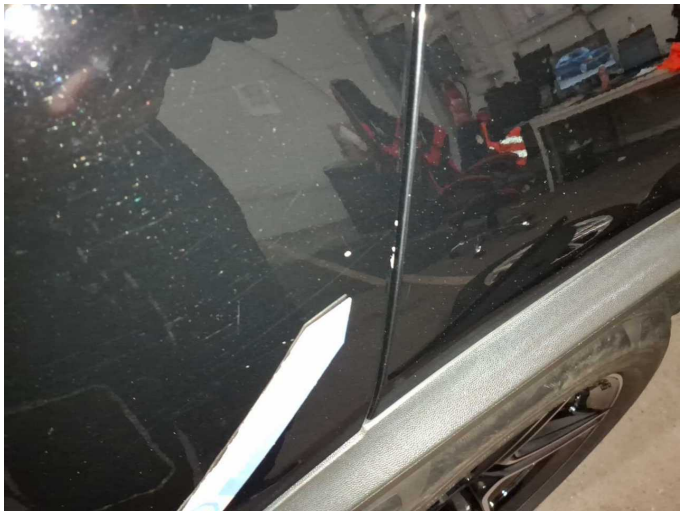
Damage 2: Door - rear left side: Door - Scratch(es) - Paint

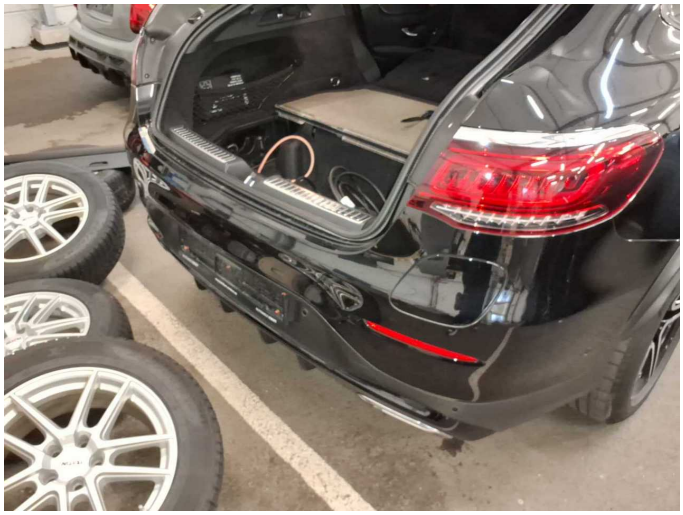
Damage 3: Rear bumper: Rear bumper - Scratch(es) - Paint

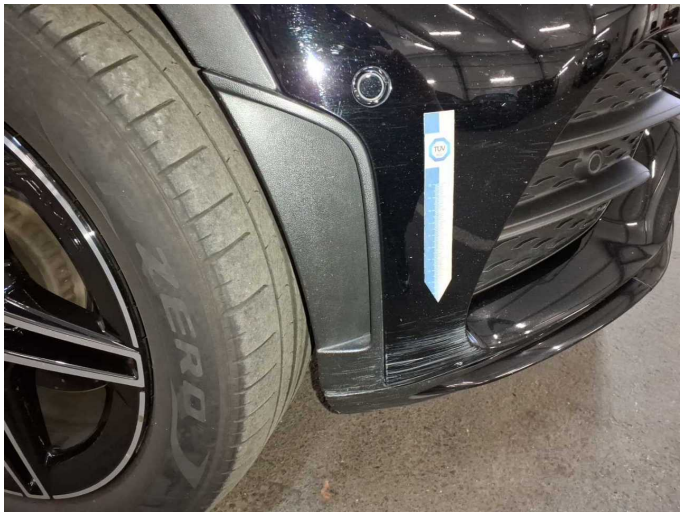
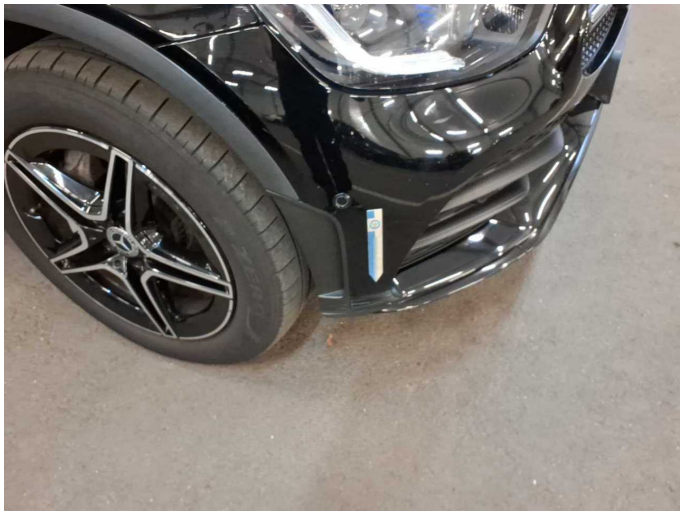
No.	Component group	Description
1	Boot lid / rear door	Boot lid - Scratch(es) - Smart repair
2	Door - rear left side	Door - Scratch(es) - Paint
3	Rear bumper	Rear bumper - Scratch(es) - Paint
4	Front bumper	Front bumper (+ Blende und Unterteil) - Damaged - repair according to calculation

Accident 1: Front
