Expertise

Protocol number: 47979471
Order No. / Reference: 26995131-1
Inspection date: 22 Sept 2026

Manufacturer: Volkswagen	Model: Golf Variant 2.0 TDI SCR DSG Life
VIN: WVWZZZCDZNW501172

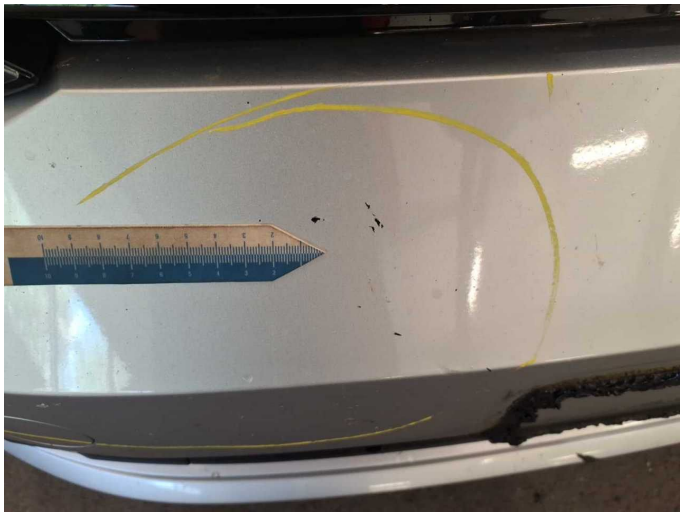
Damage 3: Front bumper: Front bumper (+ Klebereste entfernen) - Scratched - Repair and paint

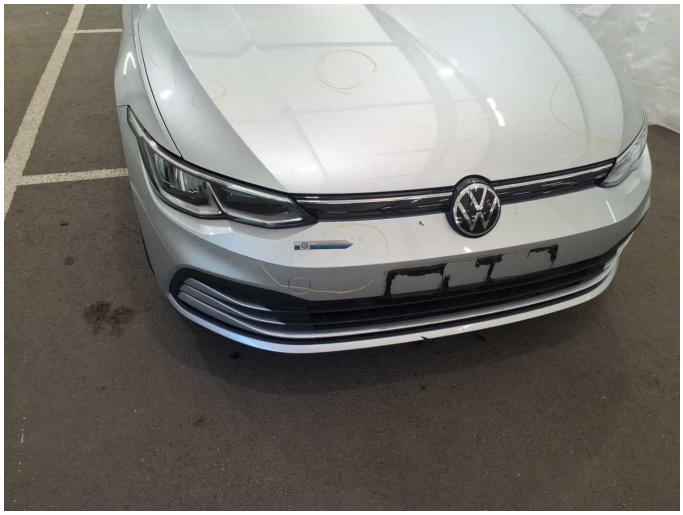
Damage 3: Front bumper: Front bumper (+ Klebereste entfernen) - Scratched - Repair and paint

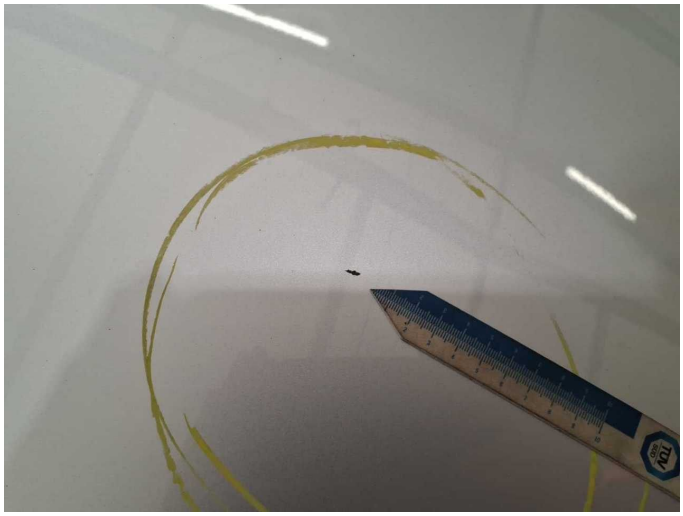
Damage 3: Front bumper: Front bumper (+ Klebereste entfernen) - Scratched - Repair and paint
