Expertise

Protocol number: 48458894
Order No. / Reference: 27248526
Inspection date: 2 Nov 2026

Manufacturer: Mercedes-Benz	Model: 311 CDI Sprinter Kompakt HA
VIN: WDB9076311P160755

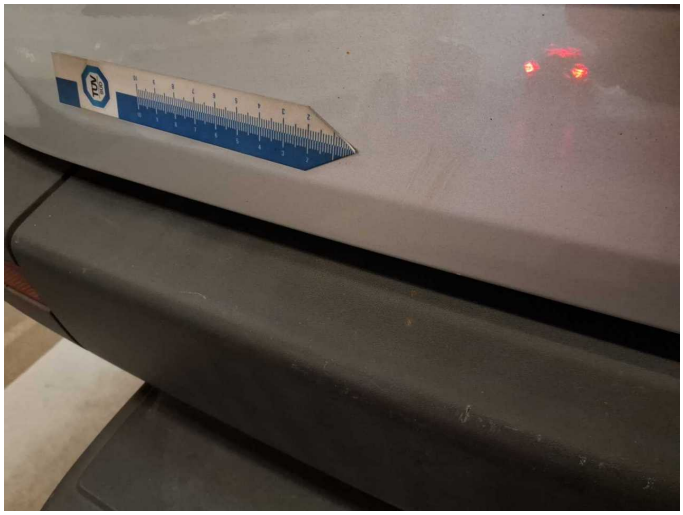
No.	Component group	Description
1	Side panel - rear left side	Side panel - Scratch(es) - Smart repair
2	Sliding door, right	Sliding door - Dent / paintcoat damage - Repair and paint
3	Mudguard - right side	Mudguard - right side (Farbabweichung) - Unprofessionally repaired - Paint
4	Door - front left side	Door (Farbabweichung) - Unprofessionally repaired - Paint
5	Boot lid / rear door	Rear door - right side (Farbabweichung) - Unprofessionally repaired - Paint
6	Boot lid / rear door	Rear door - left side - Dent / paintcoat damage - Paint
7	Door - front right side	Door - Scratch(es) - Paint

Damage 6: Boot lid / rear door: Rear door - left side - Dent / paintcoat damage - Paint
