Expertise

Protocol number: 48572719
Order No. / Reference: 27239305
Inspection date: 4 Nov 2026

Manufacturer: Volkswagen	Model: Tiguan Allspace 2.0 TDI SCR DSG Life
VIN: WVGZZZ5N9PM020347

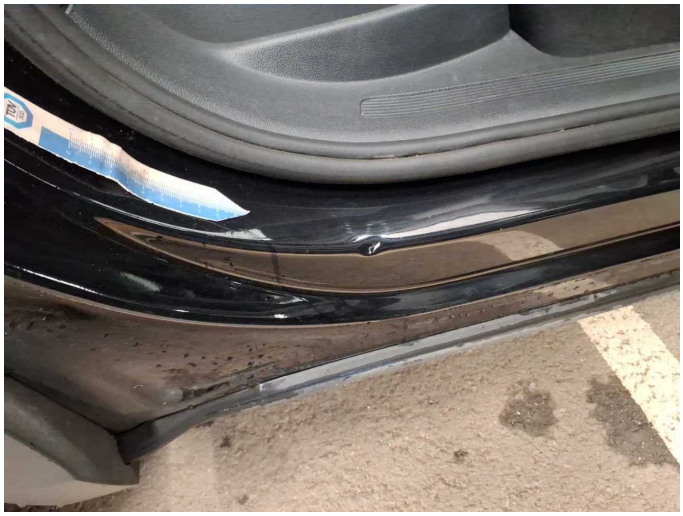
Damage 2: Side panel - rear right side: Sill (Kniestück) - Deformed - Repair and paint

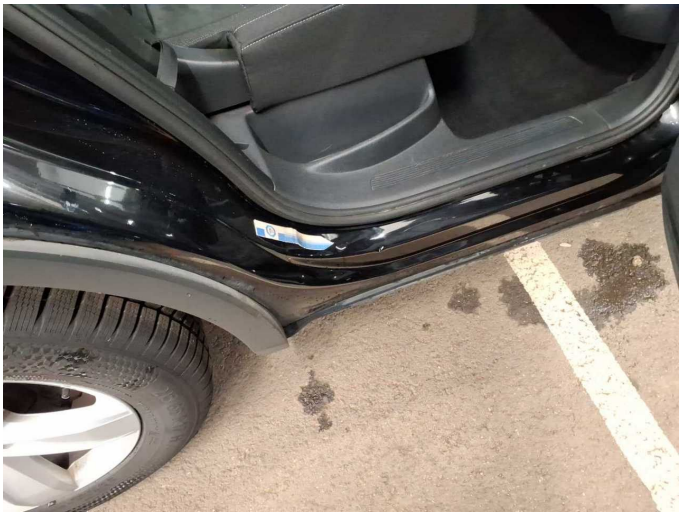
Damage 2: Side panel - rear right side: Sill (Kniestück) - Deformed - Repair and paint

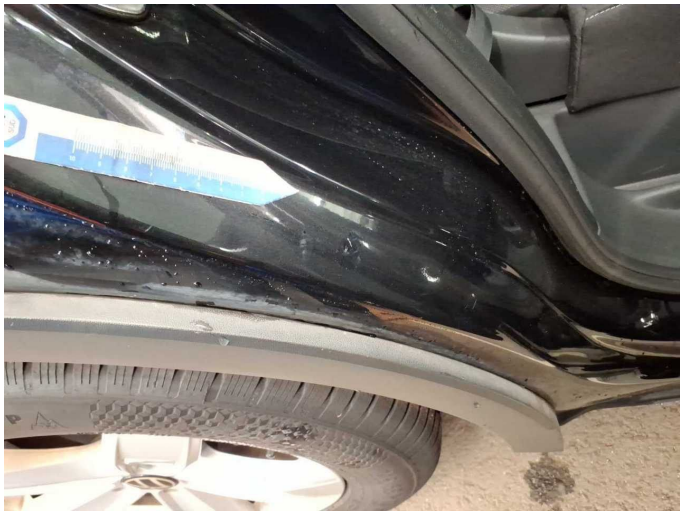
Damage 2: Side panel - rear right side: Sill (Kniestück) - Deformed - Repair and paint

Damage 3: Door - front left side: Door - Dent / paintcoat damage - Repair and paint

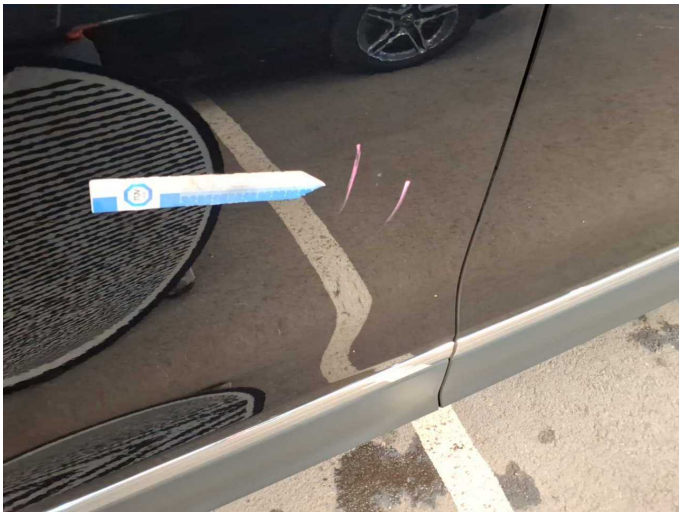
Damage 3: Door - front left side: Door - Dent / paintcoat damage - Repair and paint

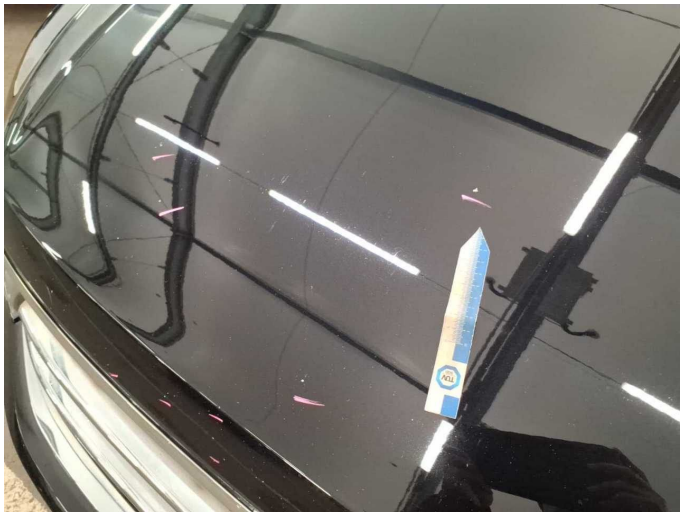
Damage 4: Bonnet: Bonnet (Übermäßige Steinschläge) - Stone chips - Paint

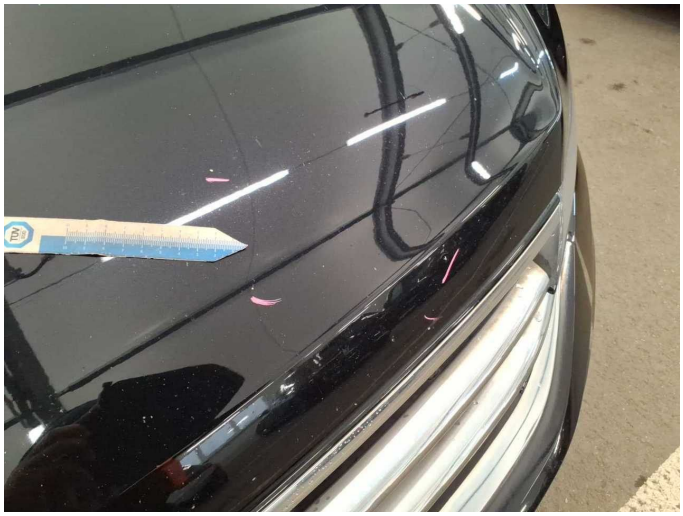
Damage 4: Bonnet: Bonnet (Übermäßige Steinschläge) - Stone chips - Paint
