Expertise

Protocol number: 48234974
Order No. / Reference: 27038177
Inspection date: 21 Oct 2026

Manufacturer: Audi	Model: A4 Avant 35 TDI S tronic
VIN: WAUZZZF49PA079181

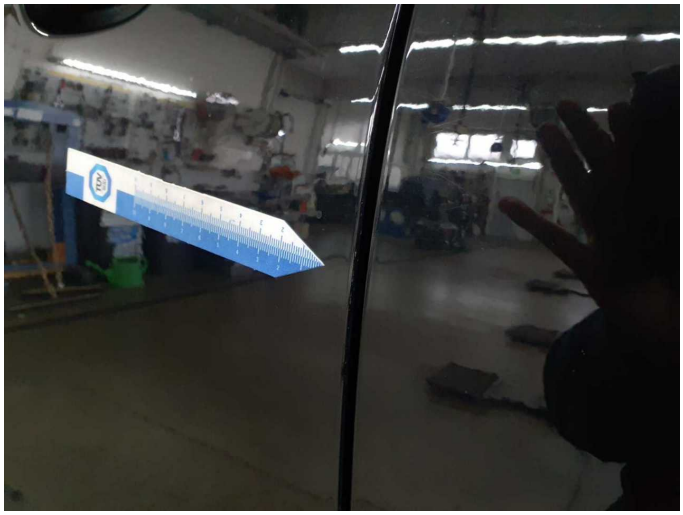
No.	Component group	Description
1	Door - front left side	Door edge - Scratch(es) - Smart repair
2	Door - front right side	Door handle - outside - Scratch(es) - Smart repair
3	Front bumper	Front bumper - Scratch(es) - Smart repair

Damage 1: Door - front left side: Door edge - Scratch(es) - Smart repair

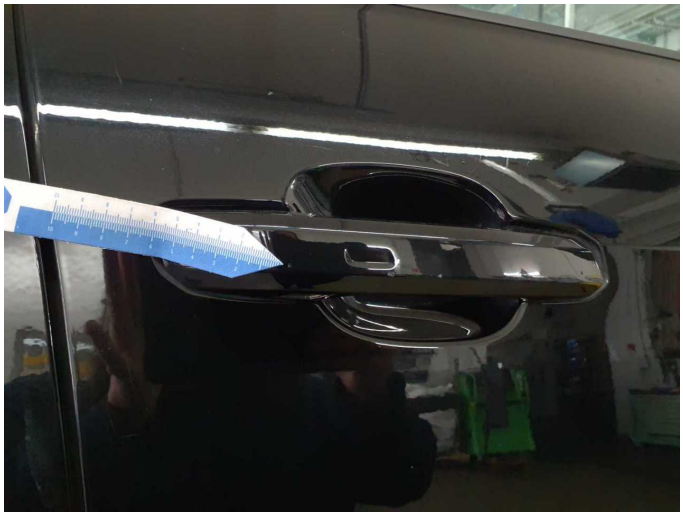
Damage 1: Door - front left side: Door edge - Scratch(es) - Smart repair

Damage 2: Door - front right side: Door handle - outside - Scratch(es) - Smart repair

Damage 3: Front bumper: Front bumper - Scratch(es) - Smart repair
