Expertise

Protocol number: 48547527
Order No. / Reference: 27175030
Inspection date: 4 Nov 2026

Manufacturer: Mercedes-Benz	Model: Vito 116 CDI Extralang HA BASE
VIN: W1V44760514134612

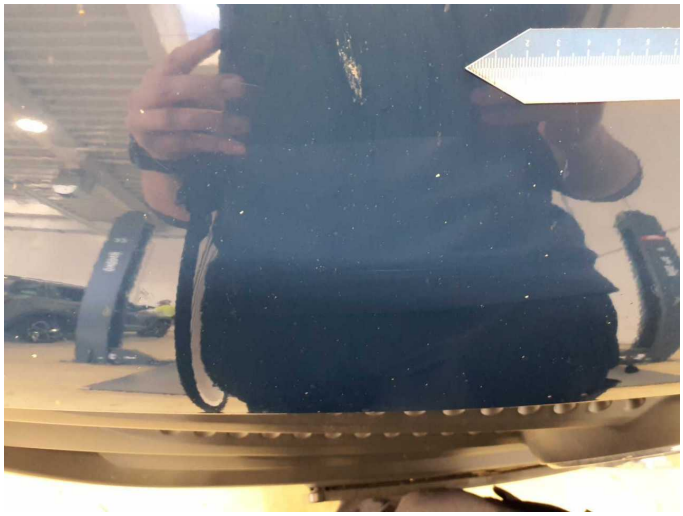
Damage 8: Bonnet: Bonnet - Dent / paintcoat damage - Repair and paint

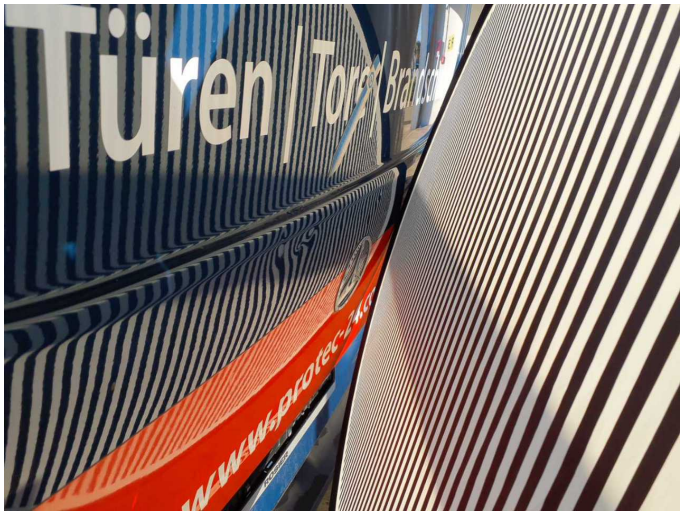
Damage 8: Bonnet: Bonnet - Dent / paintcoat damage - Repair and paint

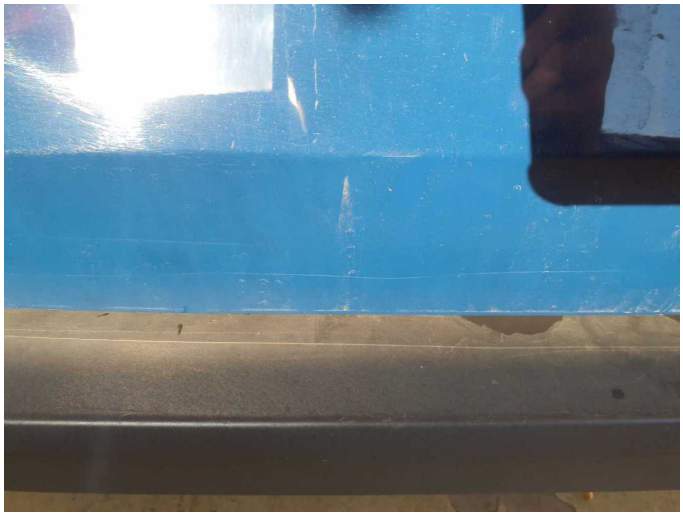
Damage 9: Boot lid / rear door: Boot lid (unterhalb) - Dent / paintcoat damage - Repair and paint

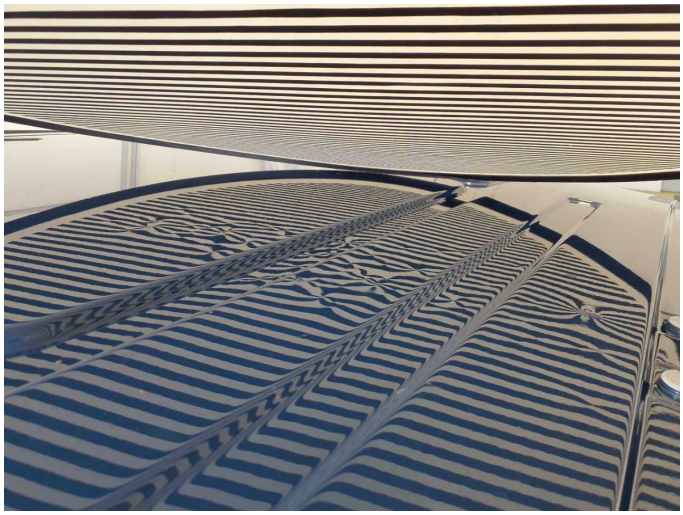
Damage 9: Boot lid / rear door: Boot lid (unterhalb) - Dent / paintcoat damage - Repair and paint

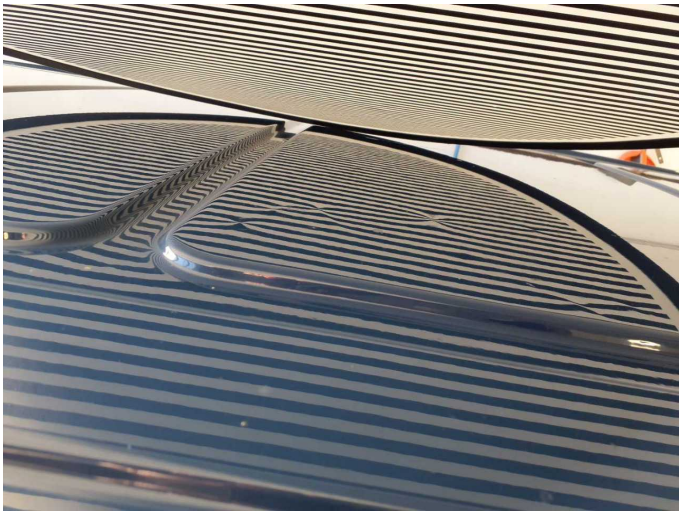
Damage 10: Roof: Roof - Deformed - repair according to calculation
