TÜV SÜD Auto Partner GmbH
Wiesenring 2
04159 Leipzig

Expertise

Protocol number: 48562438
Order No. / Reference: 27204510
Inspection date: 6 Nov 2026

Manufacturer: Skoda	Model: Enyaq iV 50
VIN: TMBJA9NY1NF027913

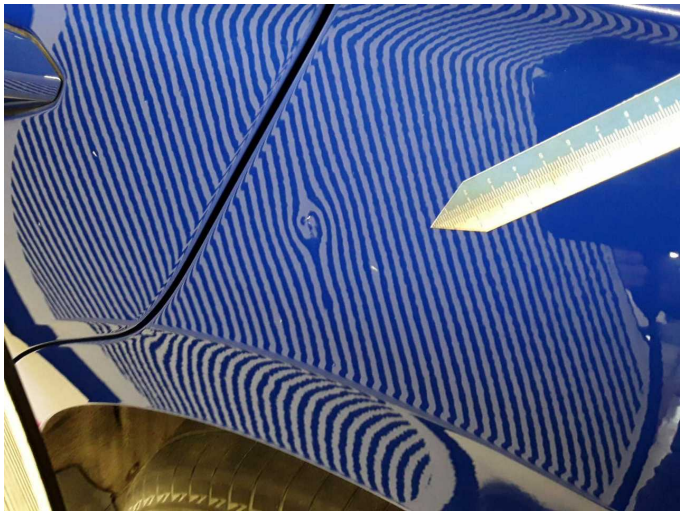
Damage 7: Door - front right side: Door - Scratch(es) - Smart repair

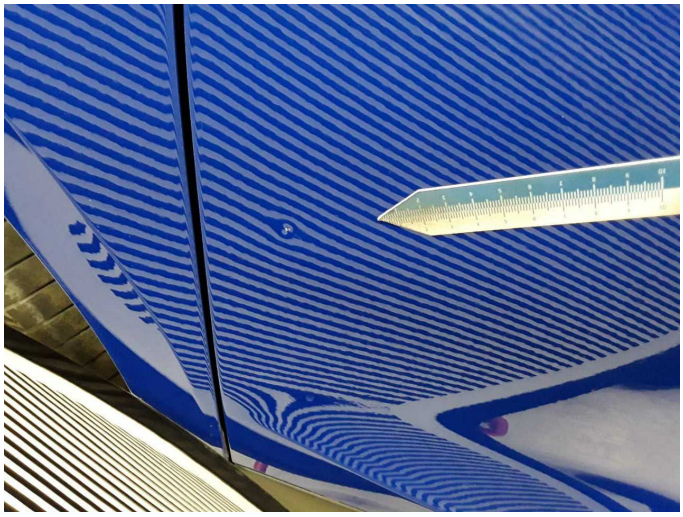
Damage 9: Door - front left side: Door - Dent / paintcoat damage - Smart repair

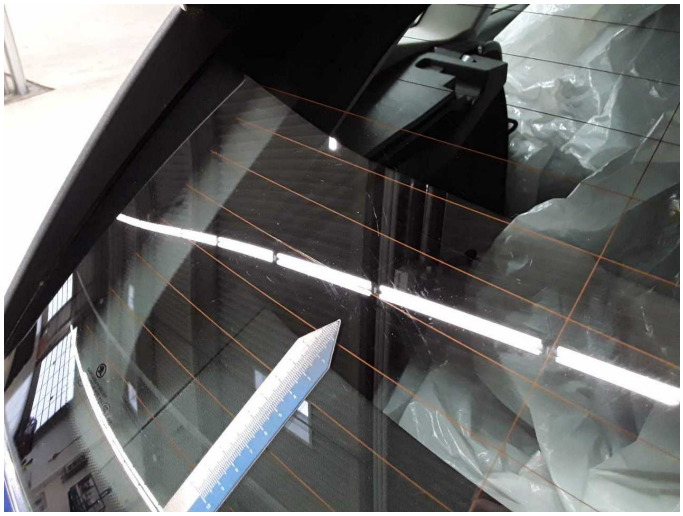
Damage 11: Vehicle glazing: Rear window - Scratch(es) - Loss in value

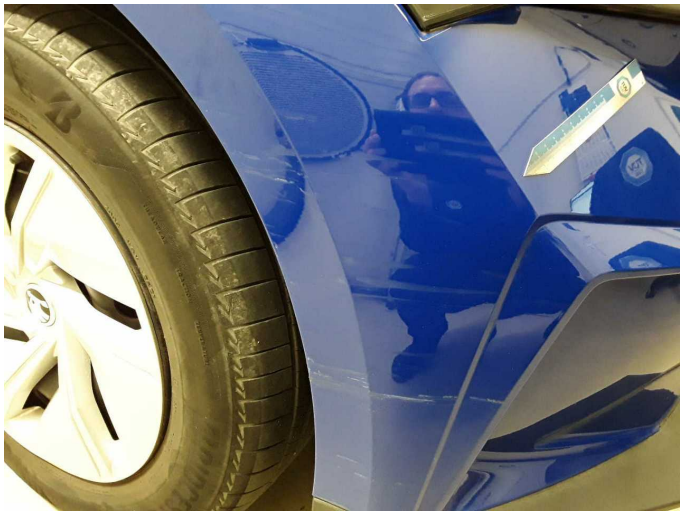
Damage 12: Front bumper: Front bumper - Scratch(es) - Paint

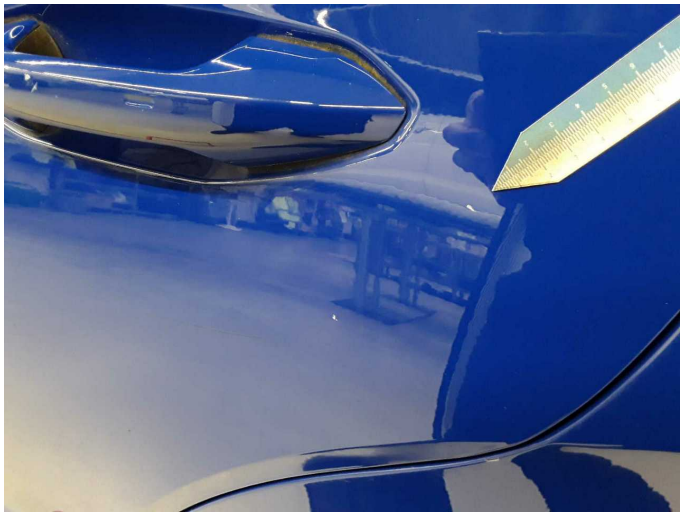
Damage 13: Door - rear left side: Door - Scratch(es) - Paint

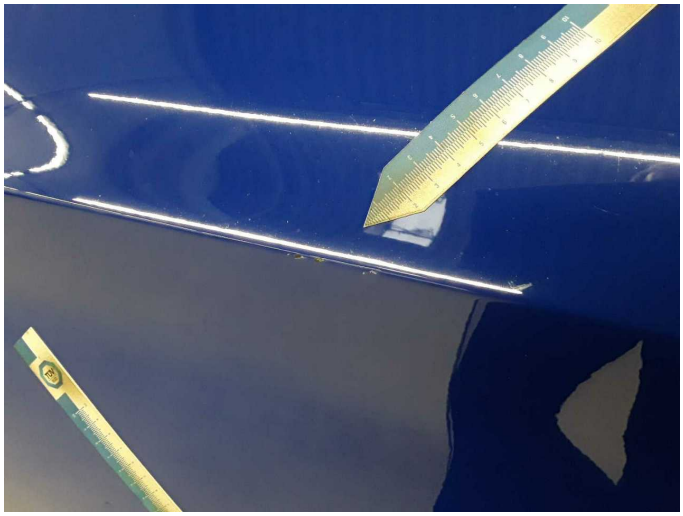
Damage 13: Door - rear left side: Door - Scratch(es) - Paint

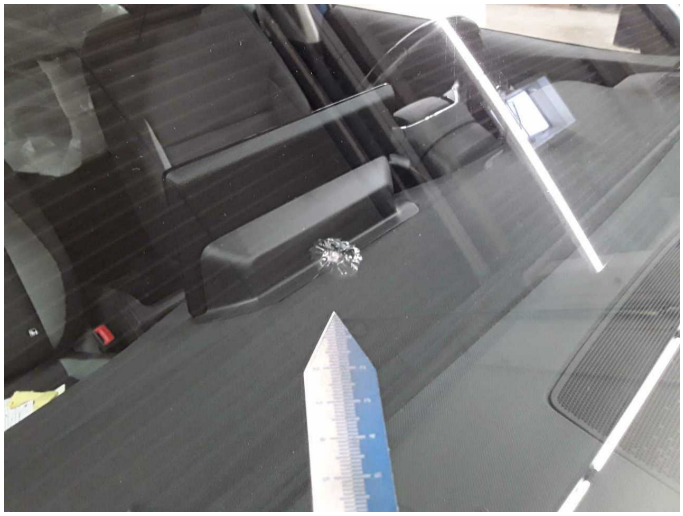
Damage 14: Bonnet: Bonnet (Lackeinätzung) - Paint defect - Paint

Damage 15: Vehicle glazing: Windscreen with lane departure assistant - Stone chips - Replace
