Expertise

Protocol number: 48115122
Order No. / Reference: 27080880
Inspection date: 14 Oct 2026

Manufacturer: Ford	Model: S-Max 2.0 EcoBlue Aut. Trend
VIN: WF0JXXWPCJNM10465

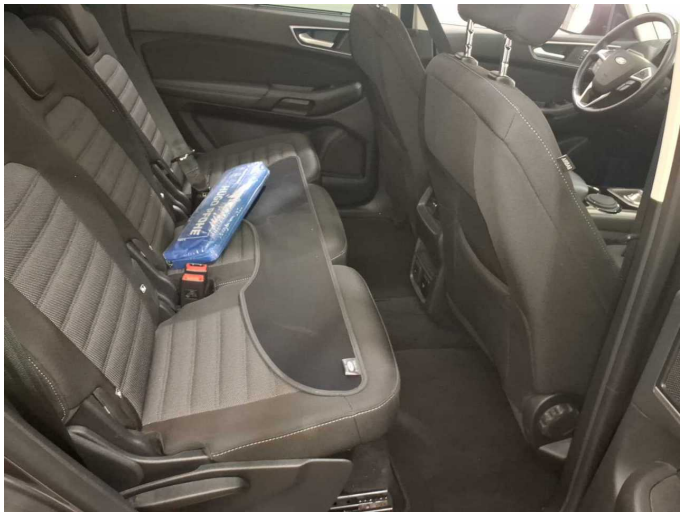
No.	Component group	Description
1	Door - front right side	Door - Scratch(es) - No deduction
2	Front bumper	Front bumper - Stone chips - No deduction
3	Interior	Interior - Scratch(es) - No deduction
4	Bonnet	Bonnet - Stone chips - No deduction
5	Vehicle glazing	Windscreen - Stone chips - No deduction
6	Rear bumper	Rear bumper - Scratch(es) - Cover / polish

Wear and tear 6: Rear bumper: Rear bumper - Scratch(es) - Cover / polish
