Expertise

Protocol number: 48008797
Order No. / Reference: 27031196-1
Inspection date: 6 Oct 2026

Manufacturer: Opel	Model: Zafira Life 2.0 D M Aut. Edition
VIN: VXEVEEHZ7NZ015735

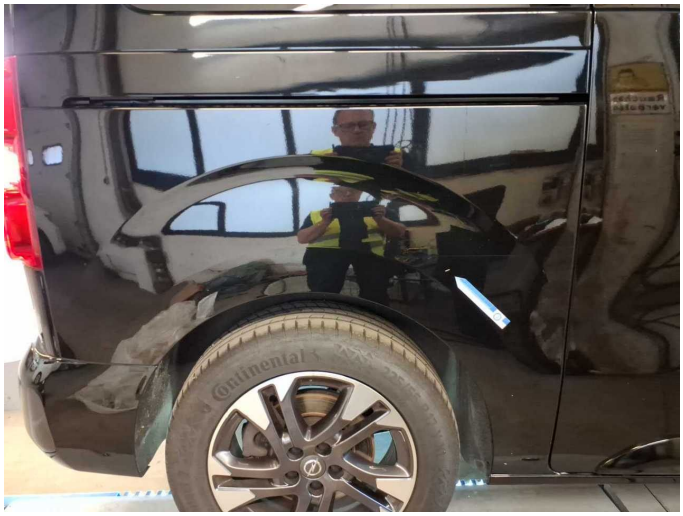
Damage 2: Side panel - rear right side: Sill - Dent / paintcoat damage - Smart repair

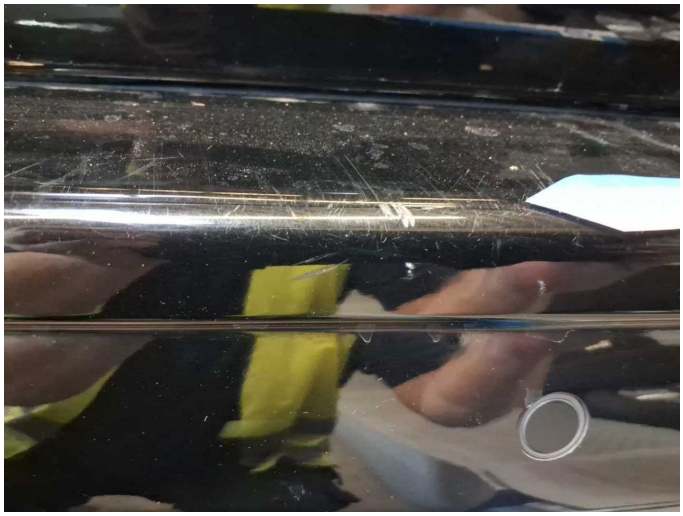
Damage 5: Rear bumper: Rear bumper - Scratch(es) - Paint

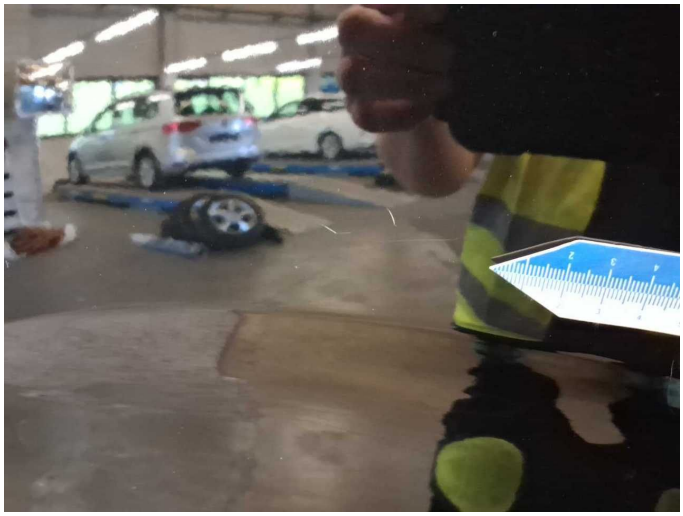
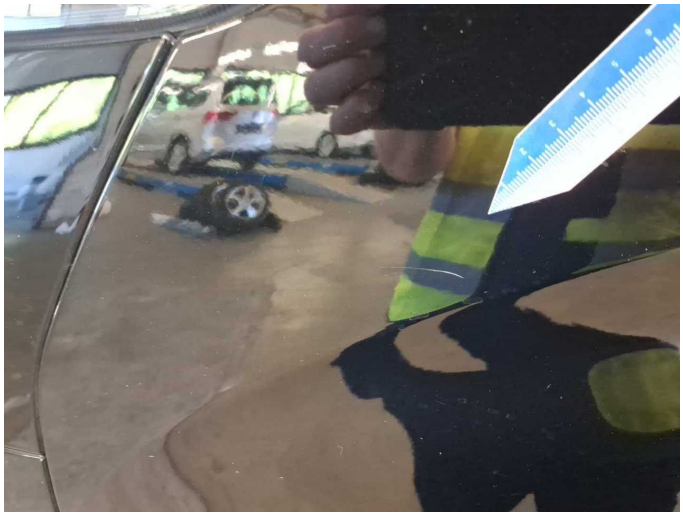
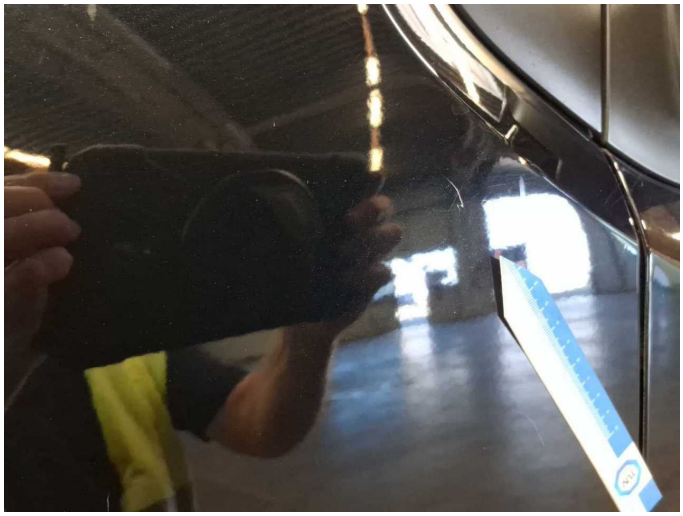
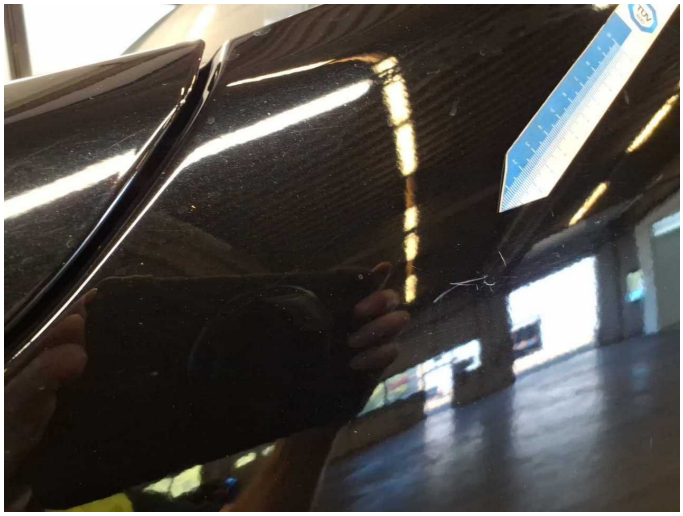
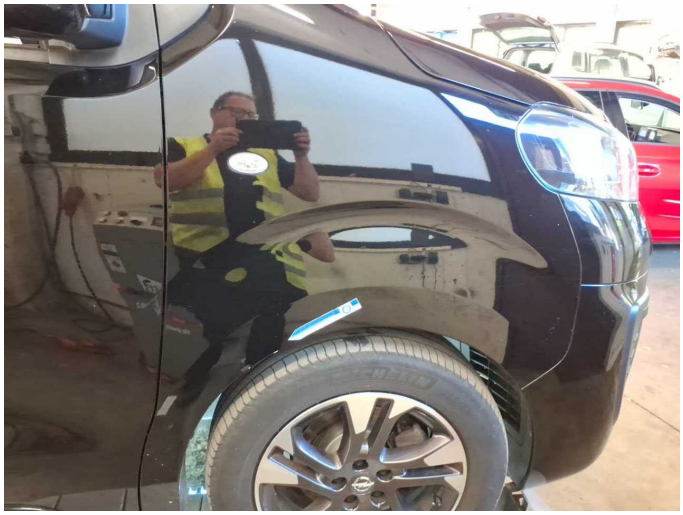
Damage 6: Mudguard - left side: Mudguard - left side - Scratch(es) - Paint

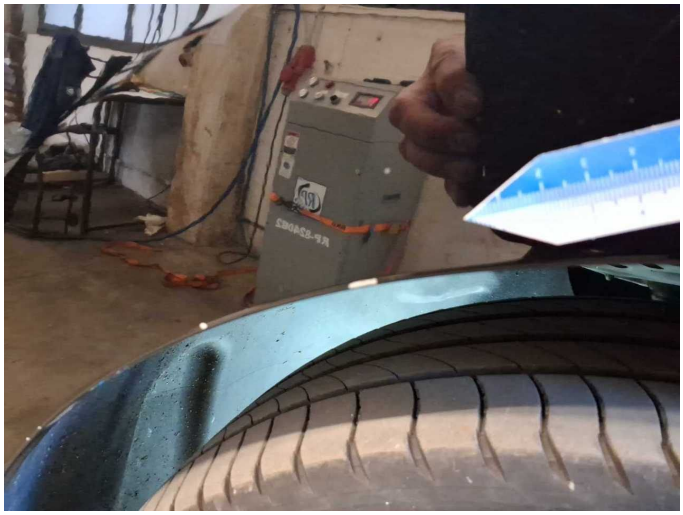
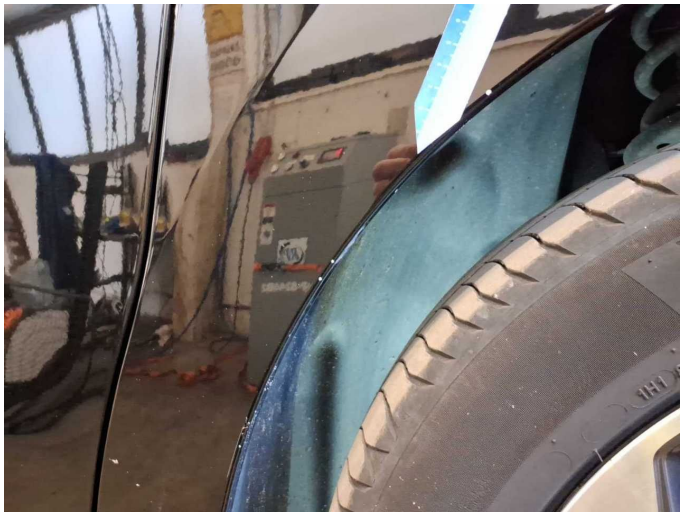
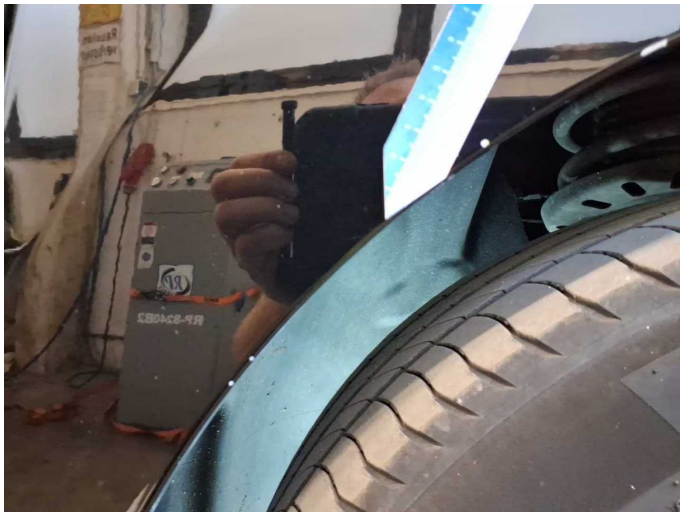
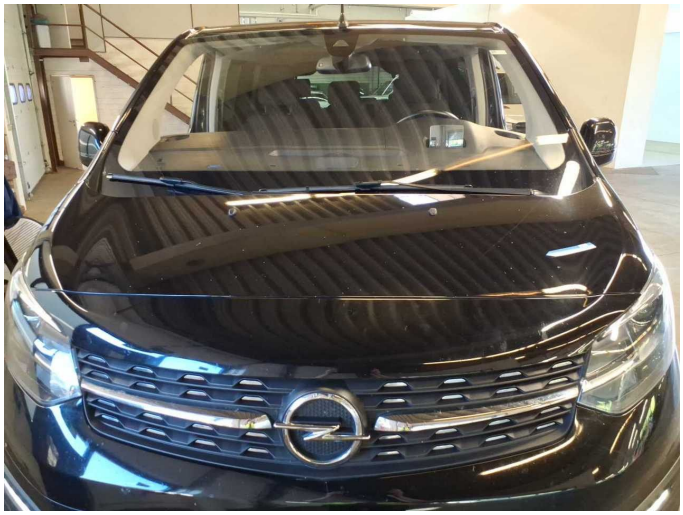
Damage 7: Mudguard - right side: Mudguard - right side - Scratch(es) - Paint

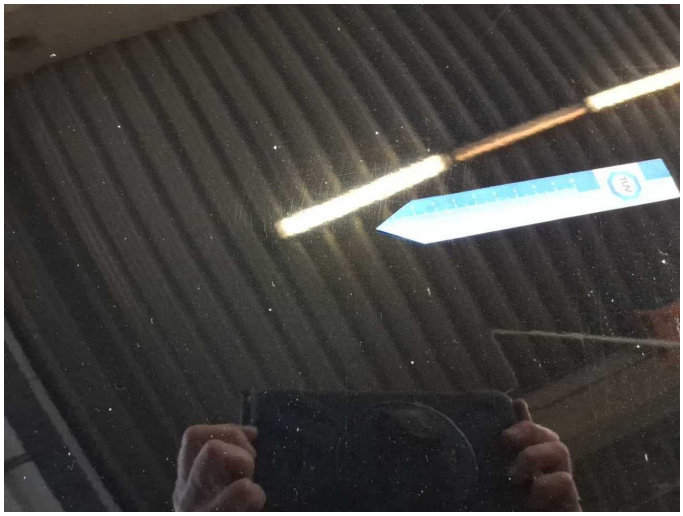
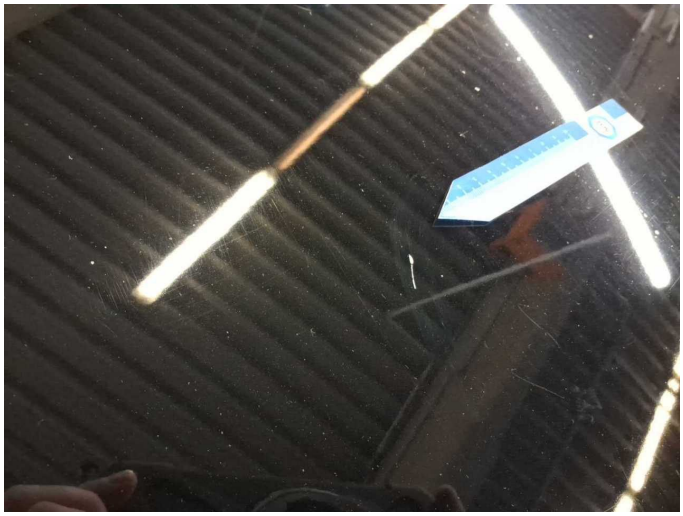
Damage 8: Bonnet: Bonnet (Streusandeffekt) - Stone chips - Paint

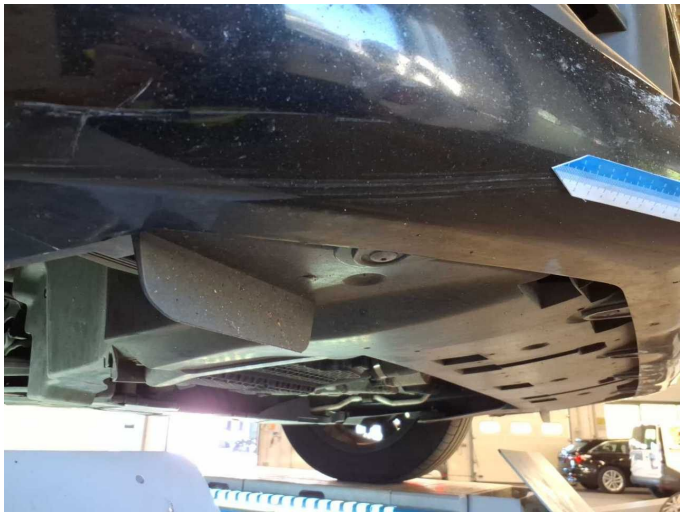
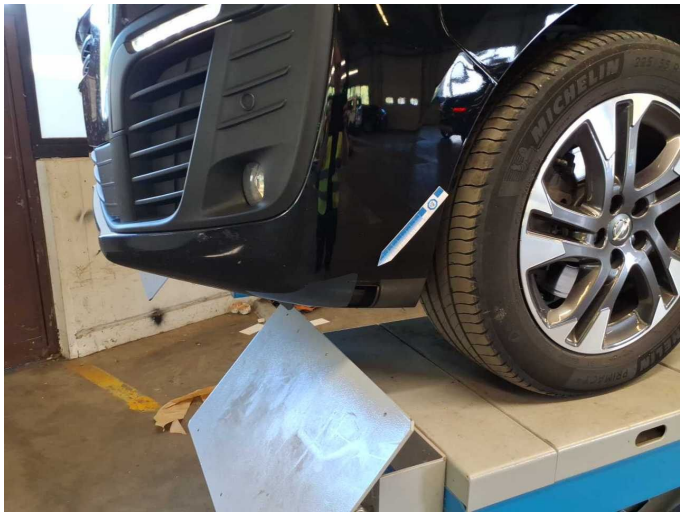
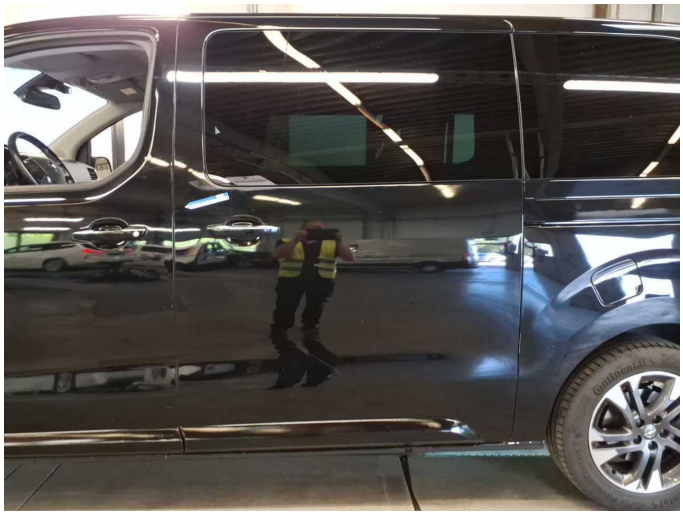
Damage 9: Front bumper: Front bumper (Streusandeffekt) - Scratched - Paint

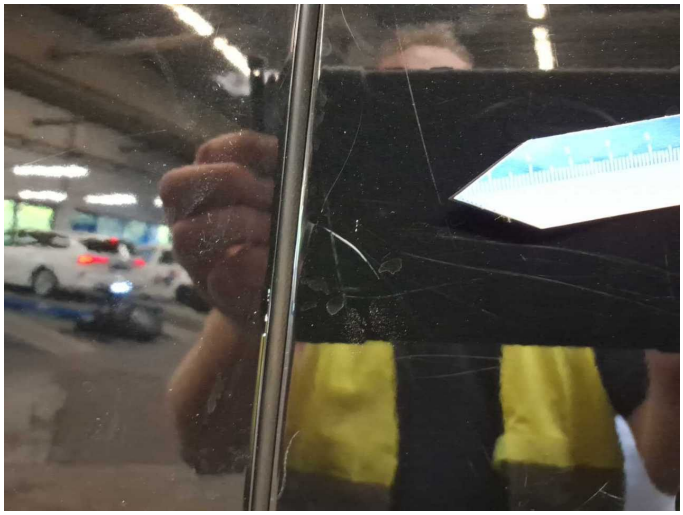
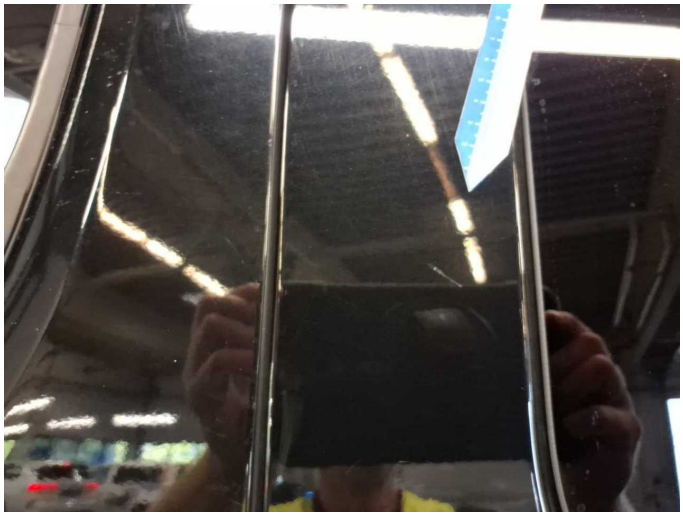
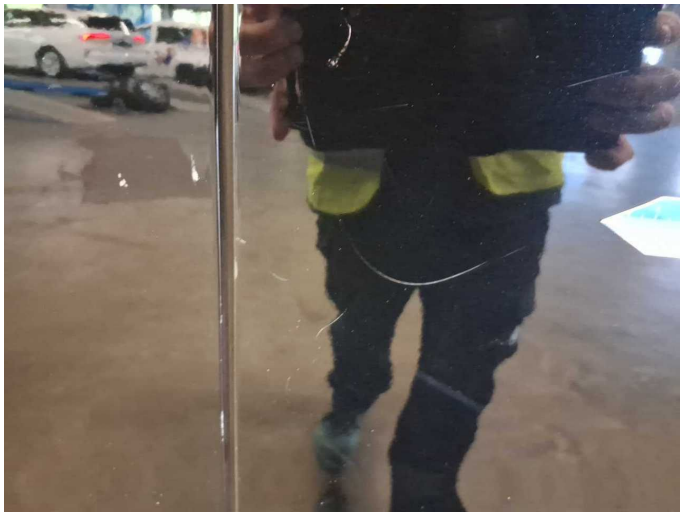
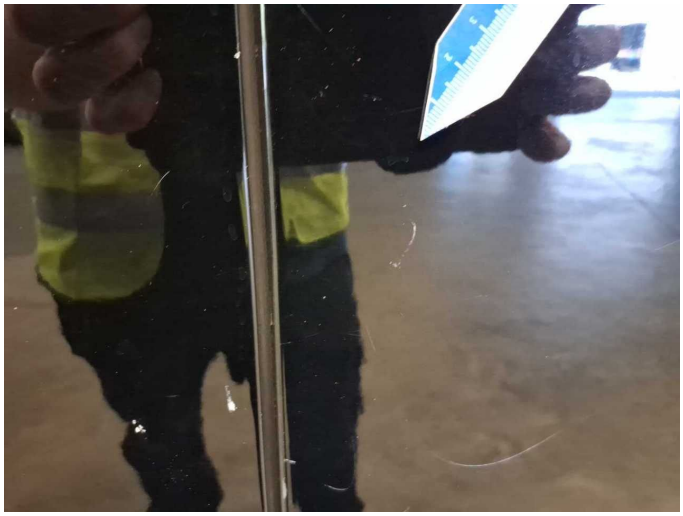
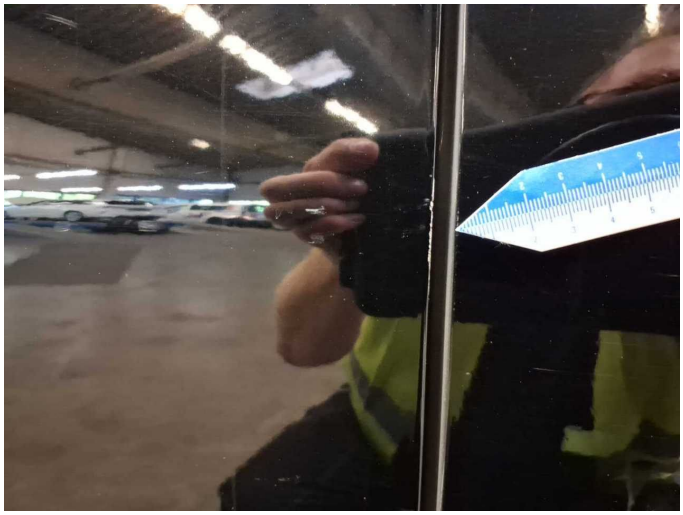
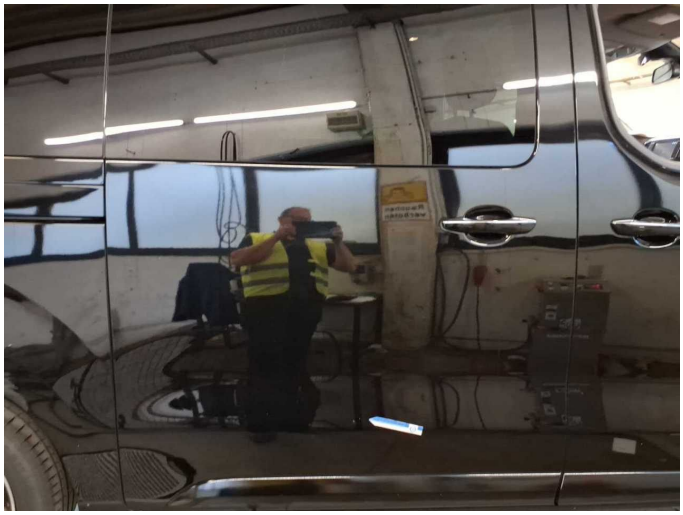
Damage 10: Sliding door - left side: Sliding door with glass panel - Scratch(es) - Paint

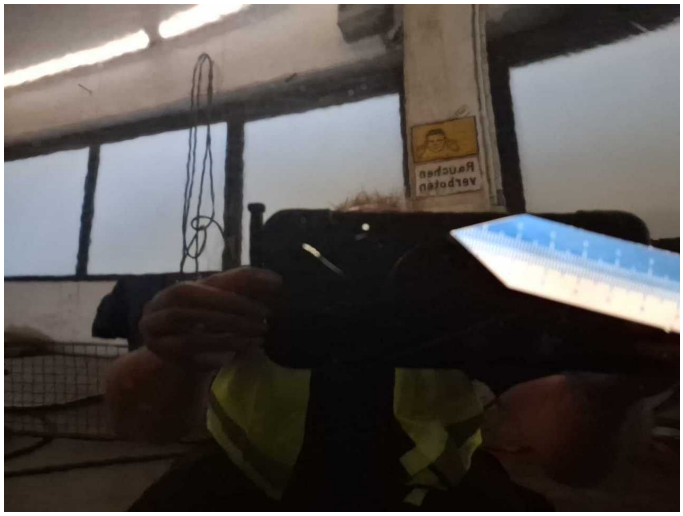
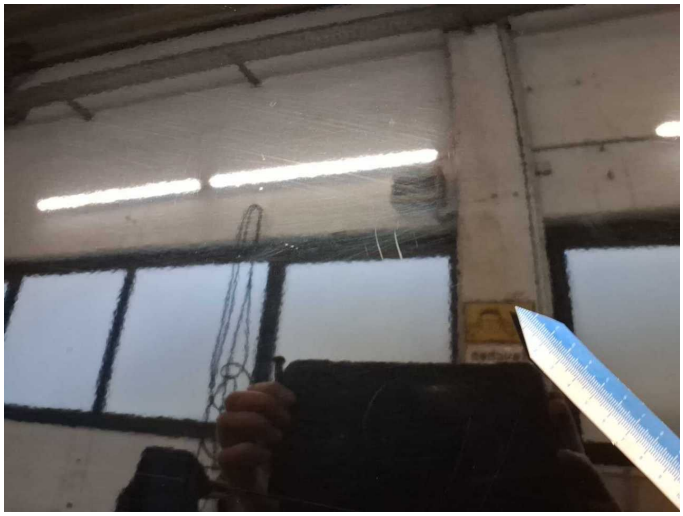
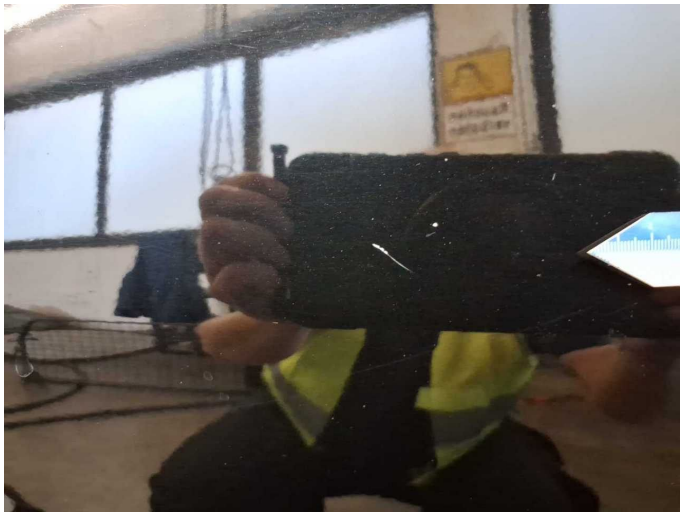
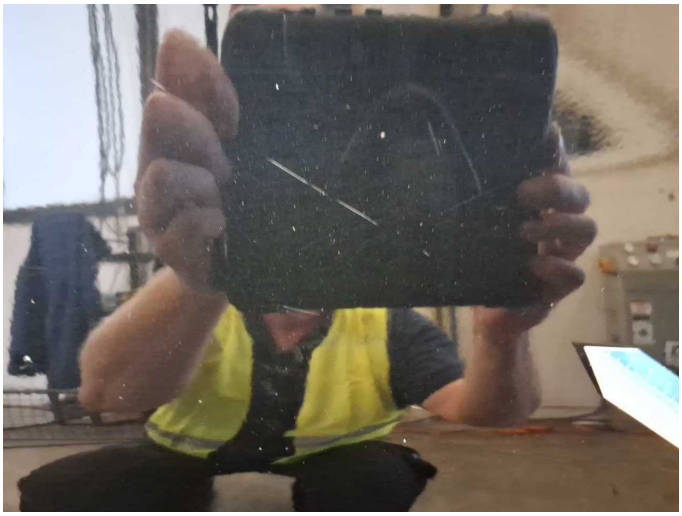
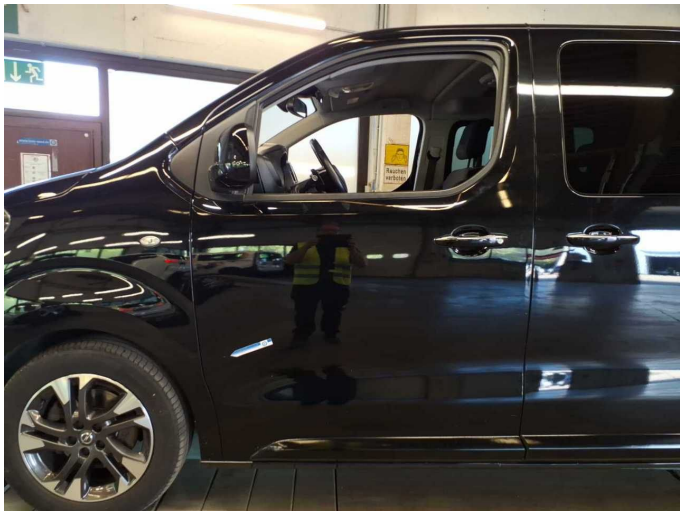
Damage 11: Sliding door, right: Sliding door with glass panel - Scratch(es) - Paint

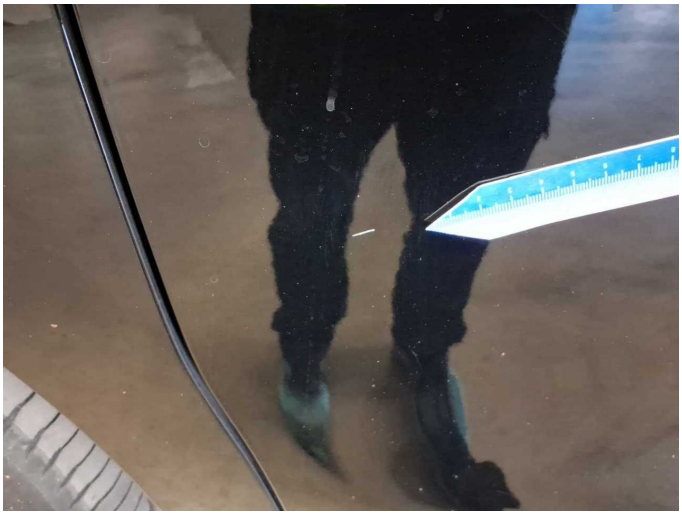
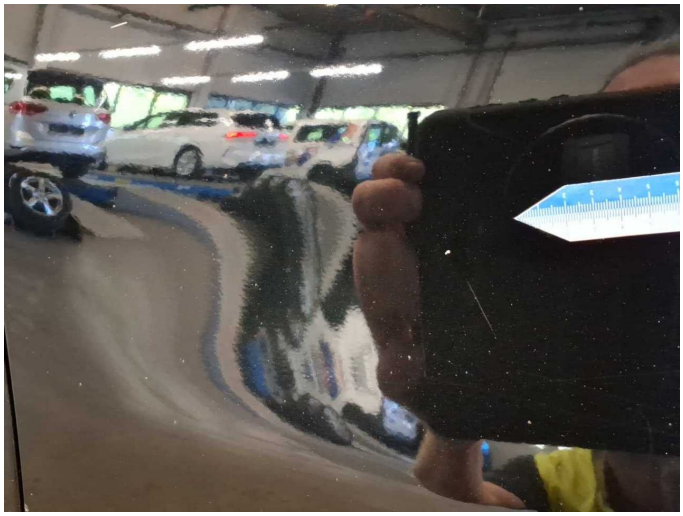
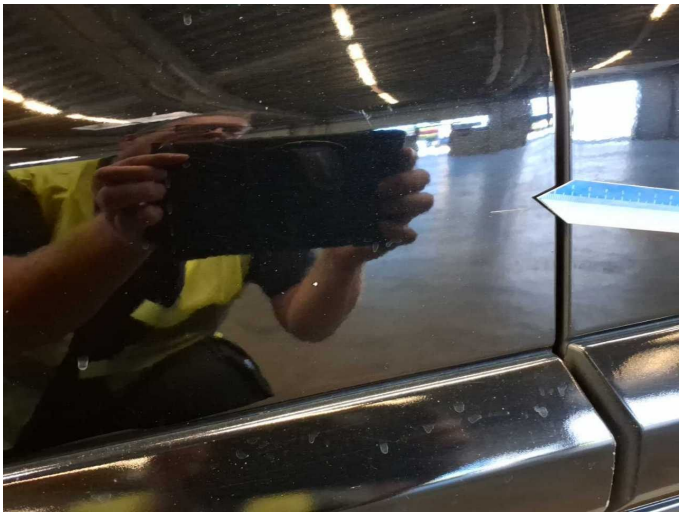
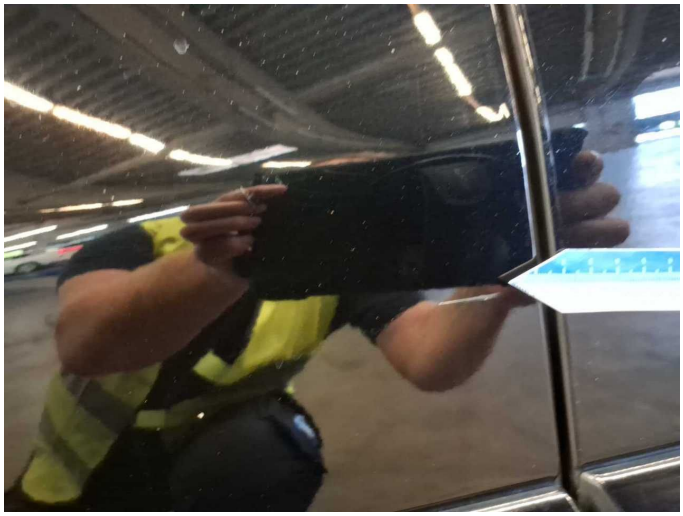
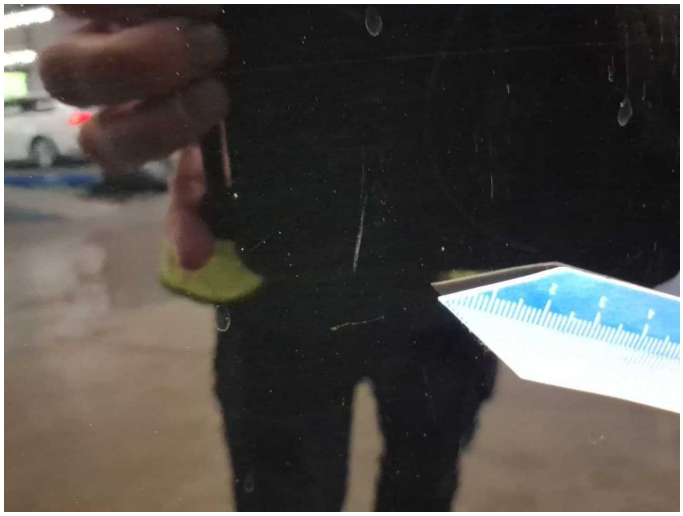
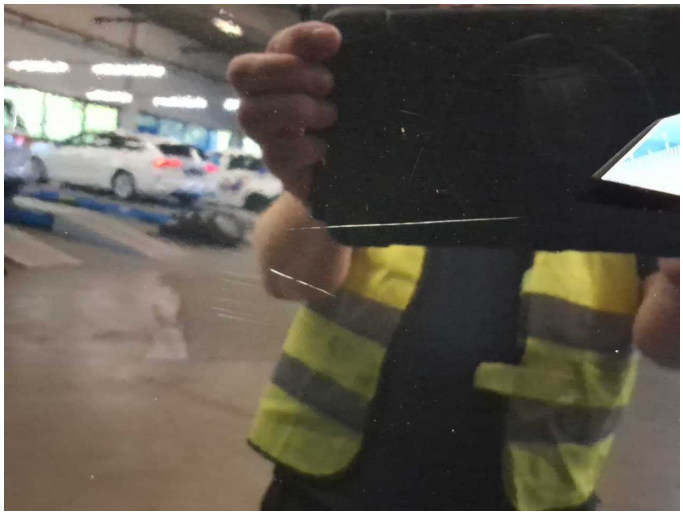
Damage 12: Door - front left side: Door - Scratch(es) - Paint

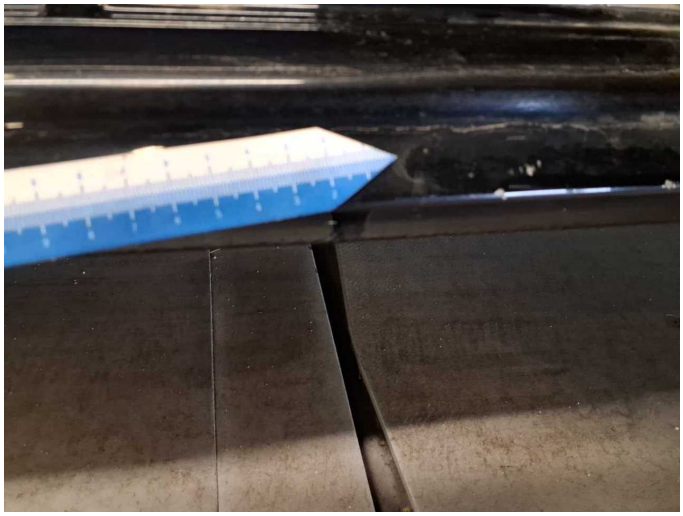
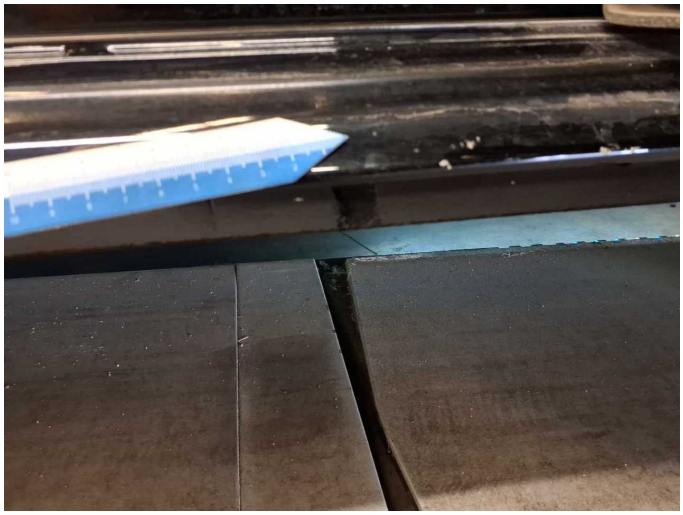
Damage 13: Sill - left side: Sill (vorne und hinten) - Dent / paintcoat damage - Repair and paint

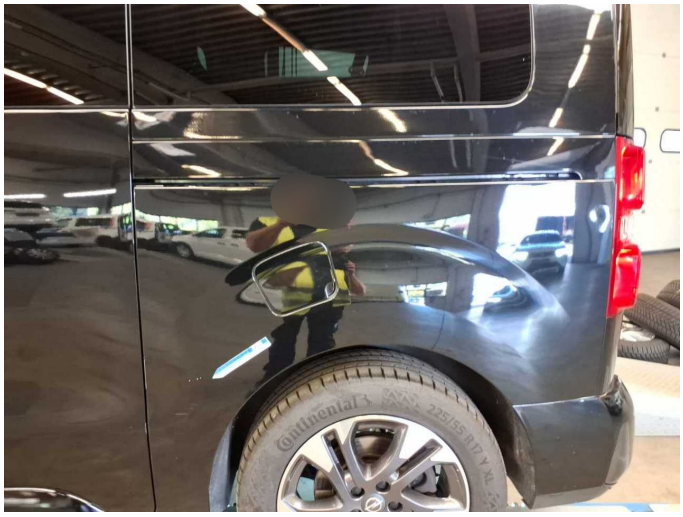
Damage 14: Side panel - rear left side: Side panel - Scratch(es) - Paint
