Expertise

Protocol number: 48149966
Order No. / Reference: 27114353
Inspection date: 15 Oct 2026

Manufacturer: Mercedes-Benz	Model: C 300 e T 9G-TRONIC AMG Line
VIN: W1KAH5EB5PF069302

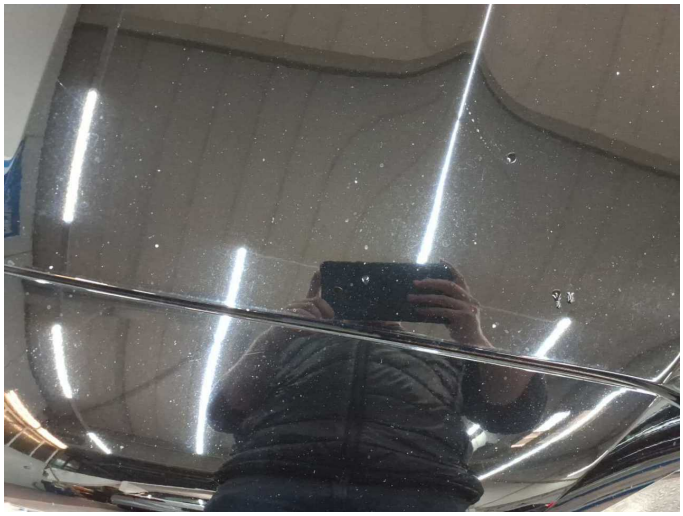
No.	Component group	Description
1	Equipment	Vehicle key - Scratch(es) - Loss in value
2	Body	A-pillar - right side - Stone chips - Smart repair
3	2nd wheel set	1 alloy rim - Scratch(es) - Loss in value
4	2nd wheel set	1 alloy rim - Scratch(es) - Loss in value
5	Rear bumper	Rear bumper - Dent / paintcoat damage - Paint
6	Bonnet	Bonnet - Stone chips - Paint

Damage 6: Bonnet: Bonnet - Stone chips - Paint

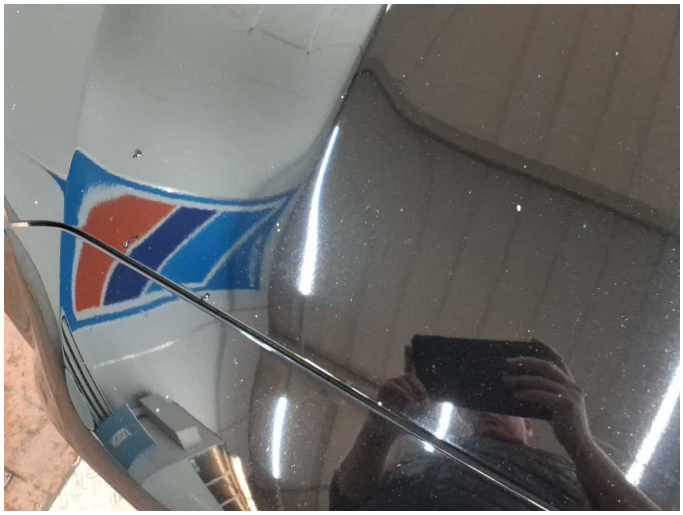
Damage 6: Bonnet: Bonnet - Stone chips - Paint

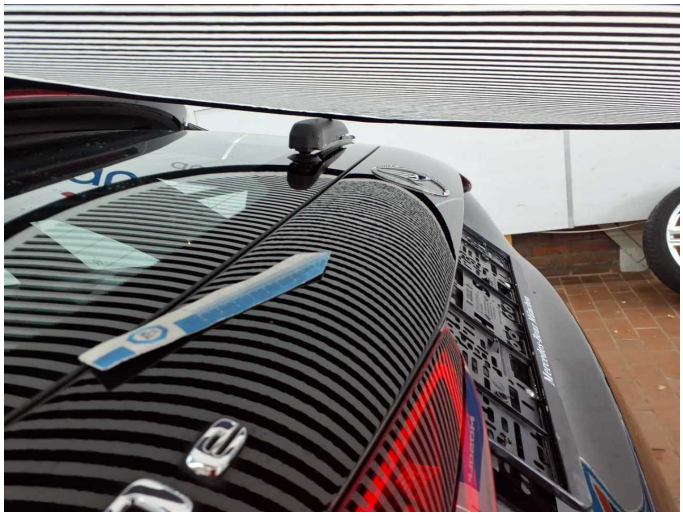
No.	Component group	Description
1	Front bumper	Front bumper - Stone chips - No deduction
2	Boot lid / rear door	Boot lid - dent(s) - No deduction

Damage 6: Bonnet: Bonnet - Stone chips - Paint

Wear and tear 2: Boot lid / rear door: Boot lid - dent(s) - No deduction
