# Expertise

Protocol number: 48337591
Order No. / Reference: 27019194
Inspection date: 22 Oct 2026

| Manufacturer: Opel | Model: Astra 1.5 D Start/Stop Sports Tourer Edition |

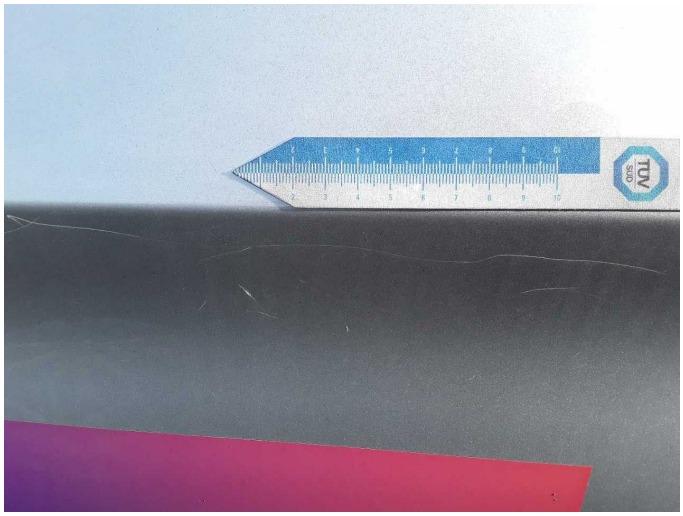
| No. | Component group | Description |
|---|---|---|
| 3 | Side panel - rear left side | Side panel - Scratch(es) - Paint |

**Damage 3:** Side panel - rear left side: Side panel - Scratch(es) - Paint

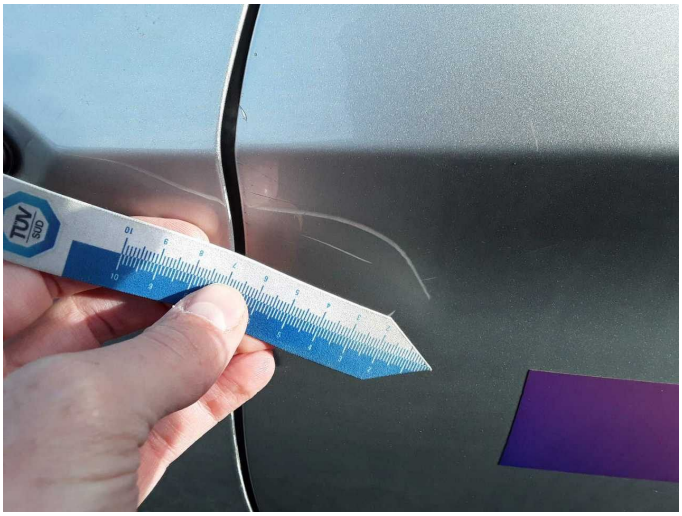
| No. | Component group | Description |
|---|---|---|
| 4 | Door - rear left side | Door - Scratch(es) - Paint |

**Damage 4:** Door - rear left side: Door - Scratch(es) - Paint
