TÜV SÜD Auto Partner GmbH
Wiesenring 2
04159 Leipzig

# Expertise

Protocol number: 48090241
Order No. / Reference: 27067122
Inspection date: 13 Oct 2026

| Manufacturer: Audi | Model: A6 Avant 50 TDI quattro tiptronic |

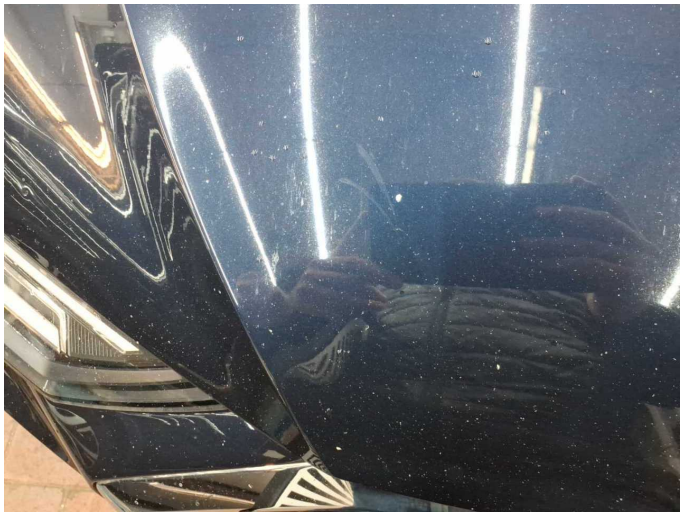
| No. | Component group | Description |
|---|---|---|
| 4 | Bonnet | Bonnet - Dent / paintcoat damage - Paint |

**Damage 4:** Bonnet: Bonnet - Dent / paintcoat damage - Paint

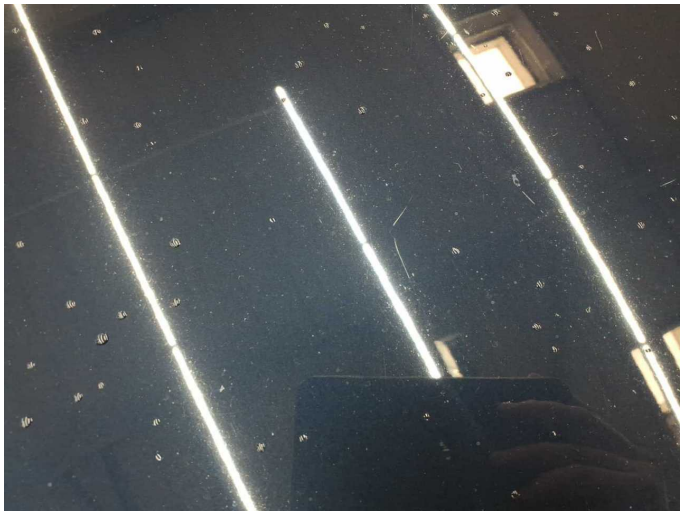
**Damage 4:** Bonnet: Bonnet - Dent / paintcoat damage - Paint

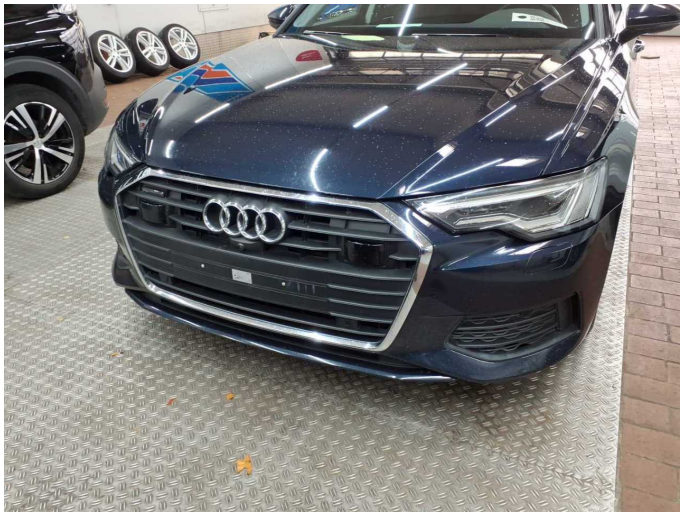
**Damage 4:** Bonnet: Bonnet - Dent / paintcoat damage - Paint
