TÜV SÜD Auto Partner GmbH
Wiesenring 2
04159 Leipzig

Expertise

Protocol number: 48397968
Order No. / Reference: 27210454
Inspection date: 27 Oct 2026

Manufacturer: Volkswagen	Model: Passat Variant 1.4 TSI Plug-In-Hybrid DSG GTE
VIN: WVWZZZ3CZME018832

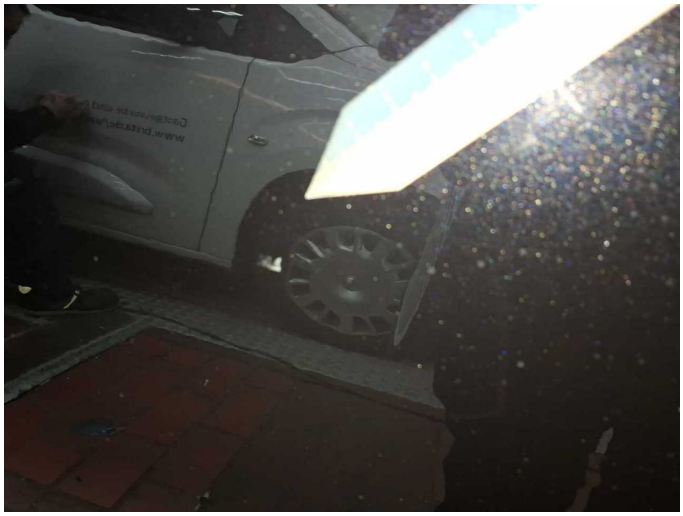
No.	Component group	Description
1	Door - rear left side	Door - Dent / paintcoat damage - Smart repair
2	Side panel - rear left side	Side panel - Scratch(es) - Smart repair
3	Rear bumper	Rear bumper - Scratch(es) - Smart repair
4	Bonnet	Bonnet (Steinschläge) - Dent / paintcoat damage - Repair and paint

Damage 1: Door - rear left side: Door - Dent / paintcoat damage - Smart repair

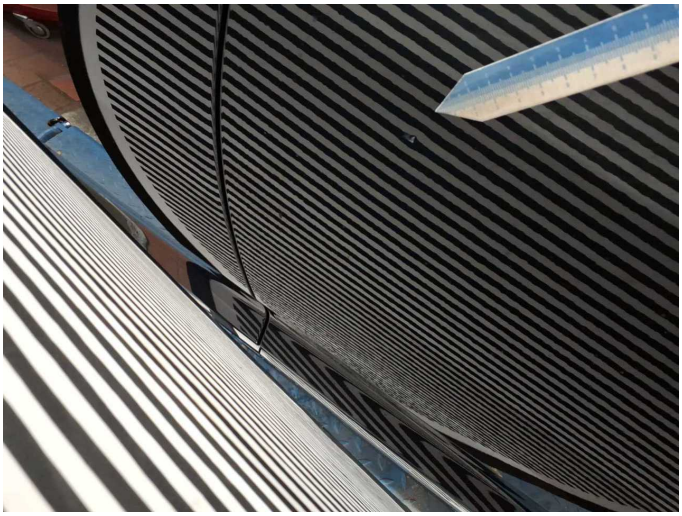
Damage 1: Door - rear left side: Door - Dent / paintcoat damage - Smart repair

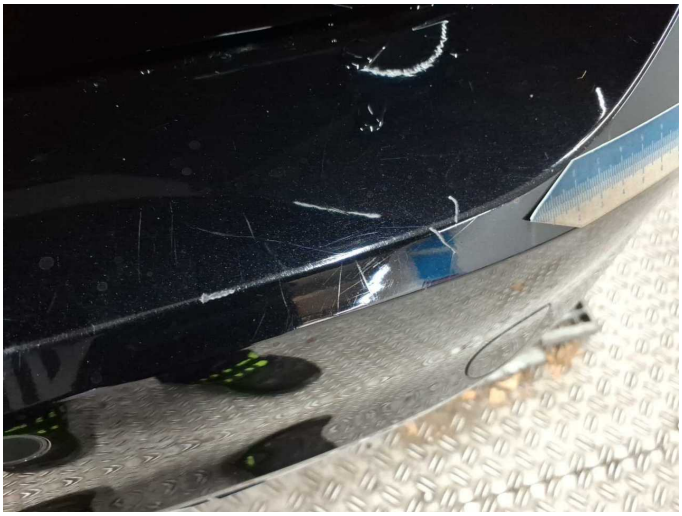
Damage 2: Side panel - rear left side: Side panel - Scratch(es) - Smart repair

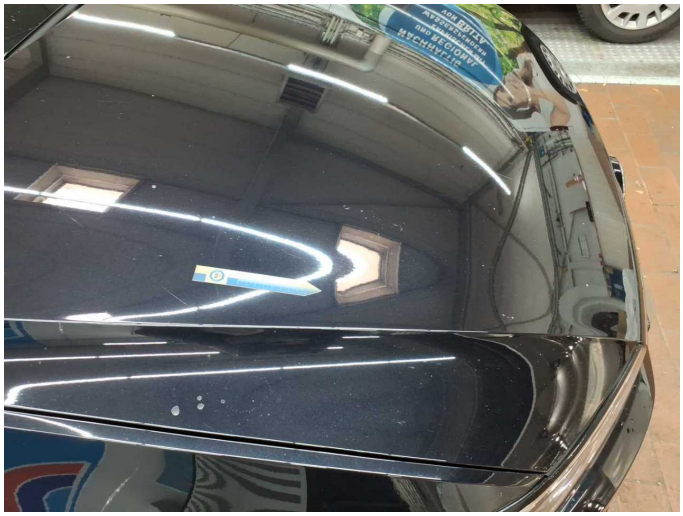
Damage 3: Rear bumper: Rear bumper - Scratch(es) - Smart repair

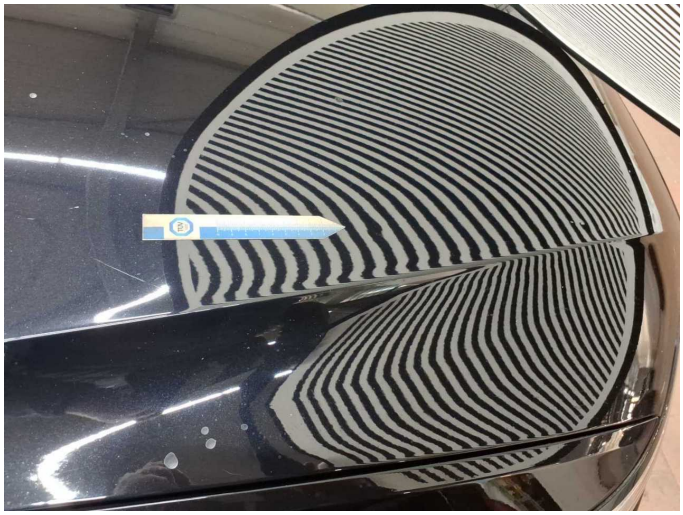
Damage 4: Bonnet: Bonnet (Steinschläge) - Dent / paintcoat damage - Repair and paint

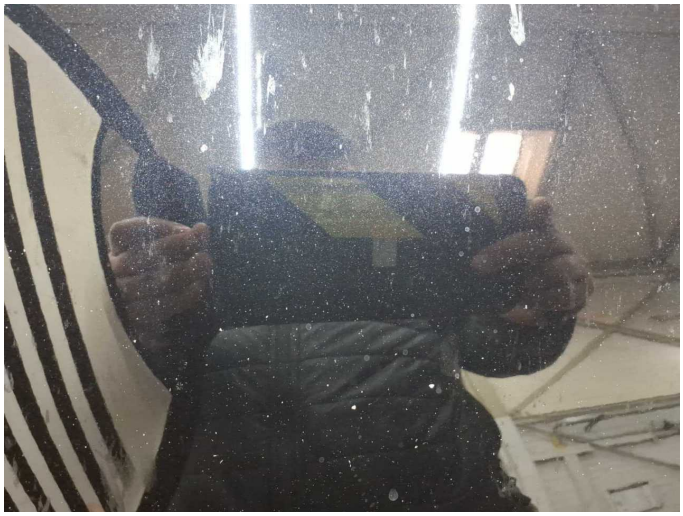
Damage 4: Bonnet: Bonnet (Steinschläge) - Dent / paintcoat damage - Repair and paint
