BMW X2

Vehicle information

Summary of damages

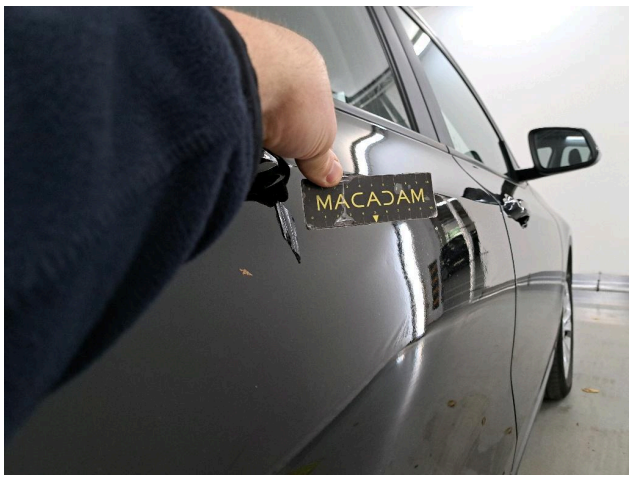
Left rear wing
repaired,
acceptable
condition.

Front right wing
repaired,
acceptable
condition.

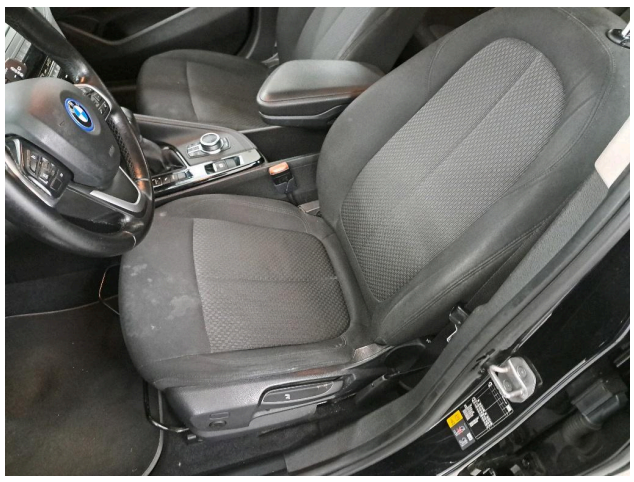
Interior

Interior - Acceptable
Wear and Tear

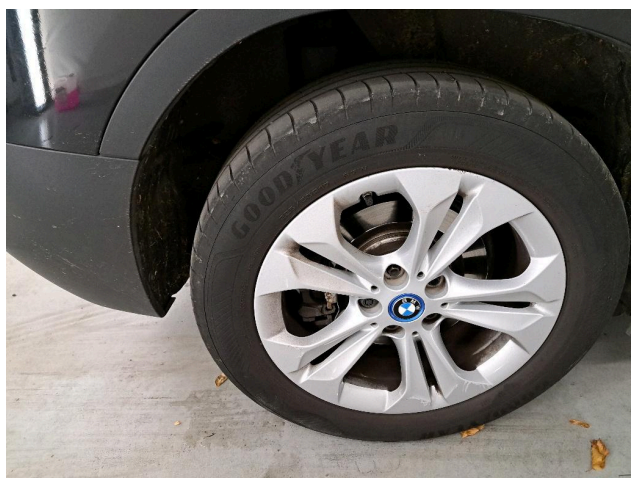
Alloy wheel, right rear, scratch
(es)
, left front - Repair and paint (complete),
right side

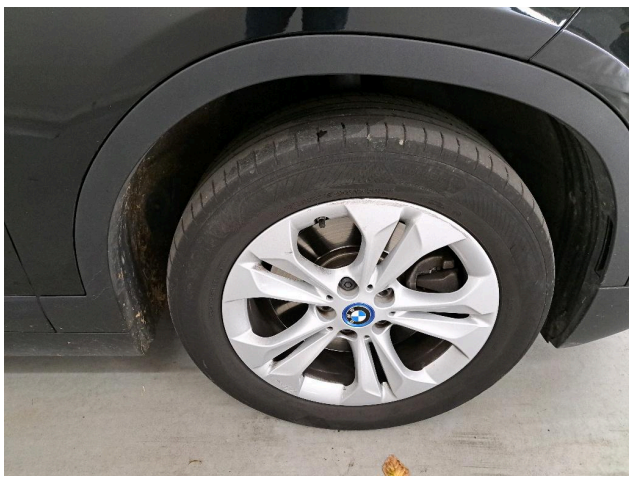
Alloy wheel, **left-hand side.**
Acceptable
.

Alloy wheel AVD
Scratch(es)
LI - Repair and paint (complete)
Right

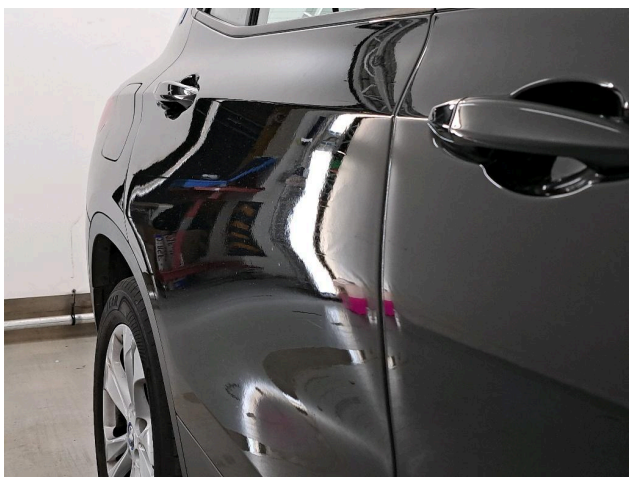
Broken **front left door seal**
-
Replace

Right rear door
repaired,
acceptable
condition.

Porte ARG
Réparé
Acceptable
Gauche
