Expertise

Protocol number: 48469694
Order No. / Reference: 26812324-1
Inspection date: 12 Aug 2026

Manufacturer: Opel	Model: Insignia Sports Tourer 2.0 Diesel Aut. Business
VIN: W0VZT8EPXN1043478

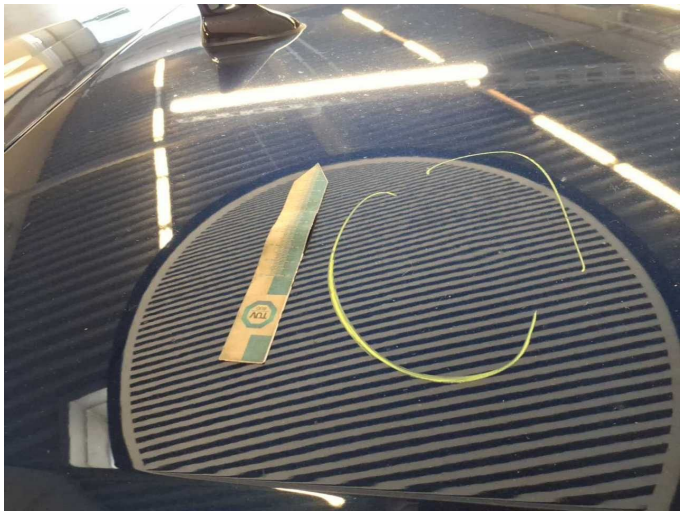
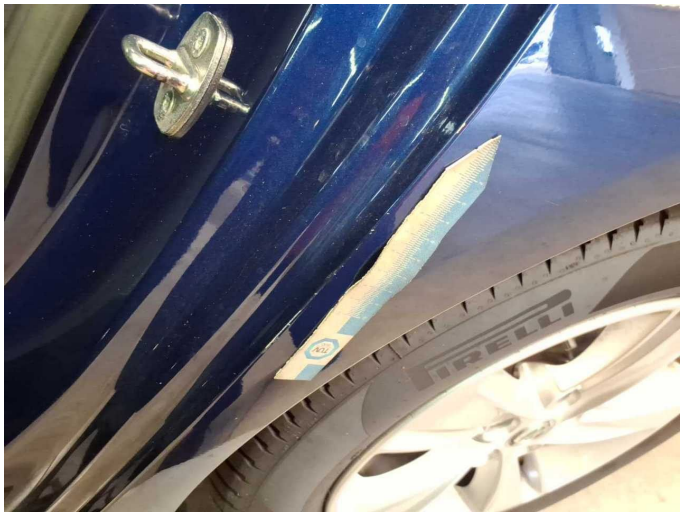
Damage 3: Roof: Roof - dent(s) - Smooth repair work

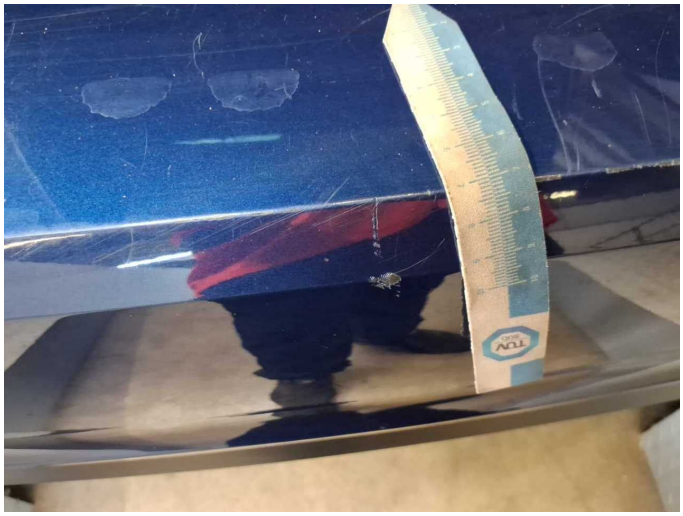
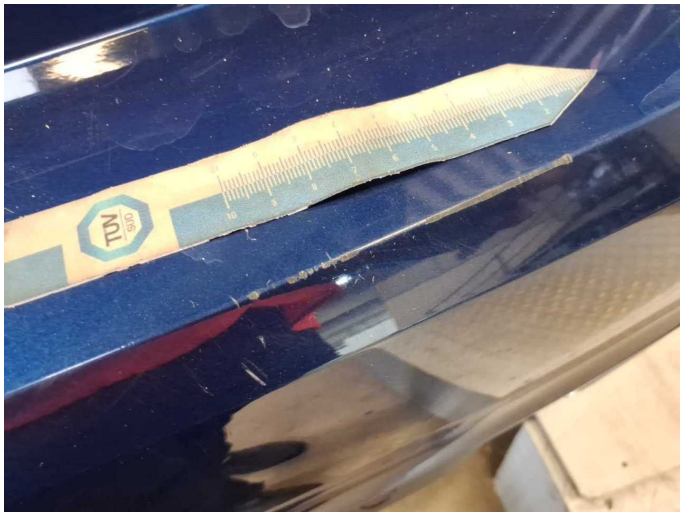
Damage 8: Rear bumper: Rear bumper - Scratched - Paint

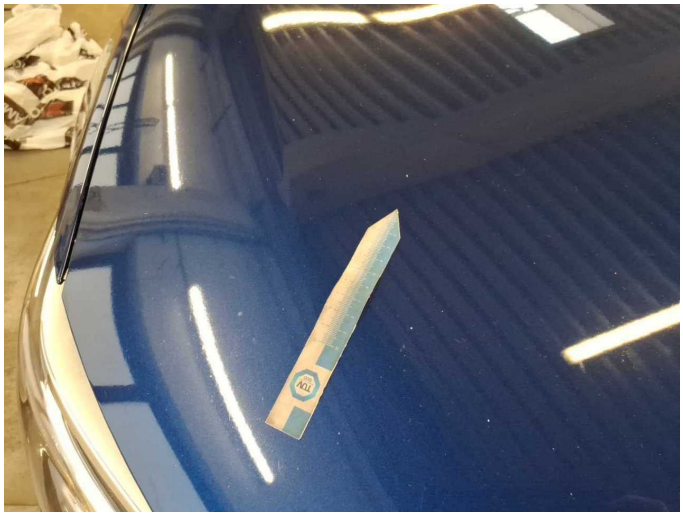
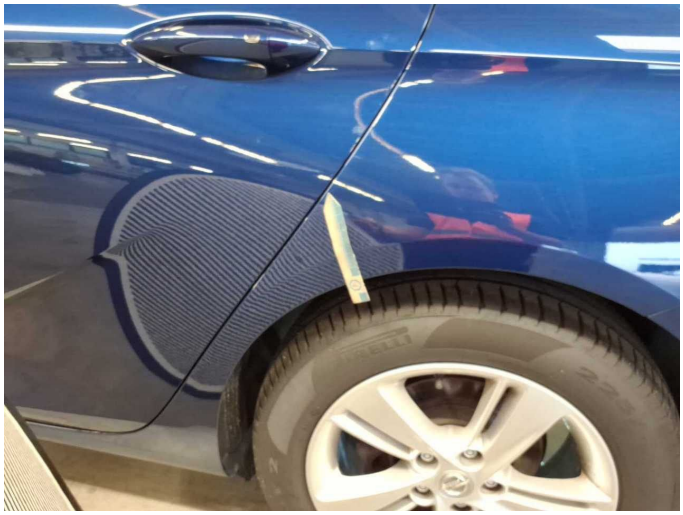
Damage 9: Bonnet: Bonnet (Sandstrahleffekt) - Stone chips - Paint
