Expertise

Protocol number: 48415910
Order No. / Reference: 27157548
Inspection date: 28 Oct 2026

Manufacturer: Mercedes-Benz	Model: C 300 e T 9G-TRONIC Avantgarde Advanced
VIN: W1KAH5EB5RF135513

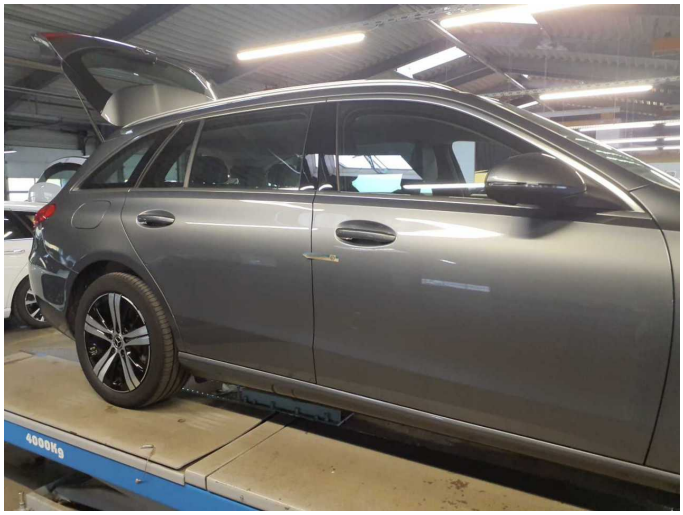
No.	Component group	Description
1	Door - front left side	Door edge - Scratch(es) - Smart repair
2	Side panel - rear right side	Side panel - dent(s) - Smooth repair work
3	Side panel - rear left side	Side panel - dent(s) - Smooth repair work
4	Sill - right side	Sill - Scratch(es) - Smart repair
5	Door - front right side	Door - Scratched - Smart repair

Damage 4: Sill - right side: Sill - Scratch(es) - Smart repair

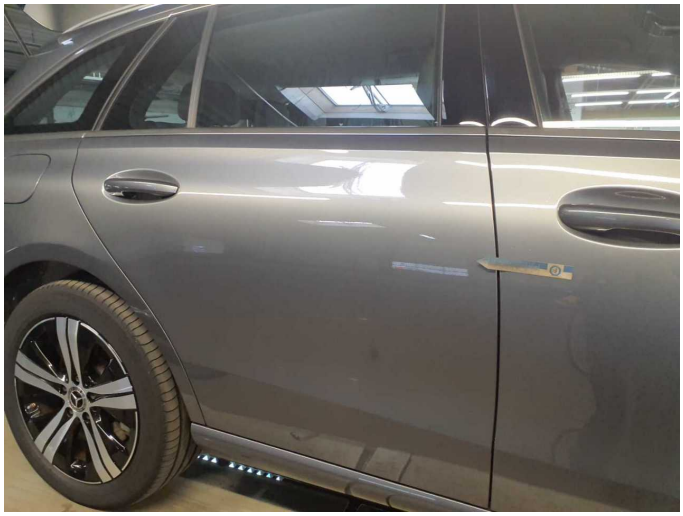
Damage 5: Door - front right side: Door - Scratched - Smart repair

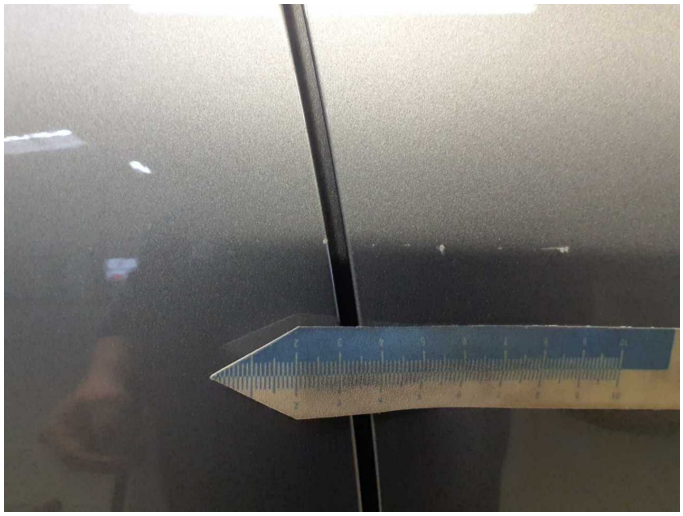
Damage 5: Door - front right side: Door - Scratched - Smart repair
