ARVAL
BNP PARIBAS GROUP

2DJN197

INSPECTION REPORT

End of contract

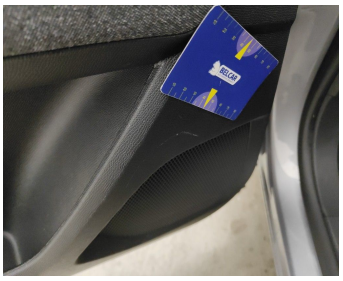
Door Rear Right // Polish-scratch

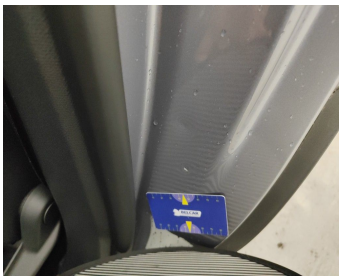
Rear Left Door Interior Coating // Replace Completely-scratch

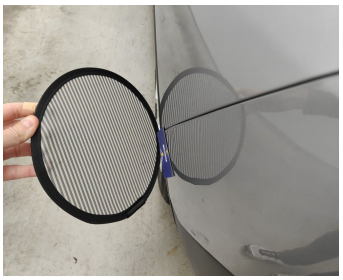
Door Rear Left // Smart Repair Large-scratch + dent
