Expertise

Protocol number: 48575004
Order No. / Reference: 27276174
Inspection date: 5 Nov 2026

Manufacturer: Ford	Model: Kuga 2.5 Duratec PHEV TITANIUM
VIN: WF0FXXWPMHPL24529

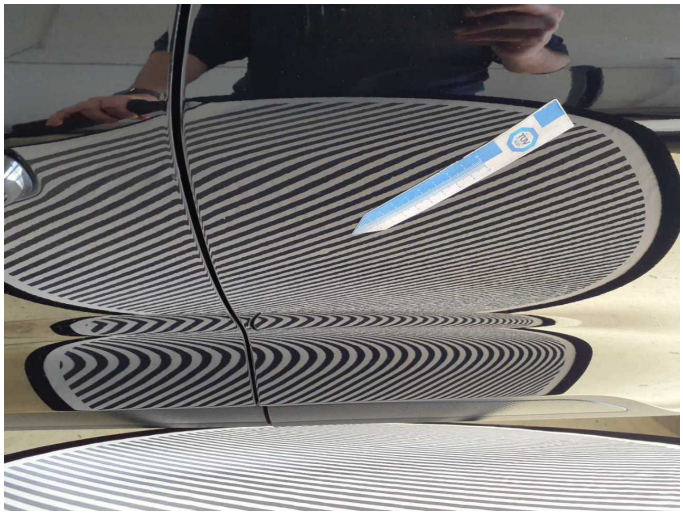
Damage 1: Mudguard - left side: Wheel well extension - Loose - Un- / install

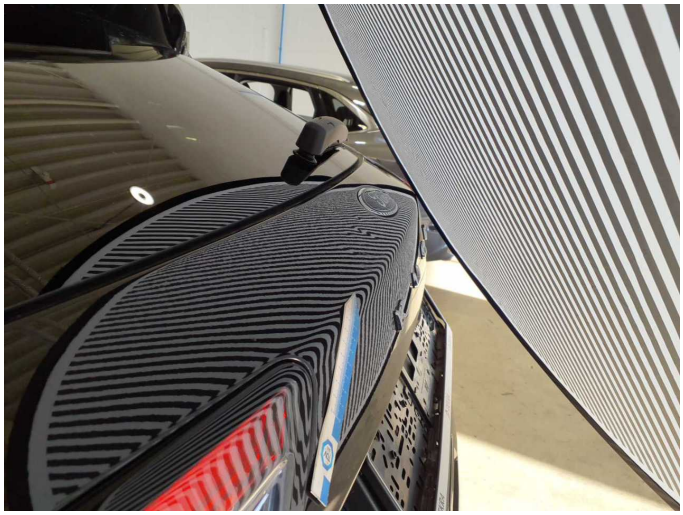
Damage 4: Rear bumper: Spoiler - Scratch(es) - Replace

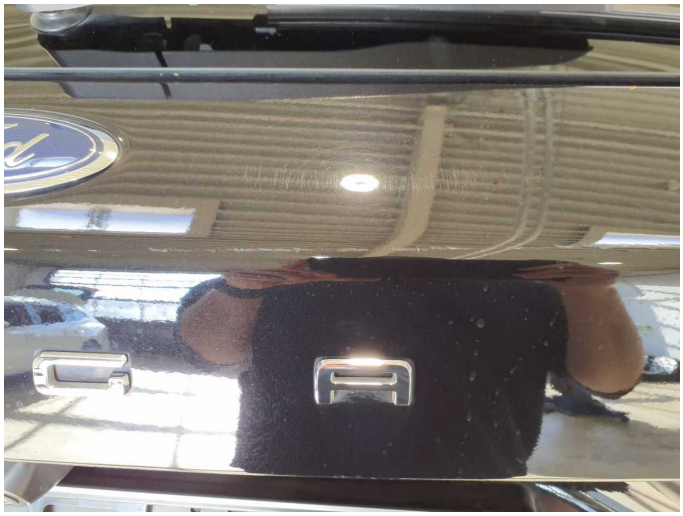
Damage 5: Boot lid / rear door: Boot lid - Dent / paintcoat damage - Repair and paint

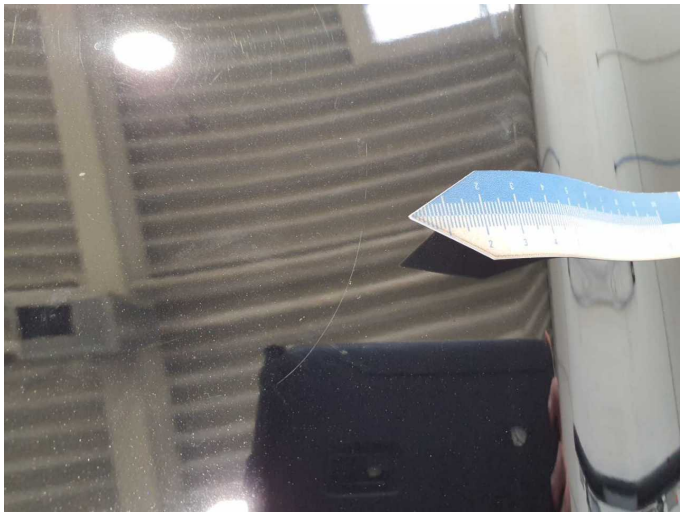
Damage 5: Boot lid / rear door: Boot lid - Dent / paintcoat damage - Repair and paint
