Expertise

Protocol number: 48536920
Order No. / Reference: 27258690
Inspection date: 4 Nov 2026

Manufacturer: Ford	Model: Transit Custom 300 L1H2 LKW VA Trend
VIN: WF0YXXTTGYMK34042

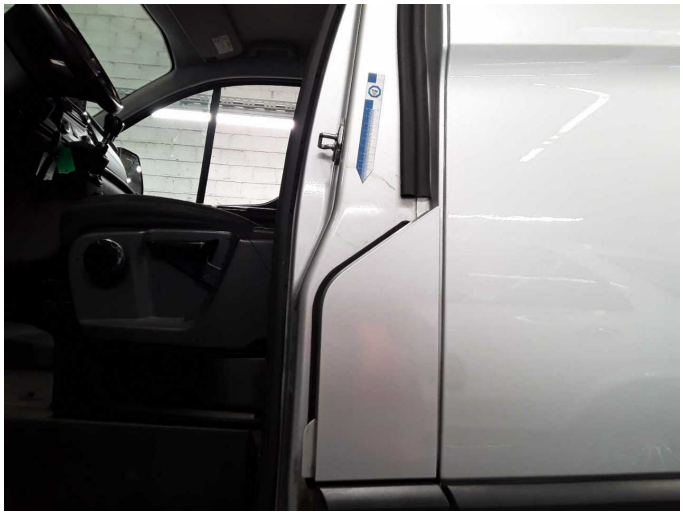
Damage 3: Body: B-pillar - right side - Scratch(es) - Smart repair

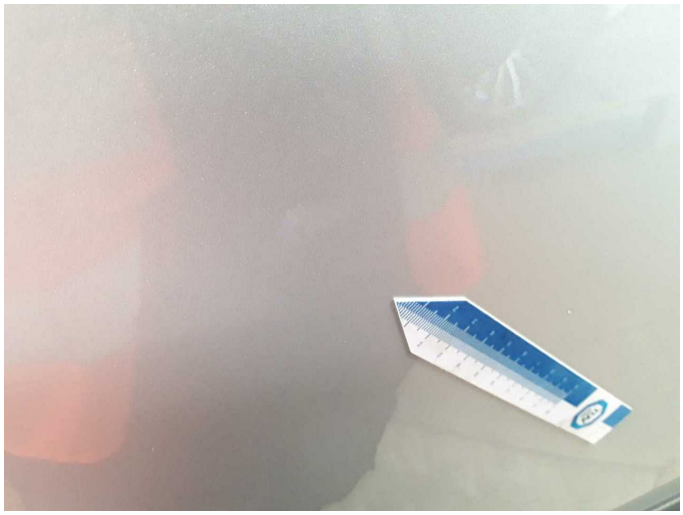
Wear and tear 4: Side panel - rear left side: Side panel - Scratch(es) - Cover / polish
