BMW

VIN: WBA11BL0X0CJ09439

Statement details

Inspection loc PARC HÖDLMAYR TONGEREN	**Statement date** 21/10/2026	**Inspection approval date** 22/10/2026

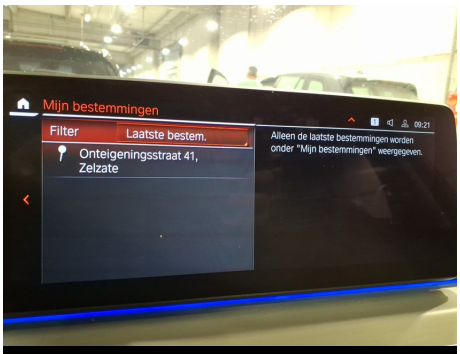
Other

Personal Data / - / Non Compliant

#	Element	Defect	Correction
001	Personal Data / -	Non Compliant	Carry out

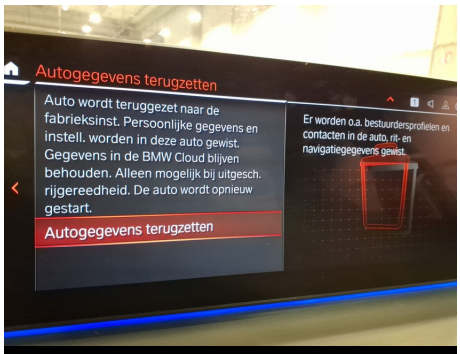
Personal Data / - / Non Compliant

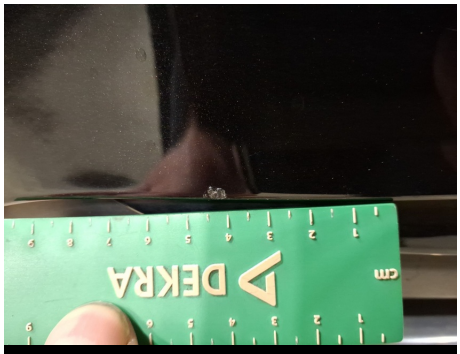
002	Rim / Front Right Material : Aluminium alloy / Rim/Tyre diameter : 17 " / Surface : Painted	Scratched	Repair

003	Windscreen / -	Sticker	Removal

004	Door / Front Left	Scratched	Acceptable

Rim / Front Right / Scratched

Windscreen / - / Sticker

Door / Front Left / Scratched

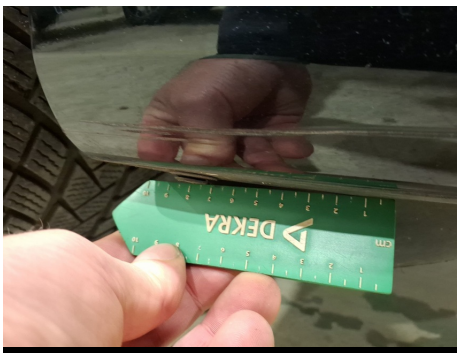
005	Wing / Back Left	Dent	Acceptable

006	Bumper / Back Painted : Yes	Scratched	Painting

007	Wing / Back Right	Dent	Repair

008	Door handles / Front Right	Scratched	Acceptable

Wing / Back Left / Dent

Bumper / Back / Scratched

Wing / Back Right / Dent

Door handles / Front Right / Scratched

Bumper / Front / Dent

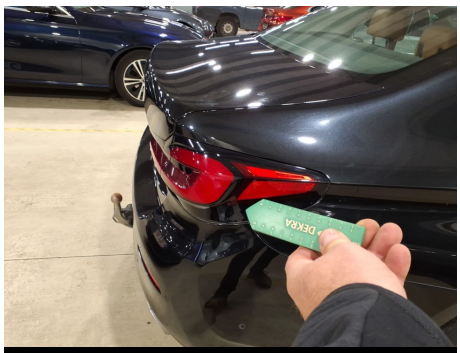
009	Bumper / Front Painted : Yes	Dent	Repair

010	Rear (wing) lamp glass / Back Right [1]	Non Compliant	Check

[1] Controle op schade, niet zeker of dit origineel is Andere kant is zo niet

Bumper / Front / Dent

Rear (wing) lamp glass / Back Right / Non Compliant
