MACADAM

Ford Mustang '19 BEV

Vehicle information

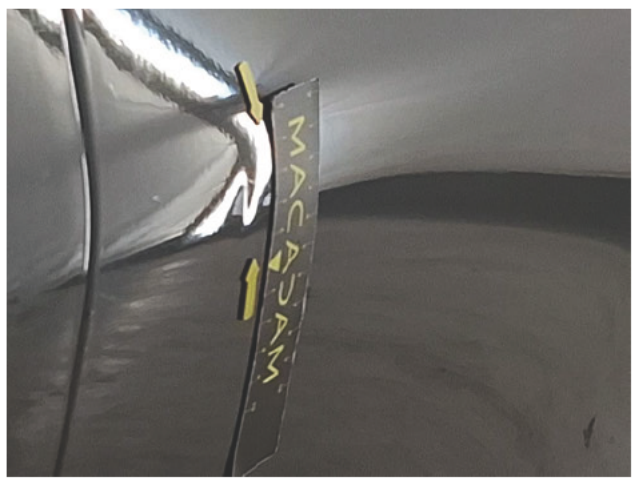
Bumper F
Scratch(es)
Repair and paint (complete)
Front
