Expertise

Protocol number: 48538159
Order No. / Reference: 27257575
Inspection date: 4 Nov 2026

Manufacturer: Ford	Model: Transit 310 L2H2 Lkw VA Trend
VIN: WF0EXXTTREKM28768

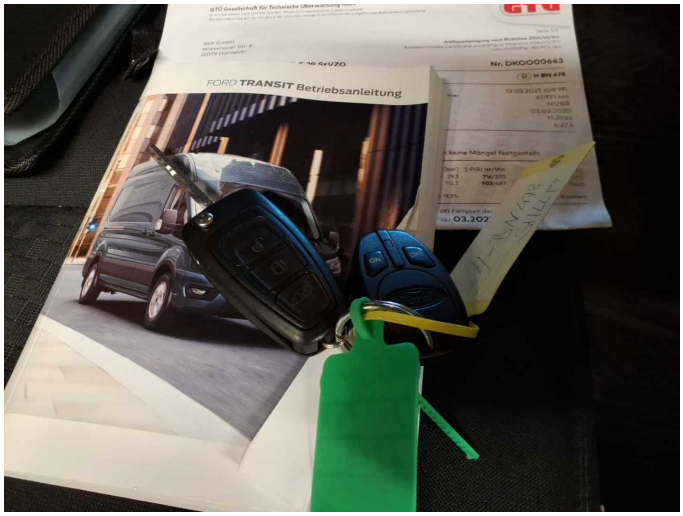
Figure 13: Documents

Documents submitted	At the time of the inspection, the vehicle registration certificate Part 2 (title) was available, but the vehicle registration certificate Part 1 (document) was not. (Copy)
VIN comparison	The vehicle identification number (VIN) was read from the vehicle and its conformity with the submitted documents was confirmed by the undersigned during the inspection.
Inspection	The inspection conditions were sufficient for the assessment of the vehicle. Lifting equipment and/or a pit were available for examining the vehicle.
Test drive	No test drive/shunting maneuver was carried out during the inspection of the vehicle.
Engine function test	An engine test run was performed.
