TÜV SÜD Auto Partner GmbH
Wiesenring 2
04159 Leipzig

Expertise

Protocol number: 48414368
Order No. / Reference: 27182097
Inspection date: 28 Oct 2026

Manufacturer: Ford	Model: Transit 350 L3H2 Lkw VA Trend
VIN: WF0EXXTTRENT86269

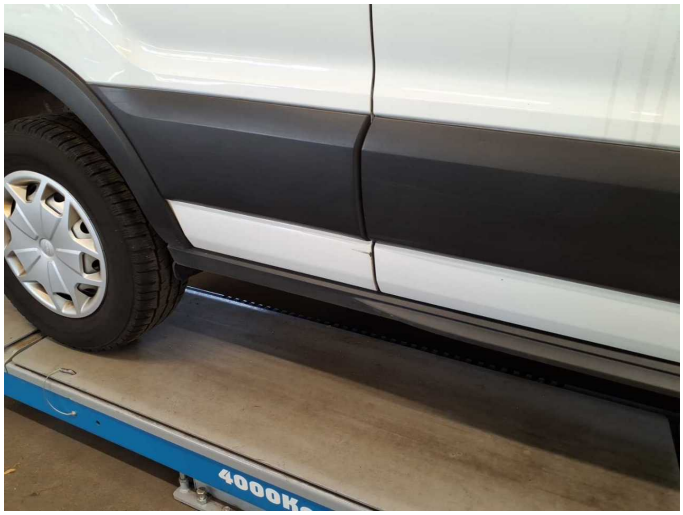
No.	Component group	Description
1	Door - front left side	Door seal - Missing - Replace
2	Equipment	Tirefit filler - Expired - Replace
3	Side panel - rear right side	Side panel (unterhalb) - Scratch(es) - Paint
4	Side panel - rear left side	Side panel - Dent / paintcoat damage - Repair and paint
5	Sliding door, right	Sliding door - Dent / paintcoat damage - Repair and paint

Damage 1: Door - front left side: Door seal - Missing - Replace

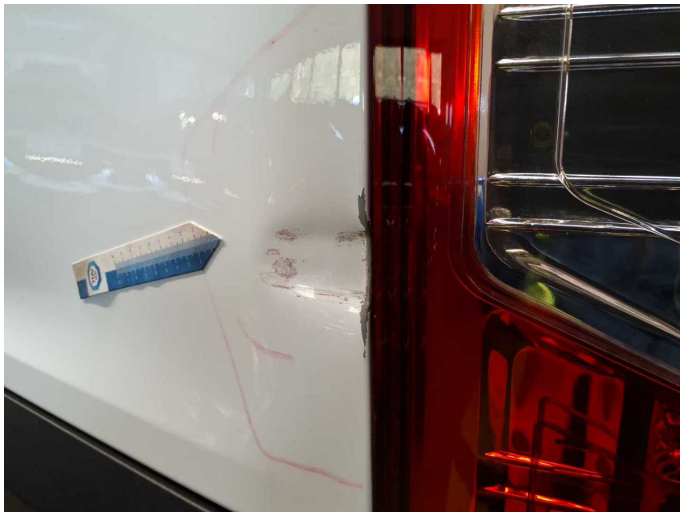
Damage 3: Side panel - rear right side: Side panel (unterhalb) - Scratch(es) - Paint
