Expertise

Protocol number: 48261076
Order No. / Reference: 27104422
Inspection date: 19 Oct 2026

Manufacturer: Mercedes-Benz	Model: C 180 T 9G-TRONIC Avantgarde
VIN: W1KAH4BB2PF125050

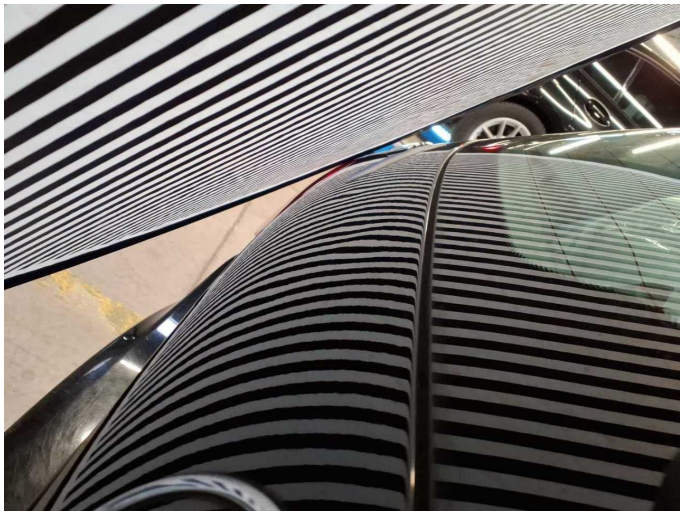
Damage 4: Boot lid / rear door: Boot lid - dent(s) - Smooth repair work

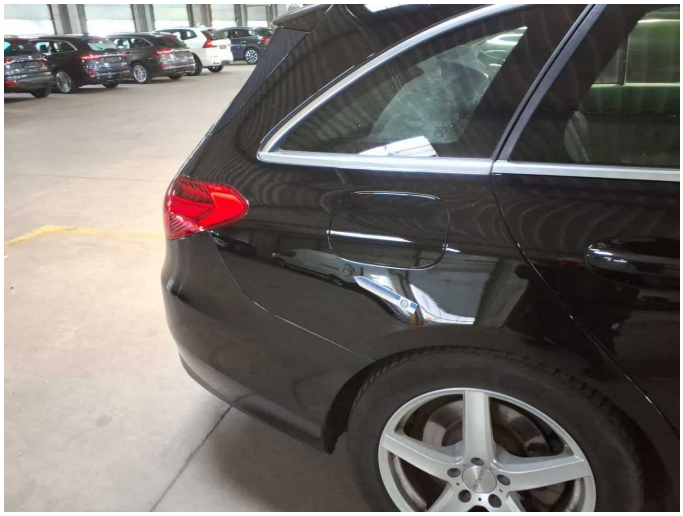
Damage 5: Side panel - rear right side: Side panel - Dent / paintcoat damage - Smart repair

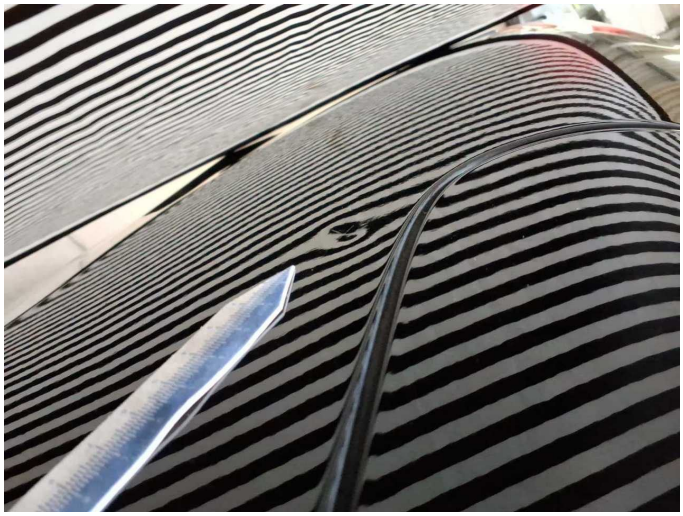
Damage 5: Side panel - rear right side: Side panel - Dent / paintcoat damage - Smart repair

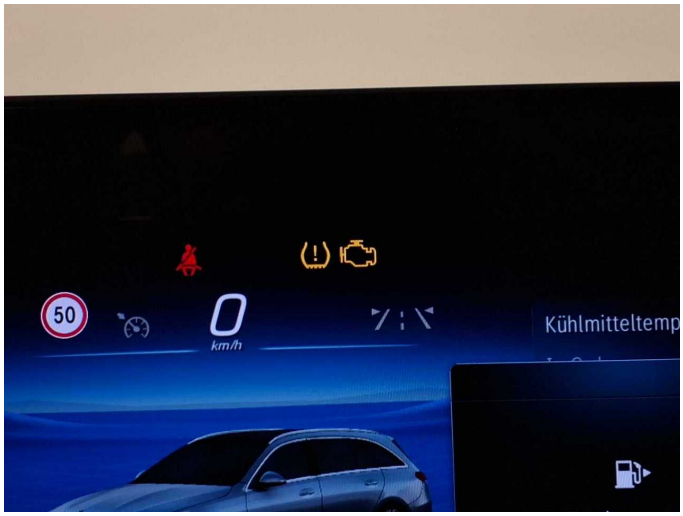
Damage 6: Engine: Engine (Motorkontrollleuchte an) - Functional / admissibility - Perform diagnosis

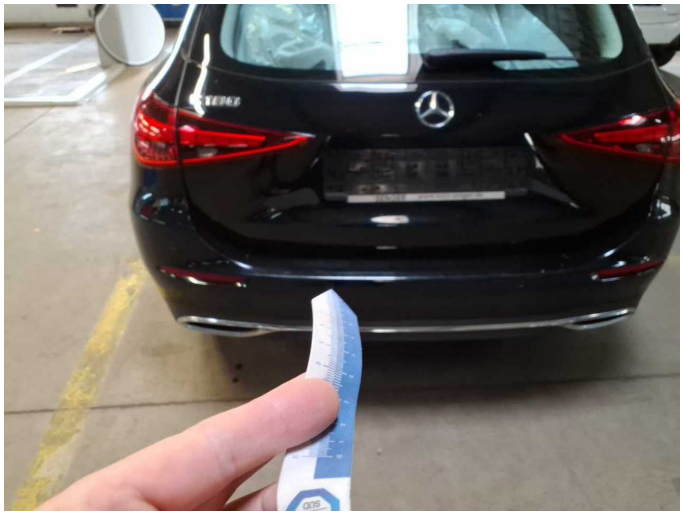
Damage 8: Rear bumper: Rear bumper - Scratched - Paint

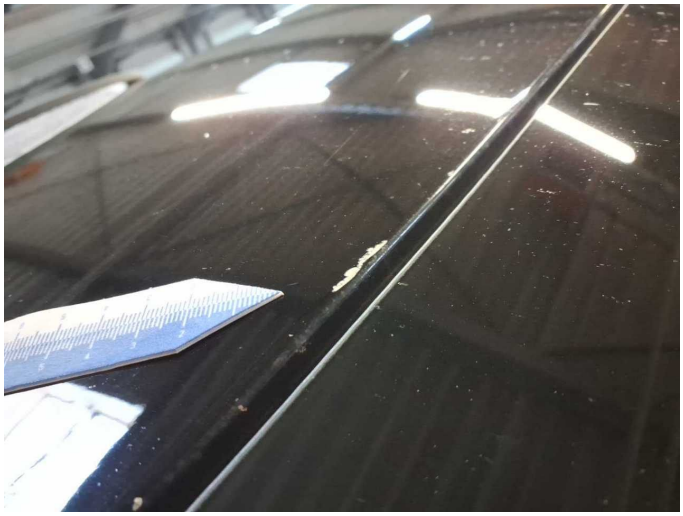
Damage 10: Roof: Roof - Paint defect - Paint

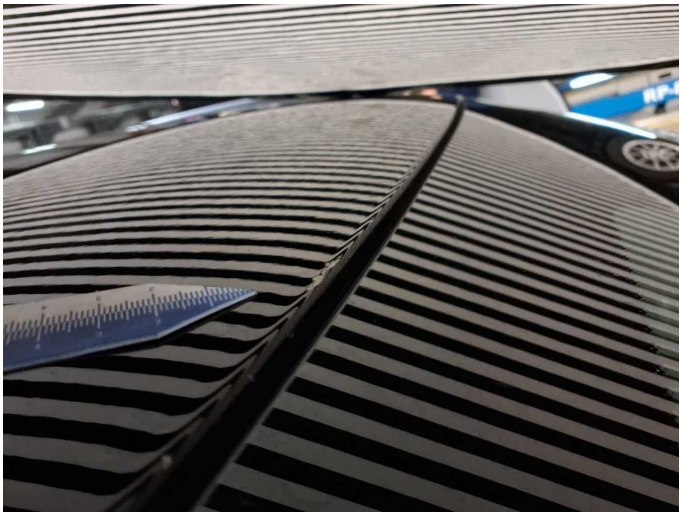
Damage 10: Roof: Roof - Paint defect - Paint
