# Expertise

Protocol number: 48398811
Order No. / Reference: 27175235
Inspection date: 29 Oct 2026

| Manufacturer: Mercedes-Benz | Model: Vito 116 CDI Extralang HA BASE |

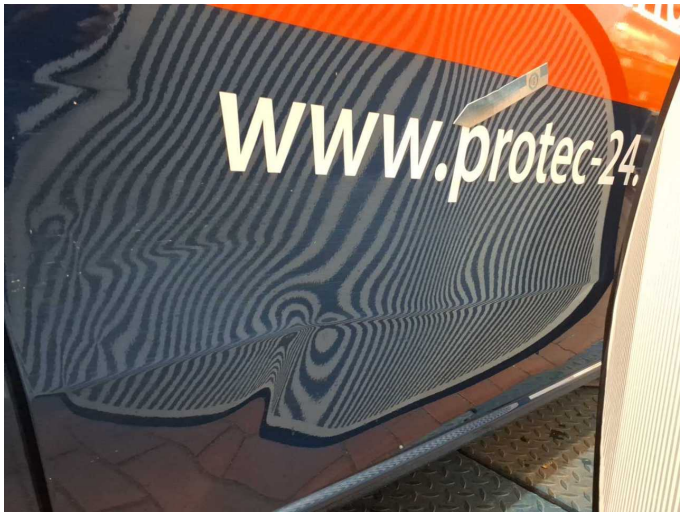
| No. | Accident |
|---|---|
| 1 | Side right |

**Accident 1:** Side right

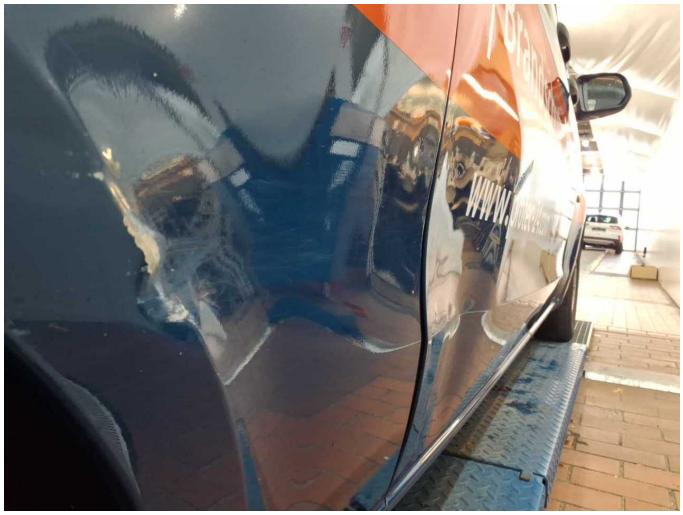
**Accident 1:** Side right

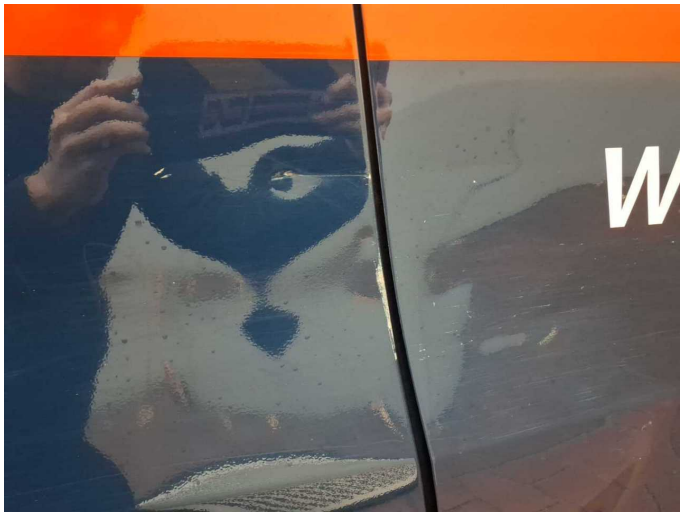
**Accident 1:** Side right
