Expertise

Protocol number: 46059540
Order No. / Reference: 26520596
Inspection date: 19 Jun 2026

Manufacturer: Opel	Model: Insignia Sports Tourer 2.0 Diesel Aut. Business
VIN: W0VZT8GP3N1042055

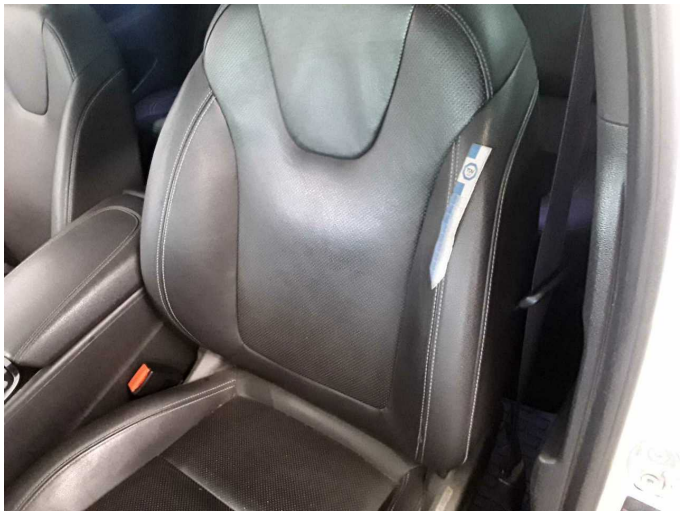
No.	Component group	Description
1	Seat - front	Backrest cover - left side - Scratch(es) - Smart repair
2	Interior	Interior (Hund / Zigarettenrauch) - Odour - Ozone treatment
3	Interior	Interior (Hundehaare) - Soiled - Conditioning
4	Side panel - rear right side	Side panel - Dent / paintcoat damage - Repair and paint
5	Sill - left side	Sill - Damaged - Repair and paint
6	Door - rear right side	Door - Scratch(es) - Paint
7	Front bumper	Front bumper - Deformed - Repair and paint
8	Bonnet	Bonnet - Dent / paintcoat damage - Repair and paint

Damage 1: Seat - front: Backrest cover - left side - Scratch(es) - Smart repair

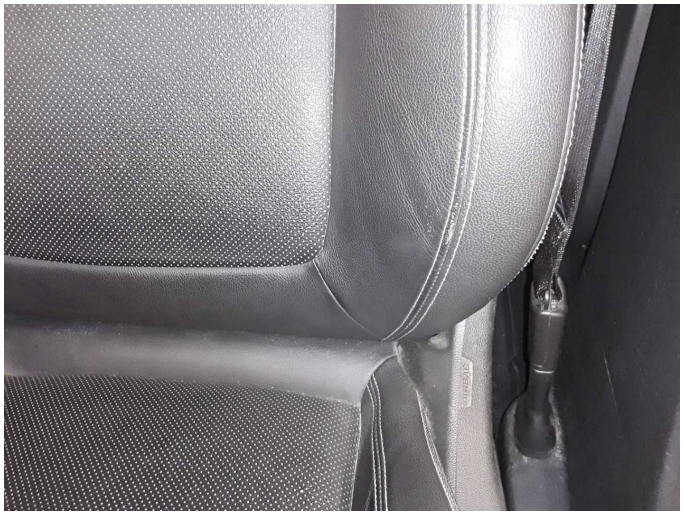
Damage 1: Seat - front: Backrest cover - left side - Scratch(es) - Smart repair

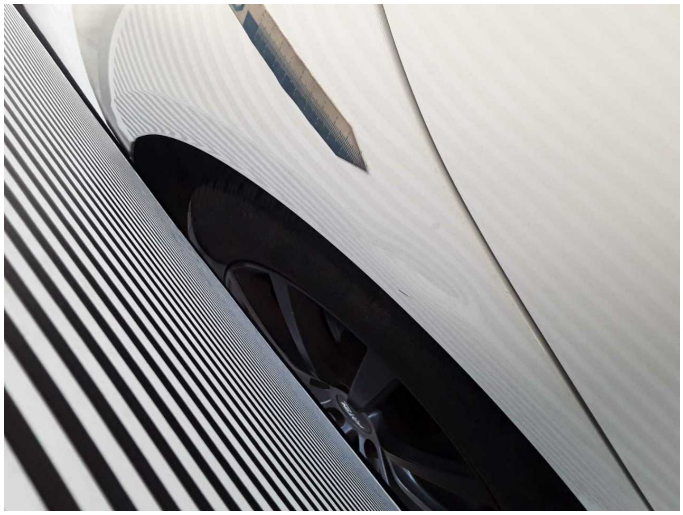
Damage 4: Side panel - rear right side: Side panel - Dent / paintcoat damage - Repair and paint

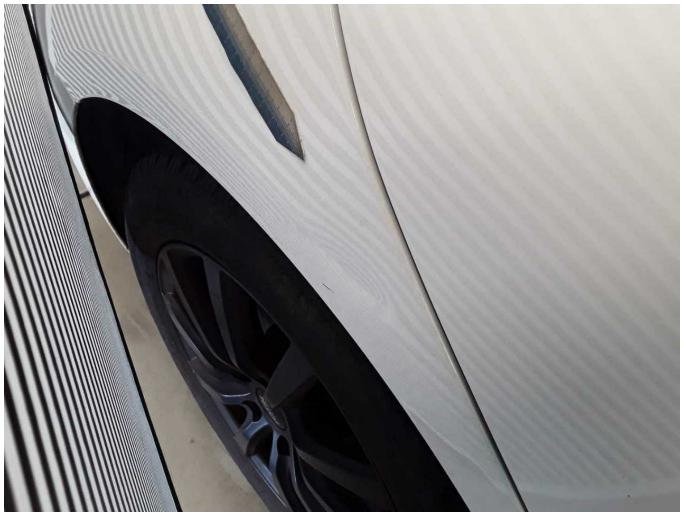
Damage 4: Side panel - rear right side: Side panel - Dent / paintcoat damage - Repair and paint

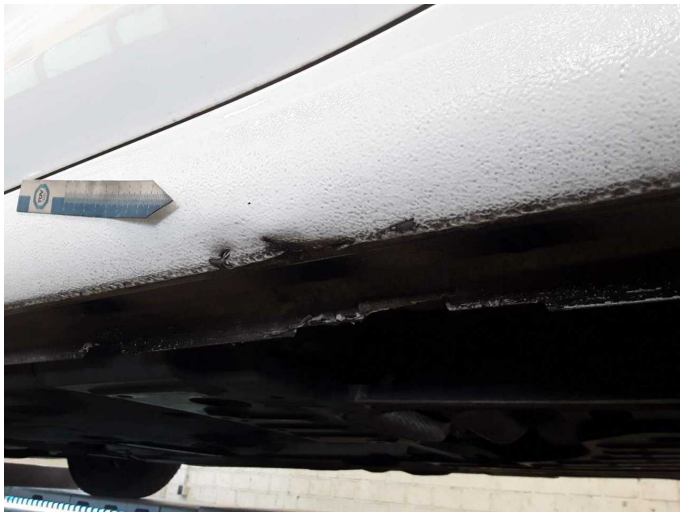
Damage 5: Sill - left side: Sill - Damaged - Repair and paint
