ARVAL
BNP PARIBAS GROUP

2BTN911

INSPECTION REPORT

End of contract

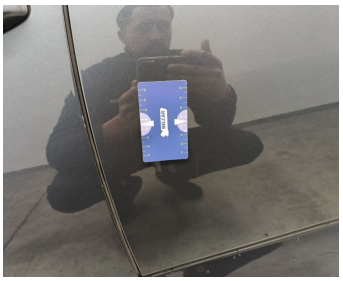
Door Rear Right // Polish-scratch

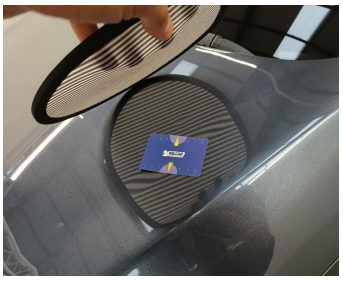
Door Rear Left // Polish-scratch
