TÜV SÜD Auto Partner GmbH
Wiesenring 2
04159 Leipzig

Expertise

Protocol number: 47686105
Order No. / Reference: 26662298
Inspection date: 21 Sept 2026

Manufacturer: Mercedes-Benz	Model: C 200 d T 9G-TRONIC Avantgarde
VIN: W1KAH0DB3PF089648

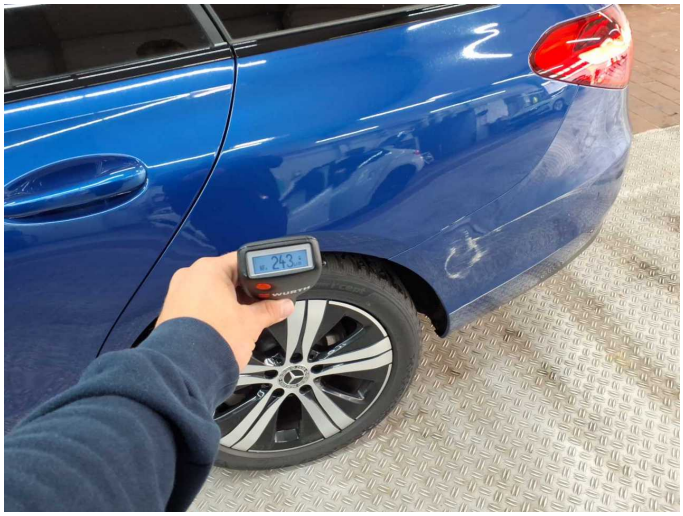
No.	Repainting
1	Mudguard - right side, Side panel - rear left side, Side panel - rear right side, Door - rear right side, Professionally carried out, Invoice of repair done Non-existent

Bonnet	192 µm	Side panel - rear left side	243 µm
Side panel - rear right side	201 µm	Door - rear right side	199 µm

Repainting 1: Mudguard - right side, Side panel - rear left side, Side panel - rear right side, Door - rear right side

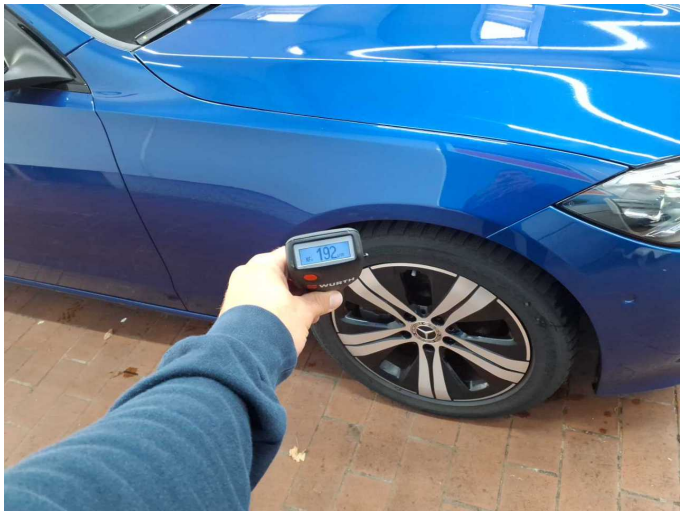
Repainting 1: Mudguard - right side, Side panel - rear left side, Side panel - rear right side, Door - rear right side
