Expertise

Protocol number: 48131276
Order No. / Reference: 27080796
Inspection date: 15 Oct 2026

Manufacturer: Volkswagen	Model: Golf Variant 2.0 TSI OPF 4Motion DSG R-Line
VIN: WVWZZZCD4PW512805

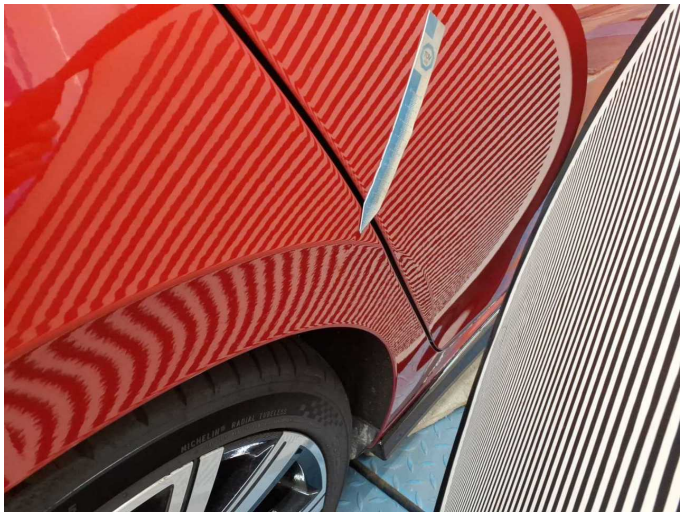
No.	Component group	Description
1	Boot lid / rear door	Boot lid - Scratch(es) - Loss in value
2	Side panel - rear right side	Side panel - dent(s) - Smart repair

Damage 2: Side panel - rear right side: Side panel - dent(s) - Smart repair
