MACADAM

Opel Corsa 5d '19 BEV

Vehicle information

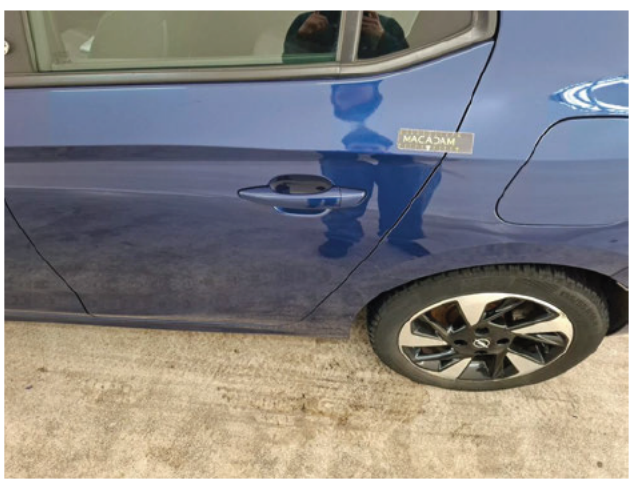
Door FL
Scratch(es)
Repair and paint (complete)
Left

Door FR
Scratch(es)
Repair and paint (complete)
Right

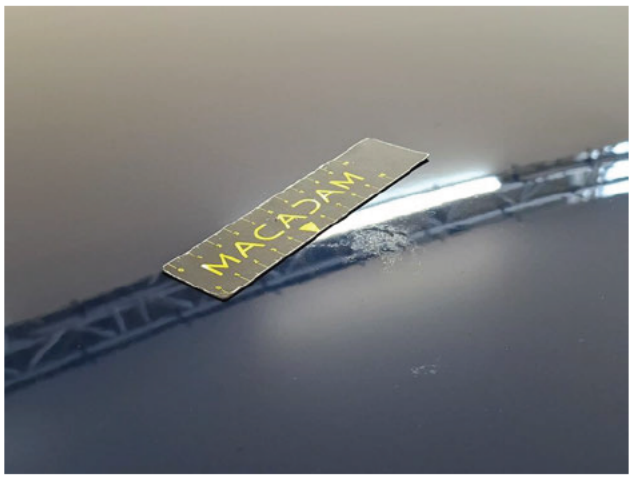
Door RL
Scratch(es)
Repair and paint (complete)
Left

Door RR
Dent(s) and scratch(es)
Repair and paint (complete)
Right
