Expertise

Protocol number: 48404217
Order No. / Reference: 27236905
Inspection date: 28 Oct 2026

Manufacturer: Skoda	Model: Octavia Combi 2.0 TDI DSG 4x4 RS Plus
VIN: TMBLK0NX0PY010407

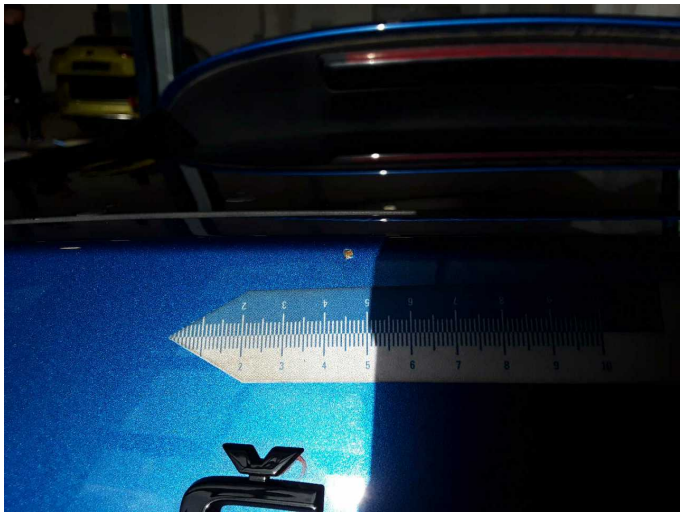
Damage 2: Rear bumper: Rear bumper - Scratch(es) - Smart repair

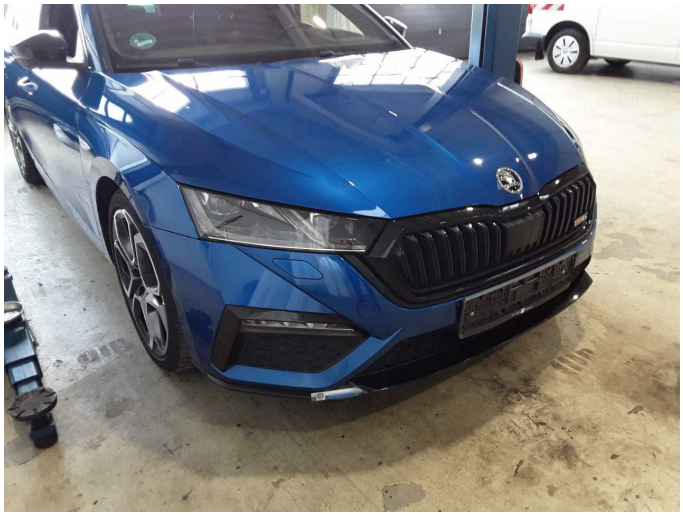
Damage 6: Front bumper: Front bumper - Scratch(es) - Smart repair

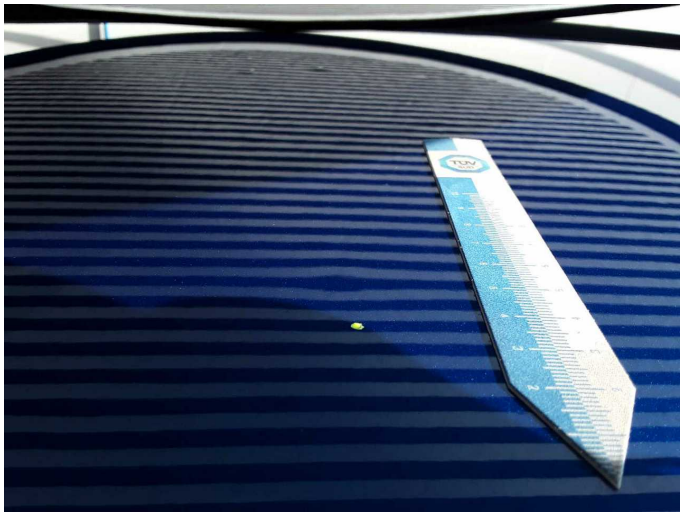
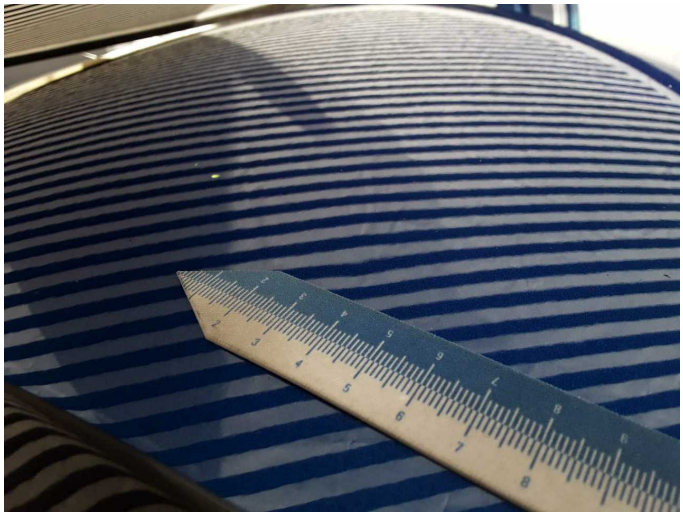
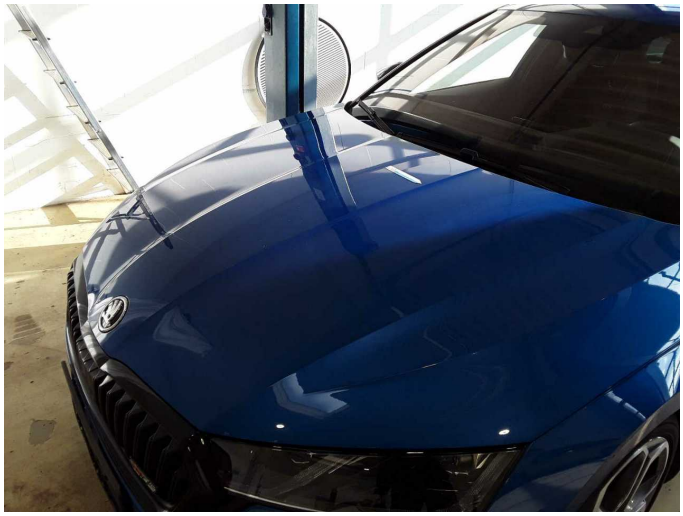
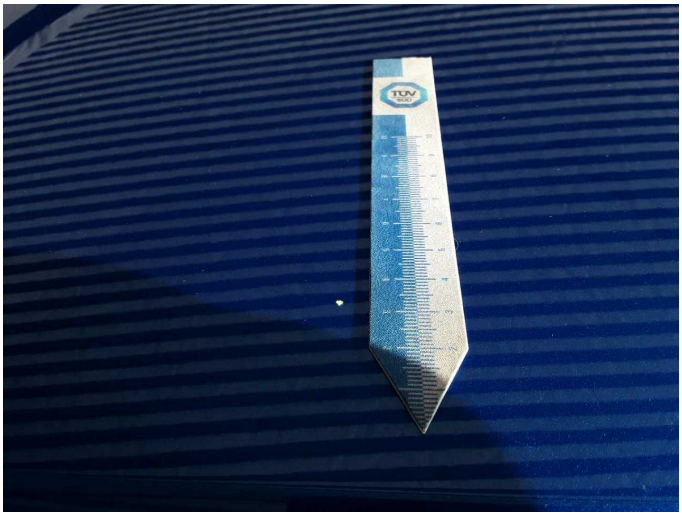
Die beigefügte Reparaturkostenkalkulation wurde nach bestem Wissen und Gewissen im demontagefreien Zustand erstellt. Es können Mehrkosten und somit Abweichung der für den Hagelschaden ausgewiesener Reparaturkosten nicht ausgeschlossen werden.

Damage 8: Body: Body - Damage by hail - repair according to calculation
