TÜV SÜD Auto Partner GmbH
Wiesenring 2
04159 Leipzig

Expertise

Protocol number: 48060083
Order No. / Reference: 27136126
Inspection date: 12 Oct 2026

Manufacturer: Volkswagen	Model: Passat Variant 2.0 TDI SCR DSG Business
VIN: WVWZZZ3CZPE043044

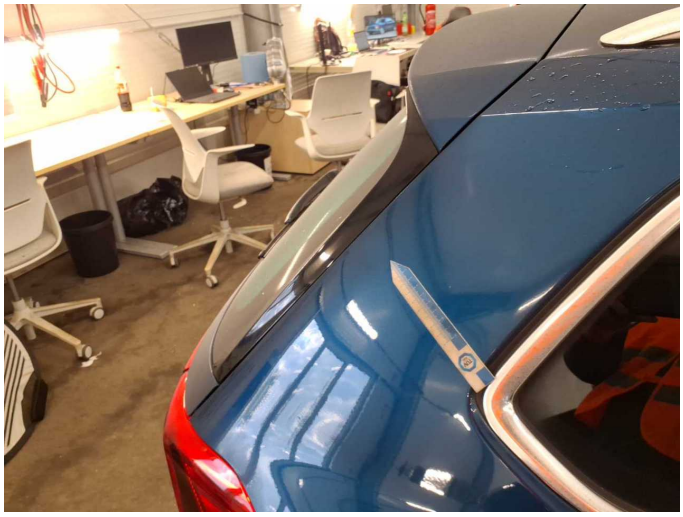
No.	Component group	Description
1	Side panel - rear right side	Side panel - dent(s) - Smooth repair work
2	Side panel - rear right side	Sill - Scratch(es) - Smart repair
3	Front bumper	Front bumper - Scratched - Paint
4	Bonnet	Bonnet (Steinschlag mit Korrosion) - Stone chips - Repair and paint
5	Door - rear left side	Door - Dent / paintcoat damage - Repair and paint

Damage 1: Side panel - rear right side: Side panel - dent(s) - Smooth repair work

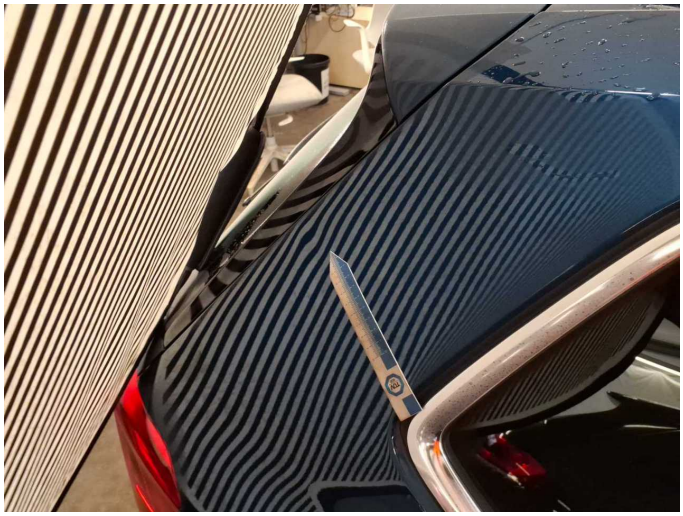
Damage 1: Side panel - rear right side: Side panel - dent(s) - Smooth repair work

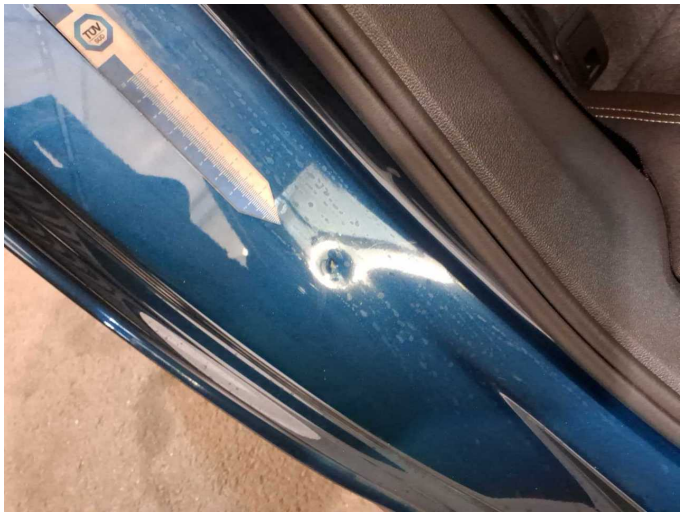
Damage 2: Side panel - rear right side: Sill - Scratch(es) - Smart repair

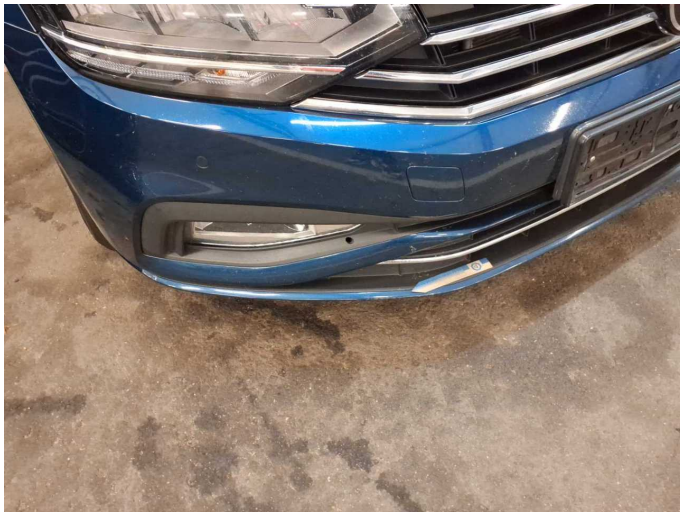
Damage 3: Front bumper: Front bumper - Scratched - Paint

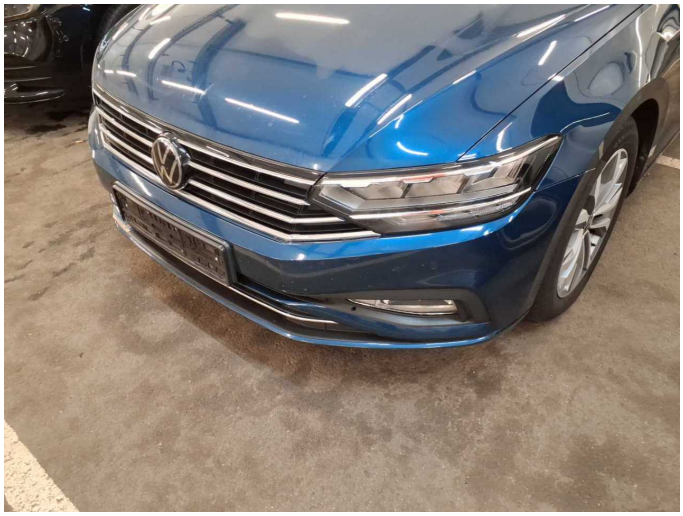
Damage 3: Front bumper: Front bumper - Scratched - Paint

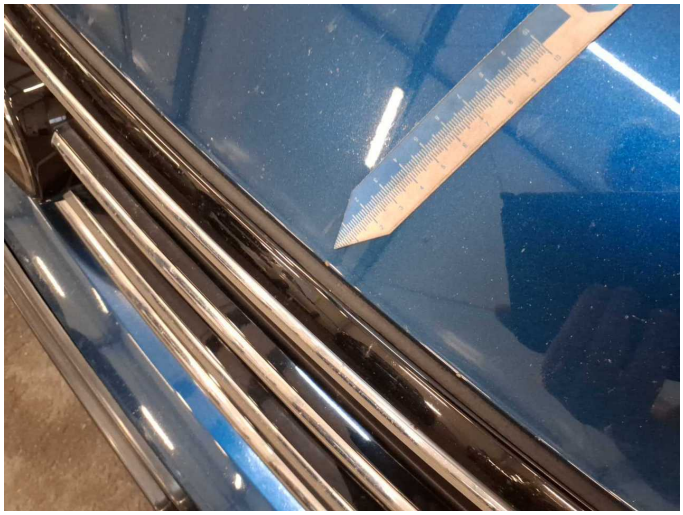
Damage 4: Bonnet: Bonnet (Steinschlag mit Korrosion) - Stone chips - Repair and paint

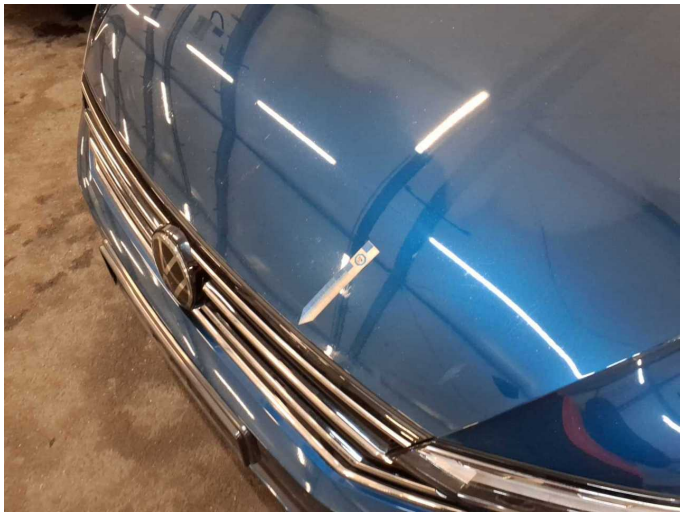
Damage 4: Bonnet: Bonnet (Steinschlag mit Korrosion) - Stone chips - Repair and paint

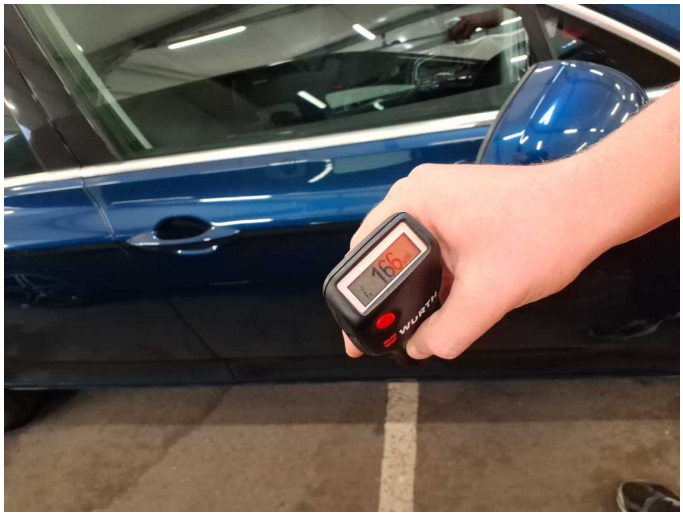
Damage 5: Door - rear left side: Door - Dent / paintcoat damage - Repair and paint
