Expertise

Protocol number: 48421881
Order No. / Reference: 27199535
Inspection date: 30 Oct 2026

Manufacturer: Mercedes-Benz	Model: C 220 d T 9G-TRONIC AMG Line
VIN: W1KAH0EB0PF124130

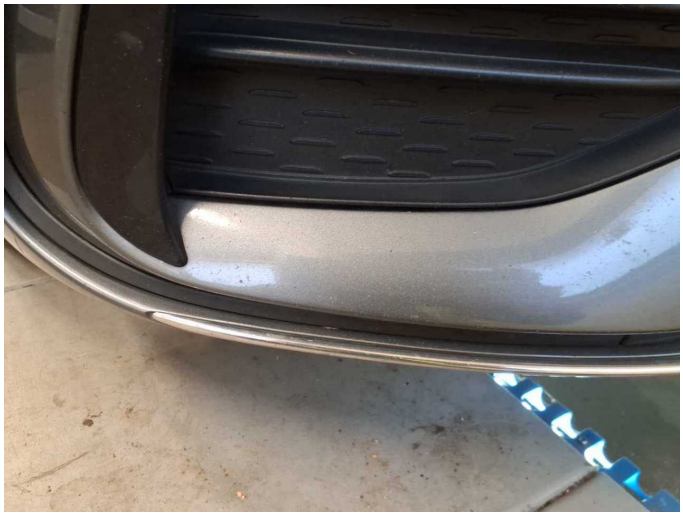
Damage 7: Front bumper: Front bumper - Stone chips - Paint
