TÜV SÜD Auto Partner GmbH
Wiesenring 2
04159 Leipzig

Expertise

Protocol number:	46214823
Order No. / Reference:	26580118
Inspection date:	26 Jun 2026

Manufacturer: Renault	Model: Kangoo Rapid Maxi Blue dCi 95 Extra
VIN: VF1WF000865762625

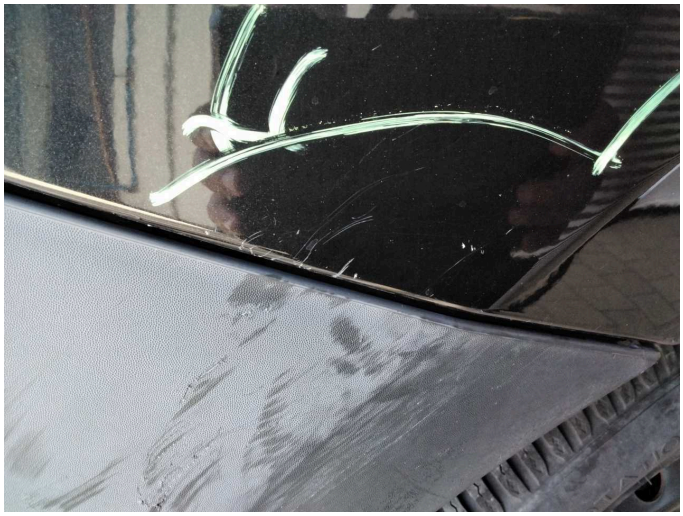
No.	Component group	Description
1	Bonnet	Bonnet - dent(s) - Smooth repair work
2	Sill - left side	Sill - Scratch(es) - Smart repair
3	Sill - right side	Sill - Dent / paintcoat damage - Smart repair
4	Side panel - rear right side	Side panel - Scratch(es) - Smart repair
5	Door - front right side	Door edge - Scratch(es) - Smart repair
6	Body	Body - Glued / labelled - De-glue / neutralise
7	Body	Body (Warntafelhalterungen, Mehrkosten möglich) - Differs from the original configuration - Remove
8	Sliding door, right	Sliding door with glass panel - Dent / paintcoat damage - Repair and paint

Damage 4: Side panel - rear right side: Side panel - Scratch(es) - Smart repair

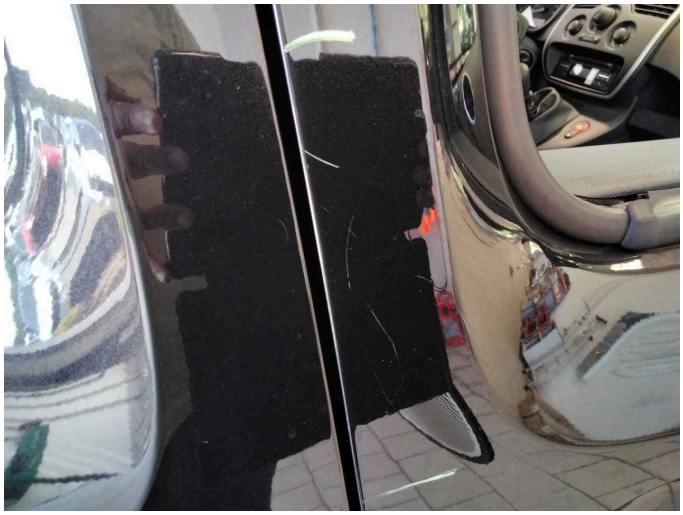
Damage 5: Door - front right side: Door edge - Scratch(es) - Smart repair

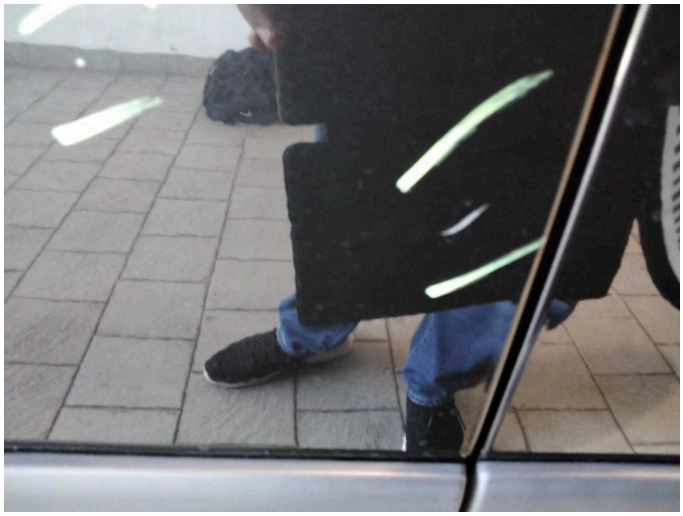
Damage 8: Sliding door, right: Sliding door with glass panel - Dent / paintcoat damage - Repair and paint

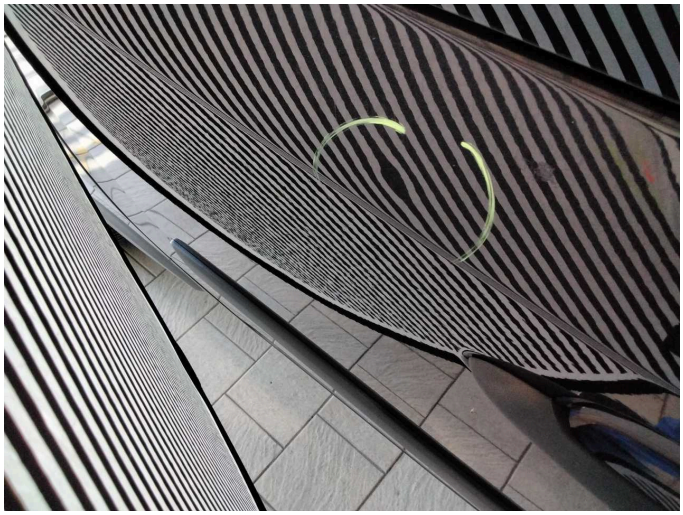
Damage 8: Sliding door, right: Sliding door with glass panel - Dent / paintcoat damage - Repair and paint

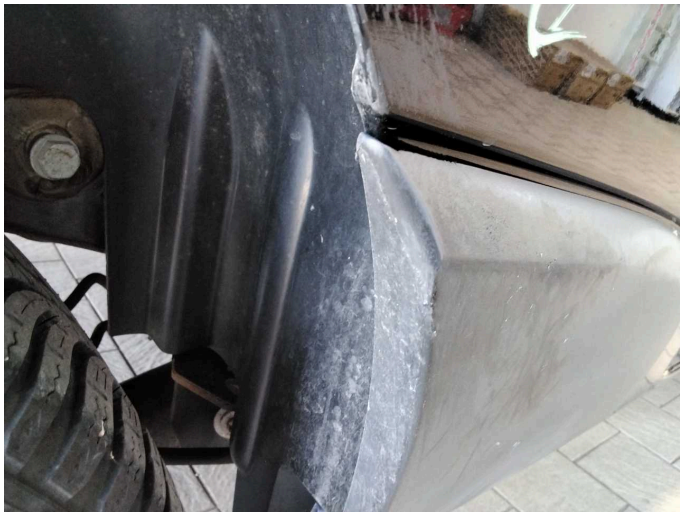
Wear and tear 3: Side panel - rear right side: Side panel (Leiste) - Scratch(es) - No deduction
