Expertise

Protocol number: 48376704
Order No. / Reference: 27199683
Inspection date: 26 Oct 2026

Manufacturer: Volkswagen	Model: Caddy Cargo 2.0 TDI BMT
VIN: WV1ZZZSKZNX056887

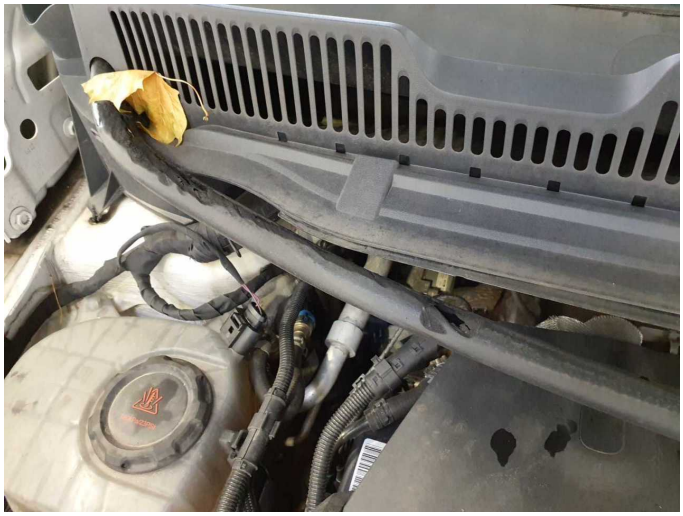
Damage 1: Trim / covers: Trim / covers - Broken / torn - Replace

Damage 2: Boot lid / rear door: Rear door - right side (Dichtung) - Broken / torn - Replace

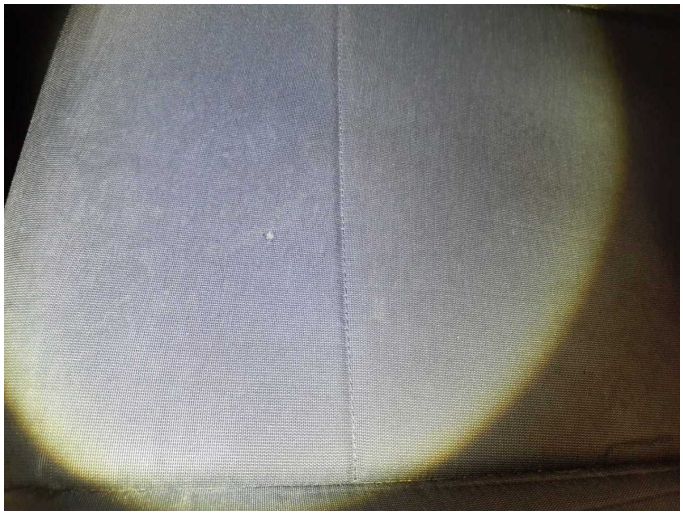
Damage 3: Seat - front: Seat cover - left side - Burn hole (cigarettes) - Smart repair

Damage 4: Instrument panel: Centre console - front - Scratch(es) - Conditioning

Damage 5: Door - front right side: Door handle - outside - Scratch(es) - Smart repair

Damage 6: Sill - right side: Sill - Dent / paintcoat damage - Smart repair

Damage 7: Door - front left side: Door - dent(s) - Smart repair

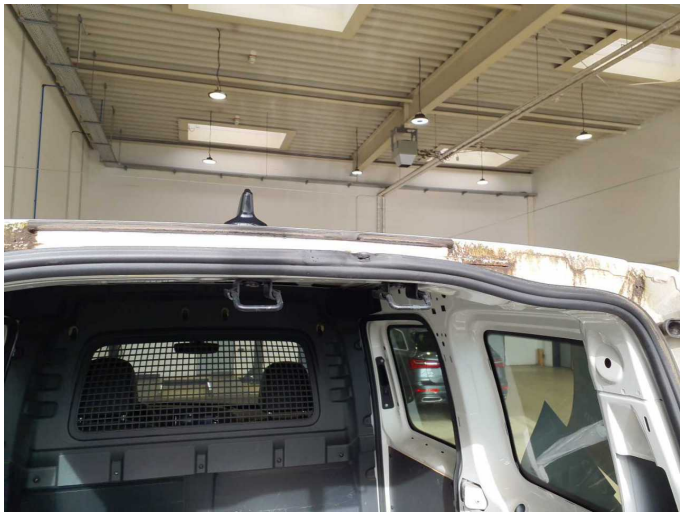
Damage 7: Door - front left side: Door - dent(s) - Smart repair

Damage 8: Boot lid / rear door: Seal - Broken / torn - Replace

Damage 9: Roof: Roof - Dent / paintcoat damage - Loss in value

Damage 10: Roof: Roof rail - right side - Dent / paintcoat damage - Smart repair

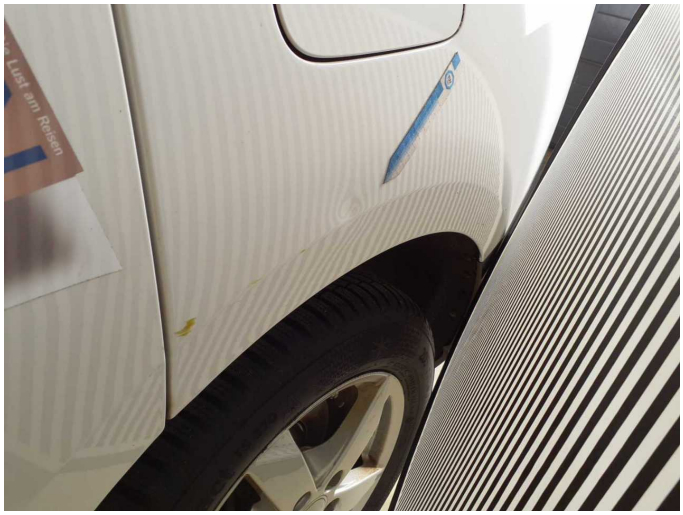
Damage 11: Side panel - rear left side: Side panel - Dent / paintcoat damage - Smart repair

Damage 12: Door - front right side: Door (Unterhalb) - Dent / paintcoat damage - Smart repair

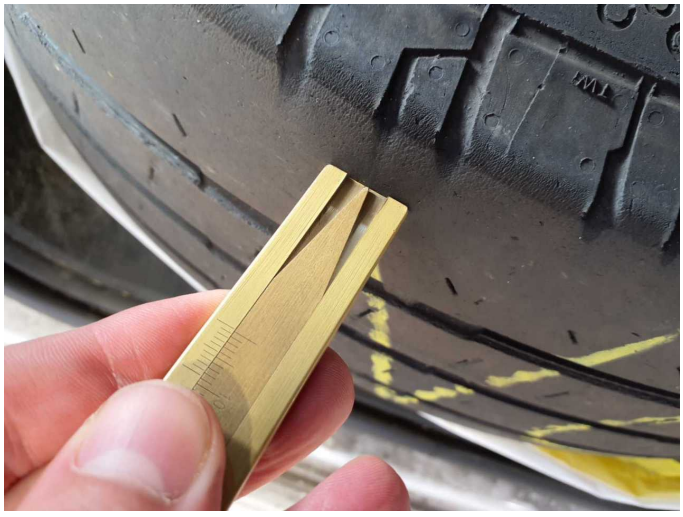
Damage 13: Front structure: Emblem - Missing - Replace

Damage 14: 2nd wheel set: 2 tyres - Worn - Replace

Damage 15: Body: Body - Glued / labelled - De-glue / neutralise

Damage 16: Front bumper: Front bumper (unpainted) - Broken / torn - Replace

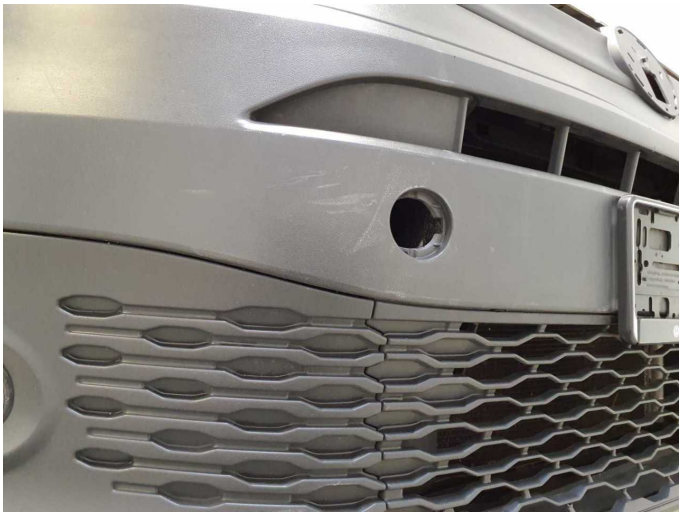
Stoßstange vorne wurde aufgrund der Laufleistung und des Alter des Fahrzeuges gemindert.

Damage 16: Front bumper: Front bumper (unpainted) - Broken / torn - Replace

Damage 17: Boot lid / rear door: Rear door - right side (Oberhalb) - Deformed - Repair and paint

Damage 18: Boot lid / rear door: Rear door - left side (+Rost) - Dent / paintcoat damage - Repair and paint

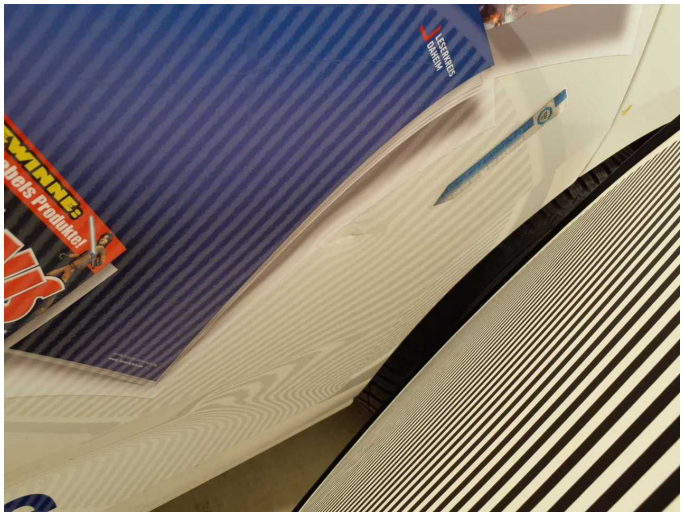
Damage 19: Sliding door - left side: Sliding door (teilweise) - Dent / paintcoat damage - Repair and paint

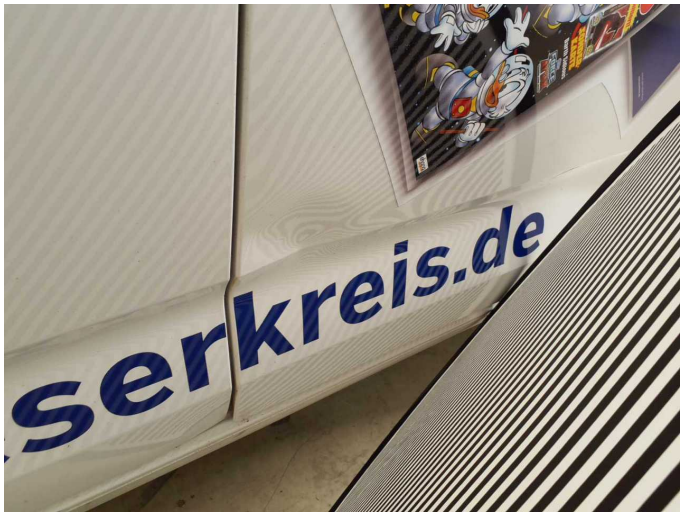
Damage 19: Sliding door - left side: Sliding door (teilweise) - Dent / paintcoat damage - Repair and paint

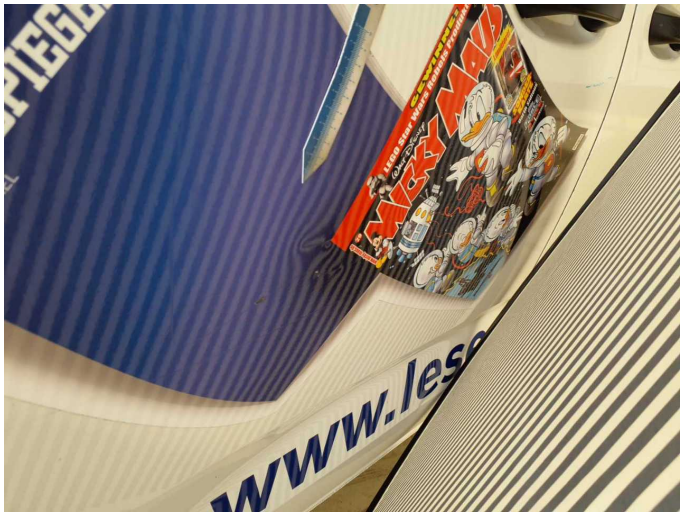
Damage 20: Sliding door, right: Sliding door (teilweise) - Dent / paintcoat damage - Repair and paint

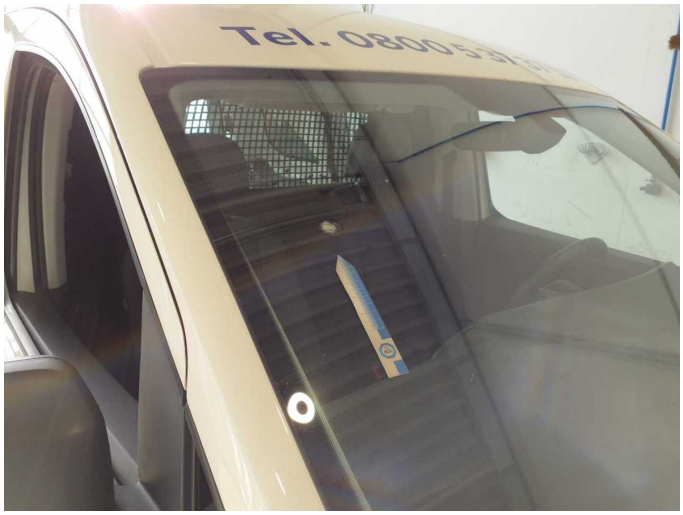
Damage 20: Sliding door, right: Sliding door (teilweise) - Dent / paintcoat damage - Repair and paint

Damage 21: Vehicle glazing: Windscreen - Broken / torn - Replace

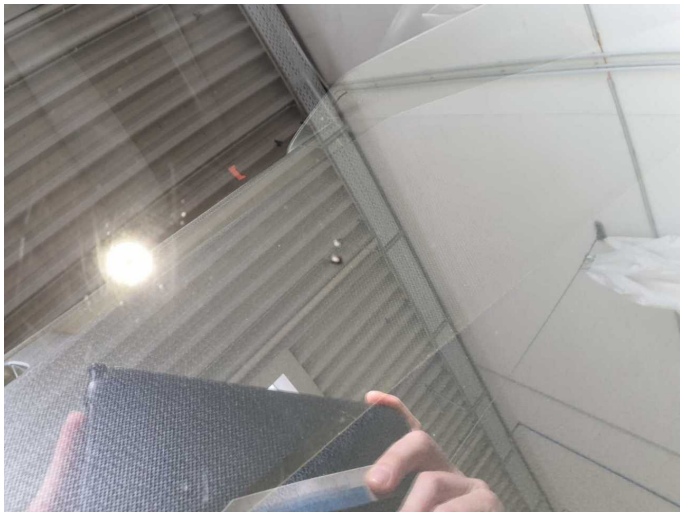
Damage 21: Vehicle glazing: Windscreen - Broken / torn - Replace

Wear and tear 1: Sill - left side: Sill - dent(s) - No deduction

Wear and tear 2: Interior: Interior - Dent / paintcoat damage - No deduction

Wear and tear 6: Mudguard - left side: Mudguard - left side - Dent / paintcoat damage - Smart repair

Wear and tear 7: Rear bumper: Rear bumper (unpainted) - Dent / paintcoat damage - No deduction
