Expertise

Protocol number: 48486292
Order No. / Reference: 27222652
Inspection date: 4 Nov 2026

Manufacturer: Audi	Model: A6 Avant allroad quattro 55 TDI tiptronic
VIN: WAUZZZF2XPN088303

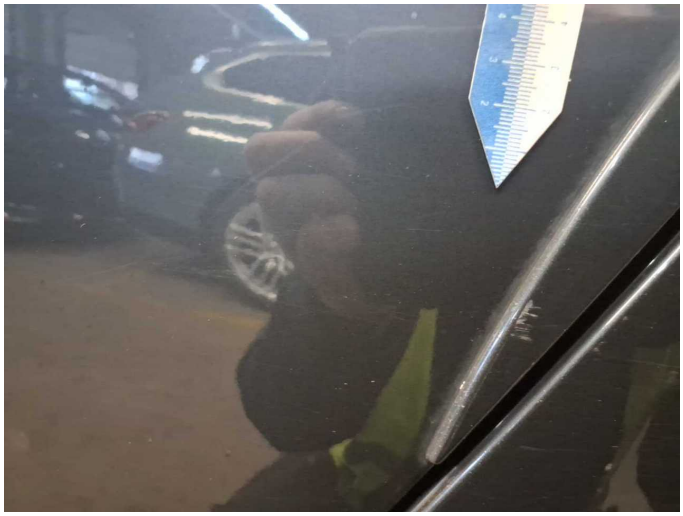
Damage 1: Sill - right side: Sill - dent(s) - Smart repair

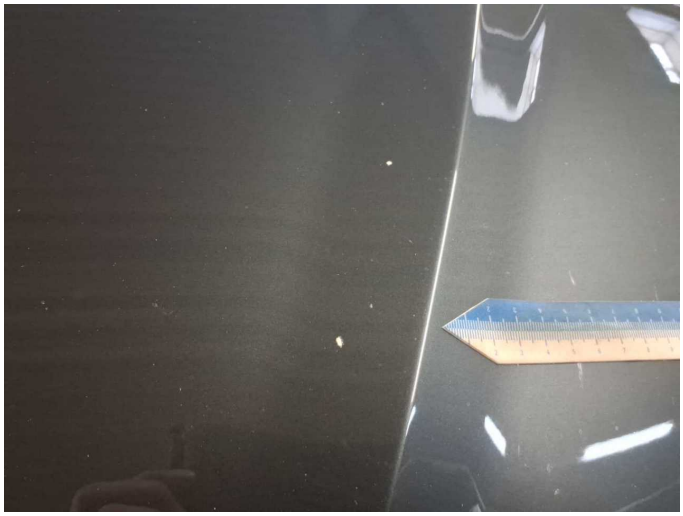
Damage 9: Bonnet: Bonnet (Mehrere) - Stone chips - Paint
