Expertise

Protocol number: 47899766
Order No. / Reference: 26826543
Inspection date: 2 Oct 2026

Manufacturer: Mercedes-Benz	Model: C 200 d T 9G-TRONIC Avantgarde
VIN: W1KAH0DB9PF116058

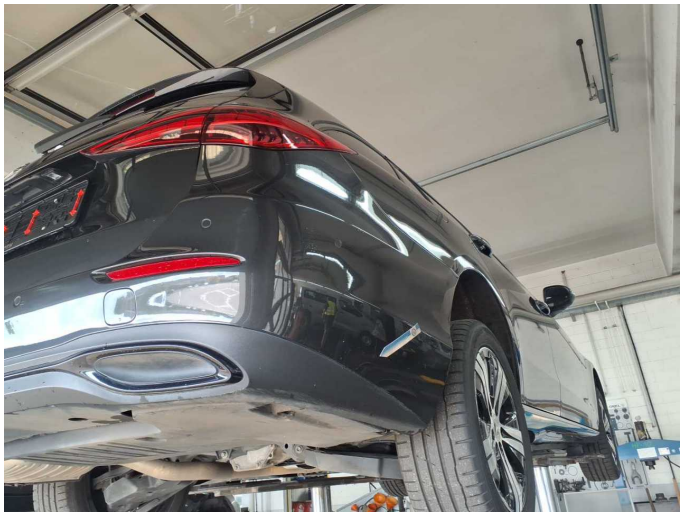
No.	Component group	Description
1	Trim / covers	Boot lid - interior trim - Scratch(es) - Loss in value
2	Rear bumper	Spoiler - Scratch(es) - Loss in value
3	Rear bumper	Rear bumper - Scratch(es) - Smart repair

Damage 1: Trim / covers: Boot lid - interior trim - Scratch(es) - Loss in value
