Expertise

Protocol number: 48349398
Order No. / Reference: 27078538
Inspection date: 22 Oct 2026

Manufacturer: Skoda	Model: Kodiaq 2.0 TDI DSG Style
VIN: TMBJJ9NS2P8037966

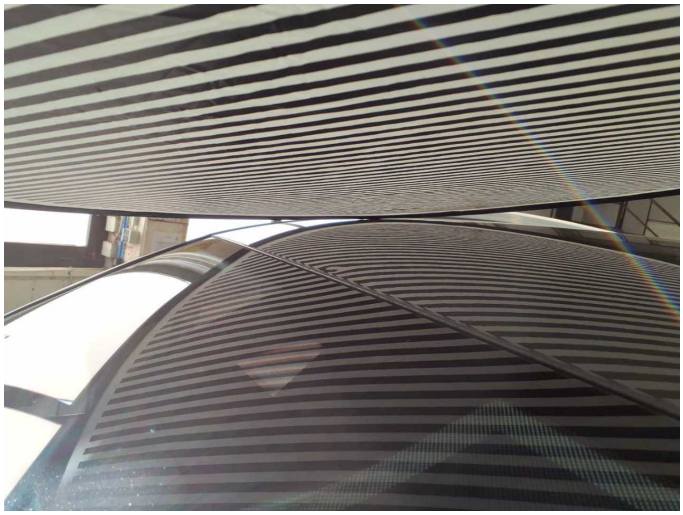
No.	Component group	Description
1	Roof	Roof - dent(s) - Smooth repair work
2	Seat - rear	Back seat - Broken / torn - Smart repair

Damage 1: Roof: Roof - dent(s) - Smooth repair work

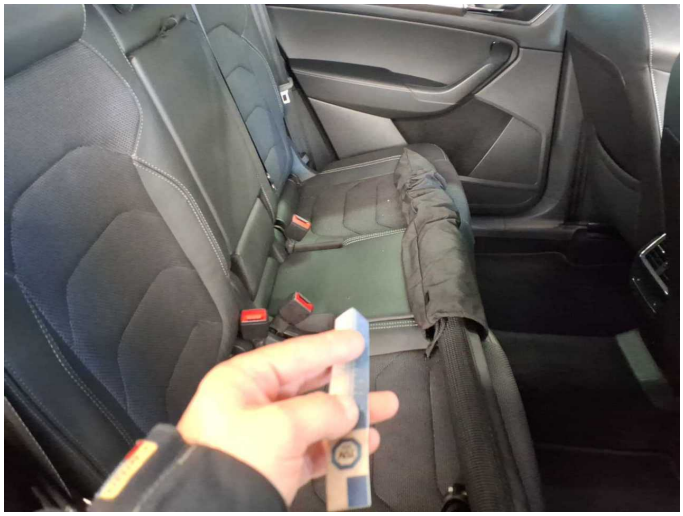
Damage 2: Seat - rear: Back seat - Broken / torn - Smart repair
