TÜV SÜD Auto Partner GmbH
Wiesenring 2
04159 Leipzig

Expertise

Protocol number: 48221368
Order No. / Reference: 27037174
Inspection date: 20 Oct 2026

Manufacturer: Mercedes-Benz	Model: C 200 d T 9G-TRONIC Avantgarde
VIN: W1KAH0DB9RF126530

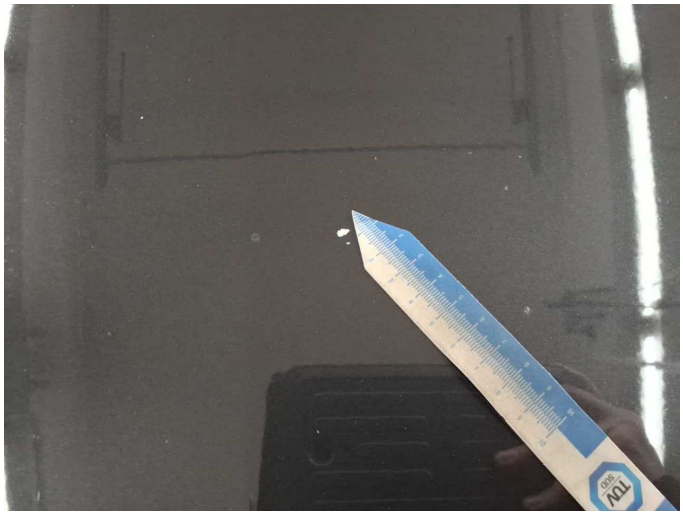
No.	Component group	Description
1	Misc.	Inspection / maintenance - No evidence - No deduction
2	Instrument panel	Indicator light (Reifendruck) - Specify findings - Perform diagnosis
3	Bonnet	Bonnet - Stone chips - Repair and paint

Damage 3: Bonnet: Bonnet - Stone chips - Repair and paint
