Expertise

Protocol number: 48518540
Order No. / Reference: 27223231
Inspection date: 28 Oct 2026

Manufacturer: MAN	Model: TGE 3.140 4X2F SB
VIN: WMA03VUY7P9023174

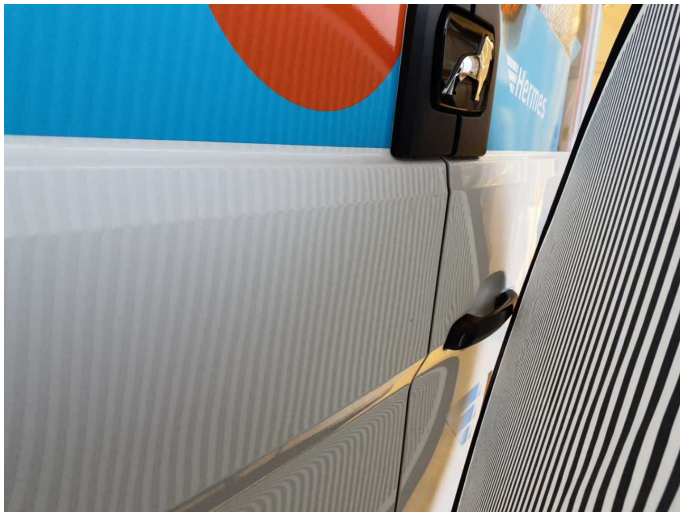
Damage 7: Boot lid / rear door: Rear door - left side - Dent / paintcoat damage - Smart repair

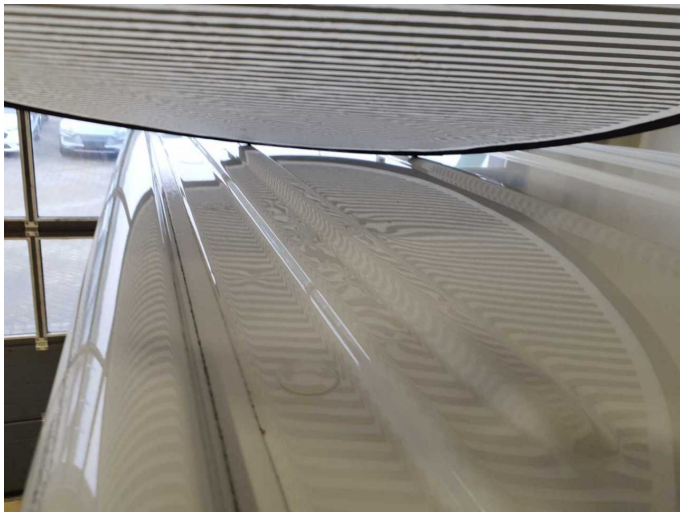
Damage 8: Roof: Roof rail - right side - Scratch(es) - Smart repair

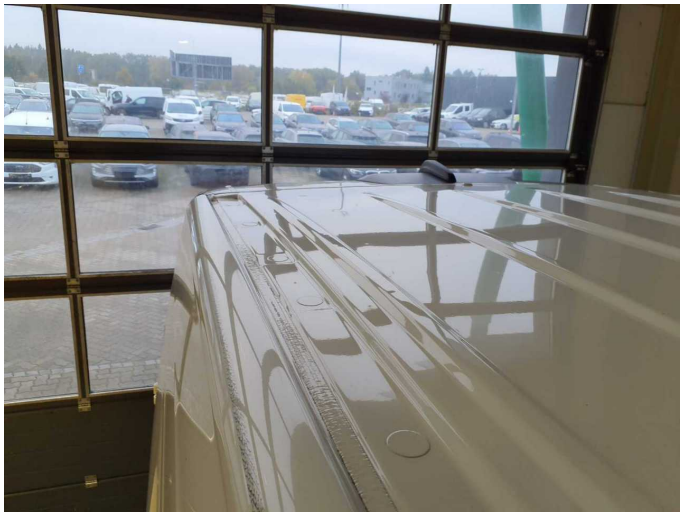
Damage 9: Roof: Roof - dent(s) - Smart repair

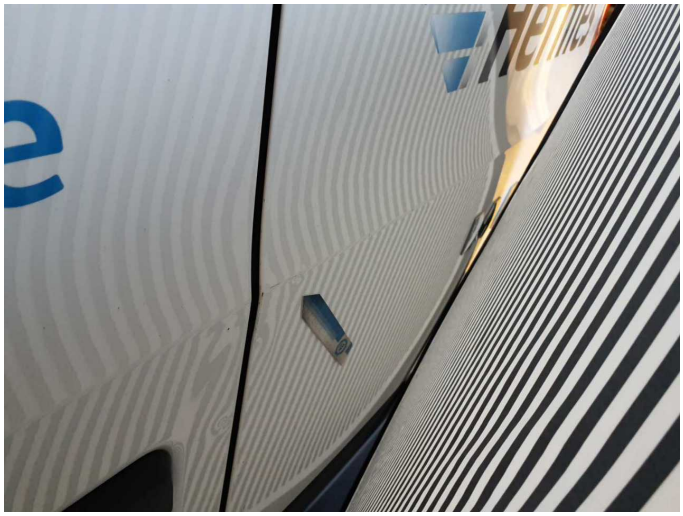
Damage 11: Body: Body - Glued / labelled - De-glue / neutralise

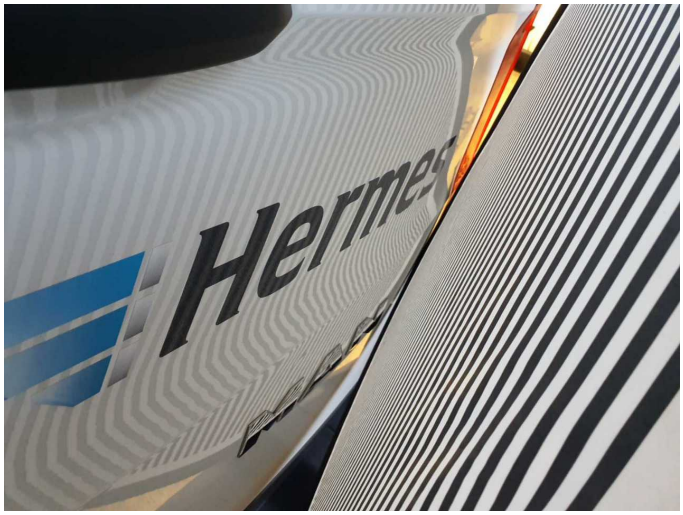
Damage 12: Boot lid / rear door: Rear door - right side - Dent / paintcoat damage - Repair and paint

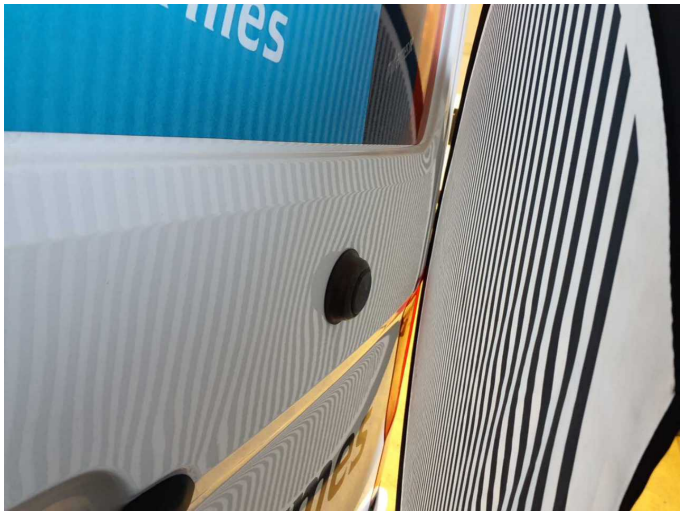
Damage 12: Boot lid / rear door: Rear door - right side - Dent / paintcoat damage - Repair and paint

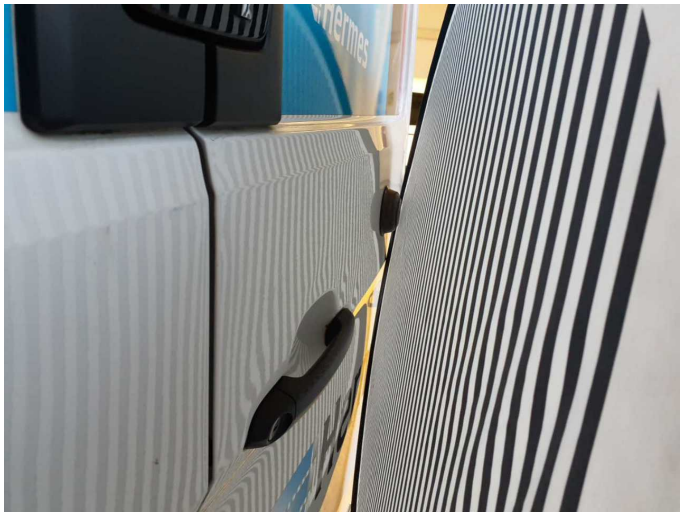
Damage 12: Boot lid / rear door: Rear door - right side - Dent / paintcoat damage - Repair and paint

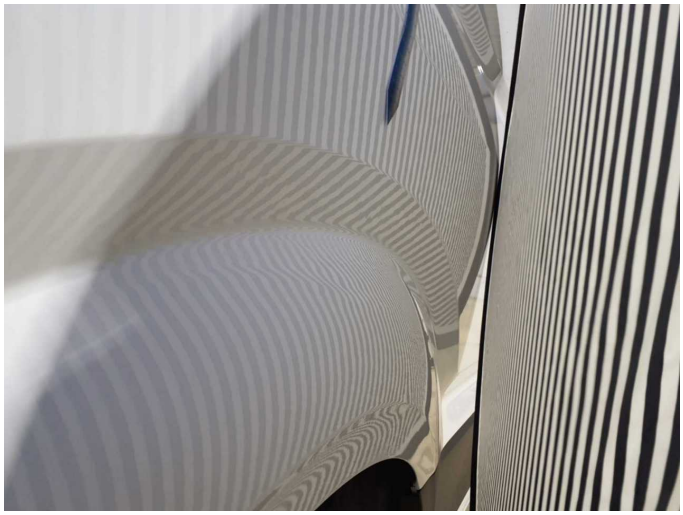
Damage 12: Boot lid / rear door: Rear door - right side - Dent / paintcoat damage - Repair and paint

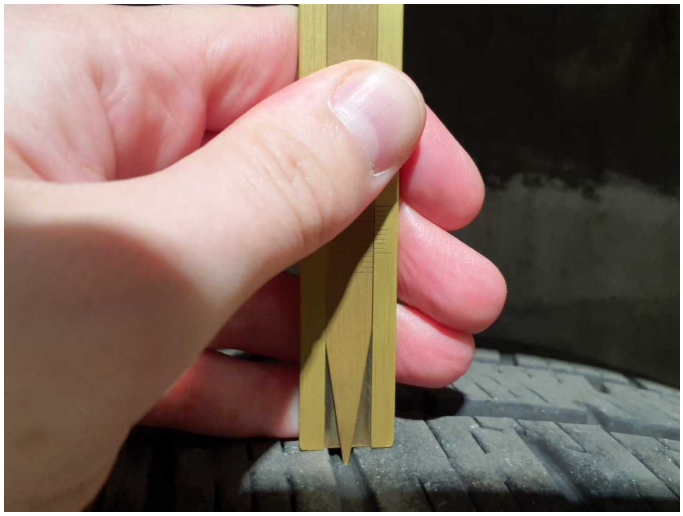
Damage 14: Wheel / tyres: Tyres - complete set - does not meet manufacturer specifications - Replace

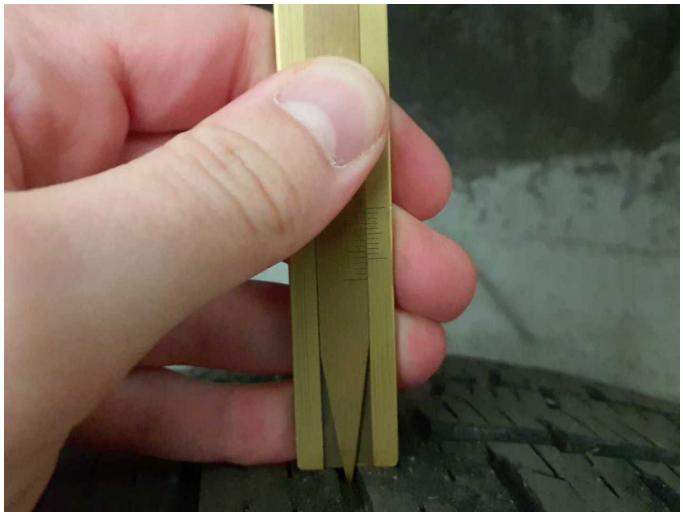
Damage 14: Wheel / tyres: Tyres - complete set - does not meet manufacturer specifications - Replace

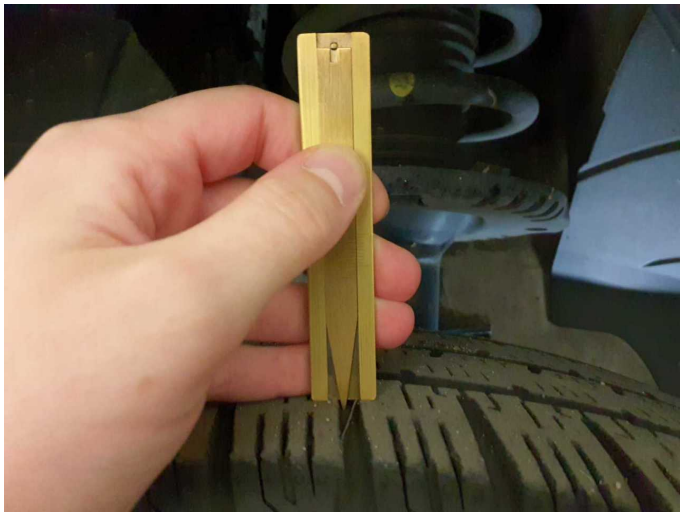
Damage 14: Wheel / tyres: Tyres - complete set - does not meet manufacturer specifications - Replace

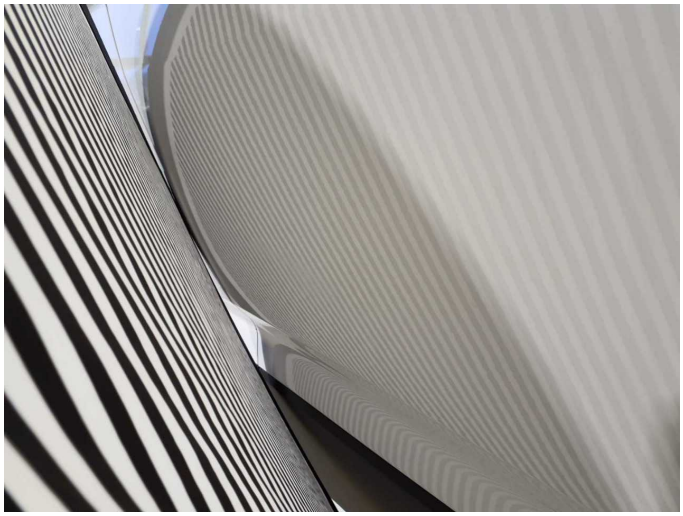
Damage 15: Sliding door, right: Sliding door (Orangenhaut) - Unprofessionally repaired - Repair and paint

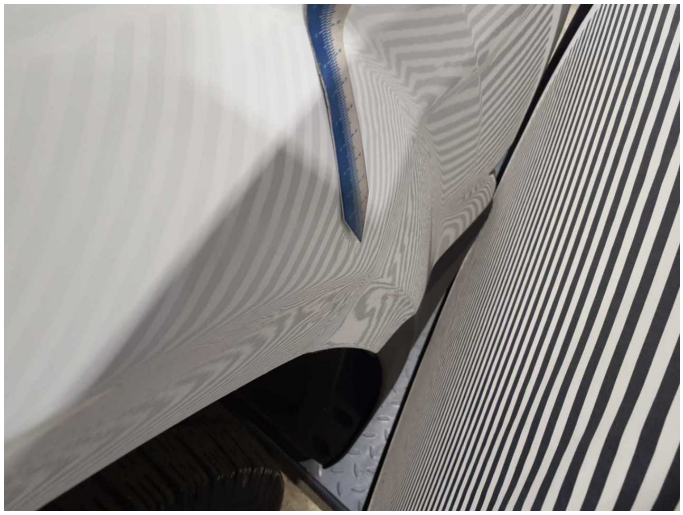
Damage 16: Mudguard - right side: Mudguard - right side (Wellig und eingefallen) - Unprofessionally repaired - Repair and paint

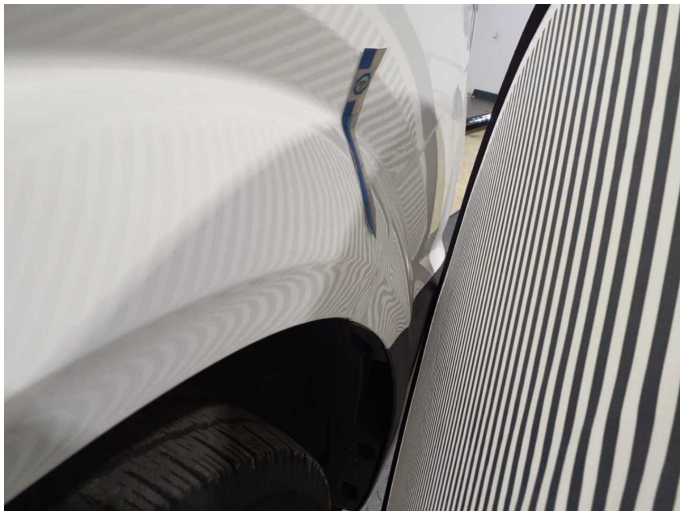
Damage 16: Mudguard - right side: Mudguard - right side (Wellig und eingefallen) - Unprofessionally repaired - Repair and paint

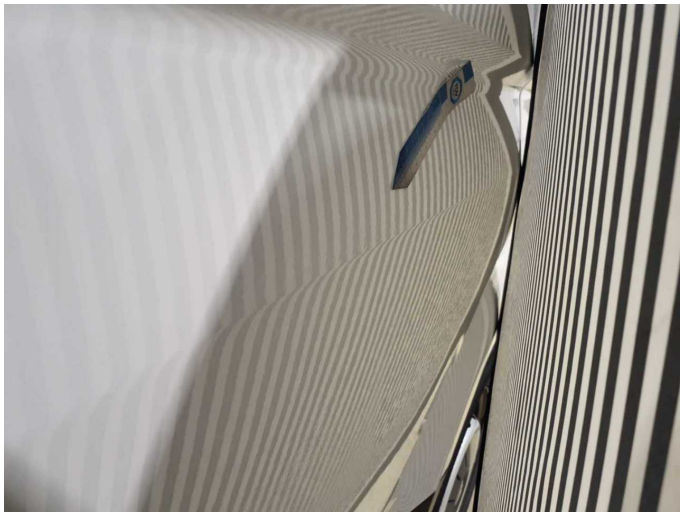
Damage 16: Mudguard - right side: Mudguard - right side (Wellig und eingefallen) - Unprofessionally repaired - Repair and paint

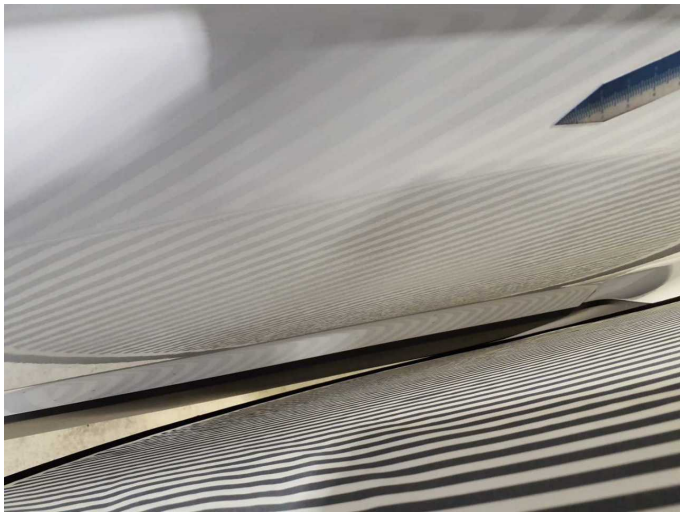
Damage 17: Door - front right side: Door (Orangenhaut und wellig) - Unprofessionally repaired - Repair and paint

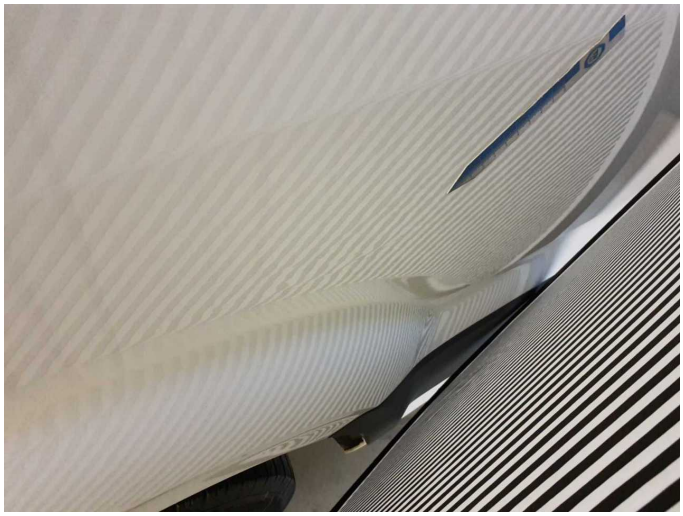
Damage 17: Door - front right side: Door (Orangenhaut und wellig) - Unprofessionally repaired - Repair and paint

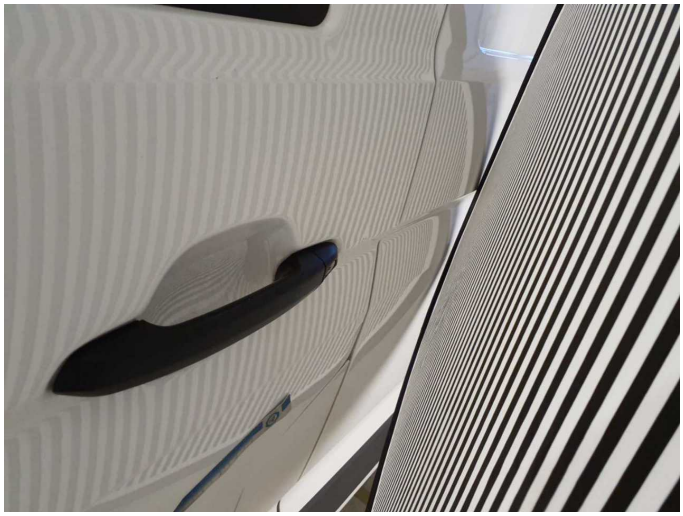
Wear and tear 4: Door - front left side: Door - dent(s) - No deduction
