Expertise

Protocol number: 48111763
Order No. / Reference: 27009990
Inspection date: 25 Sept 2026

Manufacturer: Ford	Model: Kuga 2.0 EcoBlue Hybrid VIGNALE
VIN: WF0FXXWPMFLS88018

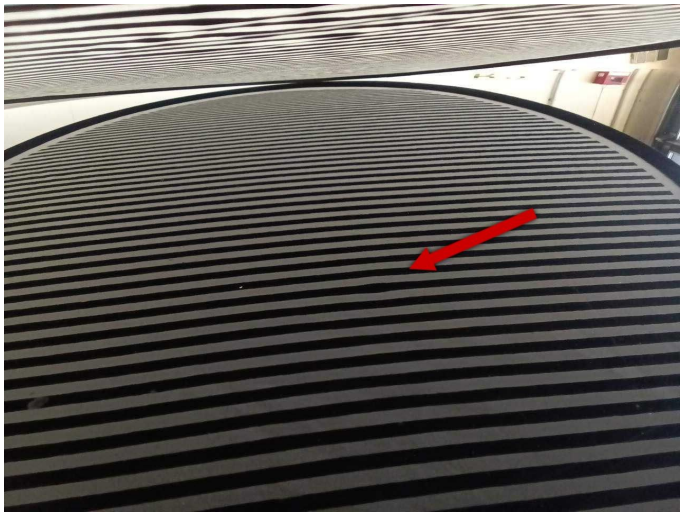
No.	Component group	Description
1	Equipment	Tirefit filler - Expired - Replace
2	Roof	Roof - dent(s) - Smooth repair work
3	Trim / covers	Brightware / decorative strip (Ausgeklippst) - Loose - Repair
4	Roof	Roof rail - right side - dent(s) - Smooth repair work

Damage 2: Roof: Roof - dent(s) - Smooth repair work
