Expertise

Protocol number: 48577736
Order No. / Reference: 27144529
Inspection date: 3 Nov 2026

Manufacturer: Skoda	Model: Kodiaq 2.0 TDI DSG Sportline
VIN: TMBJJ7NS6R8505060

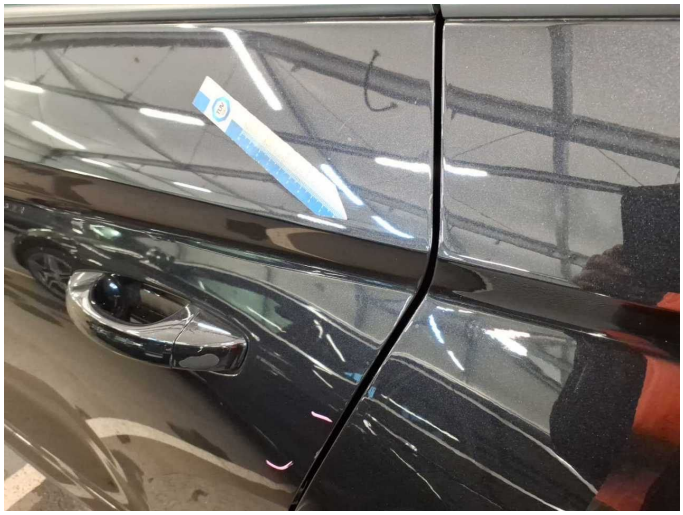
Damage 1: Door - rear left side: Door edge - Scratch(es) - Smart repair

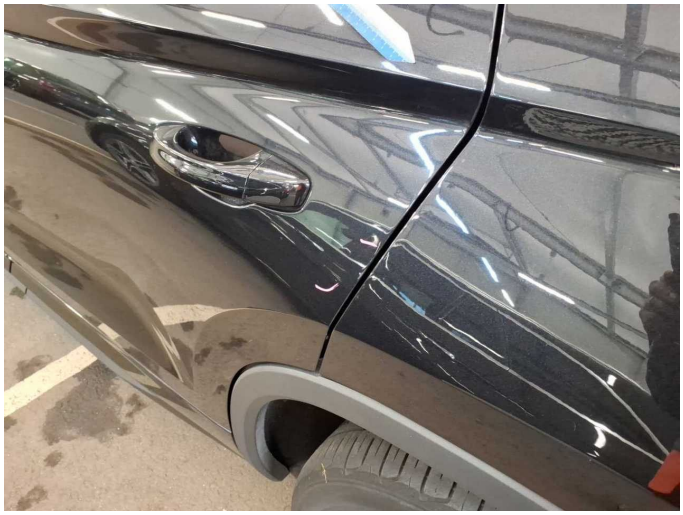
Damage 1: Door - rear left side: Door edge - Scratch(es) - Smart repair

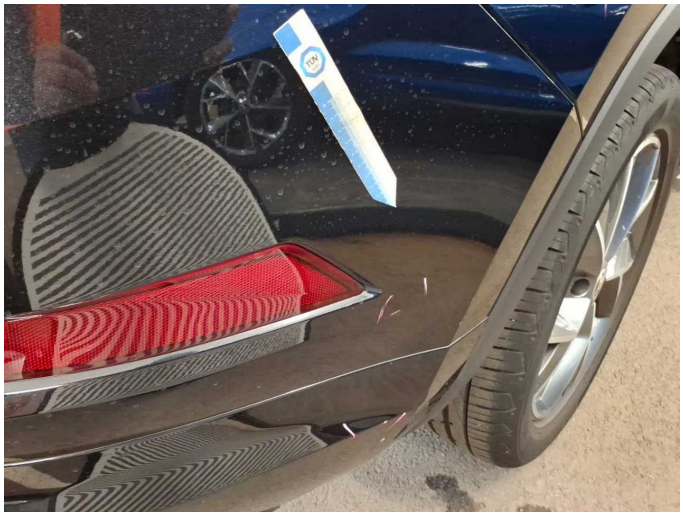
Damage 2: Rear bumper: Rear bumper - Scratch(es) - Smart repair

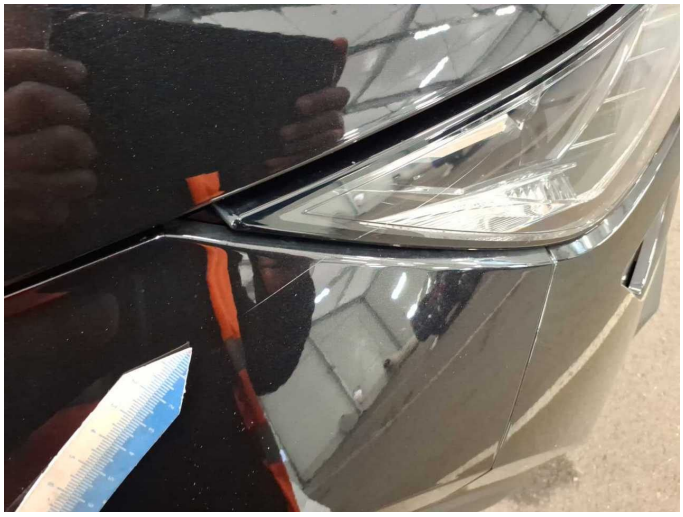
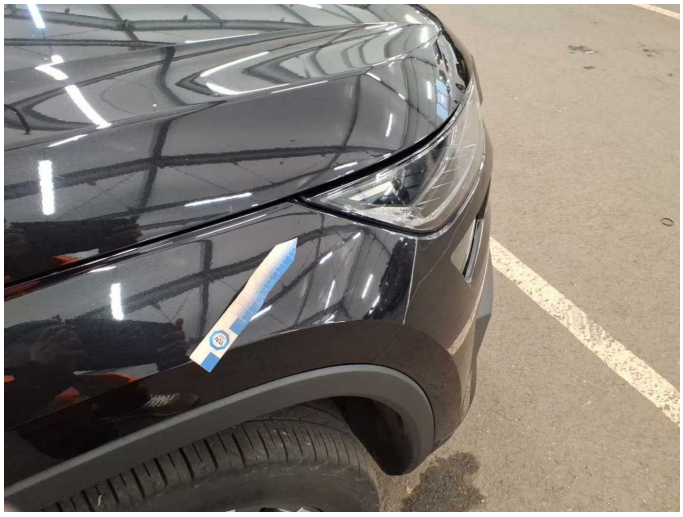
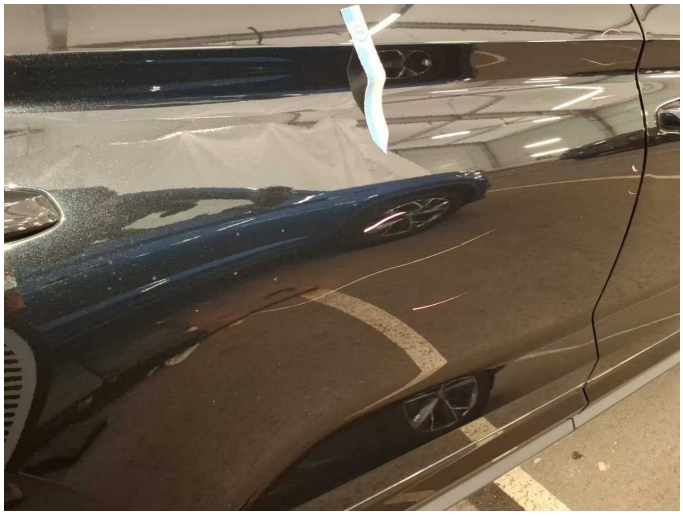
Damage 9: Mudguard - right side: Mudguard - right side - Scratch(es) - Paint

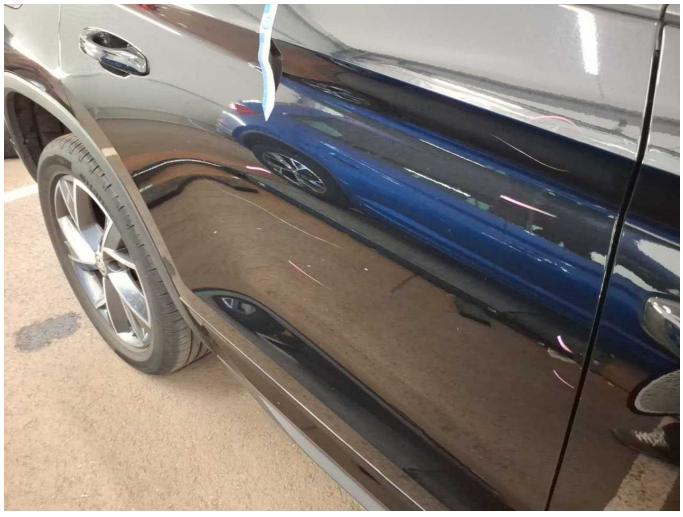
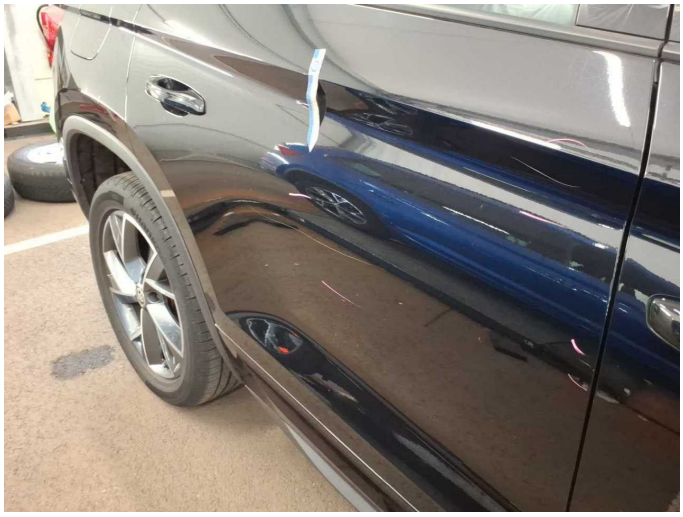
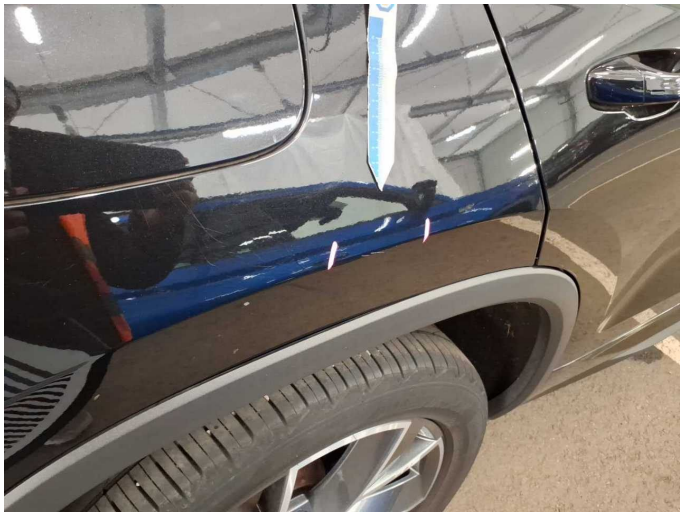
Damage 10: Door - rear right side: Door - Scratched - Paint

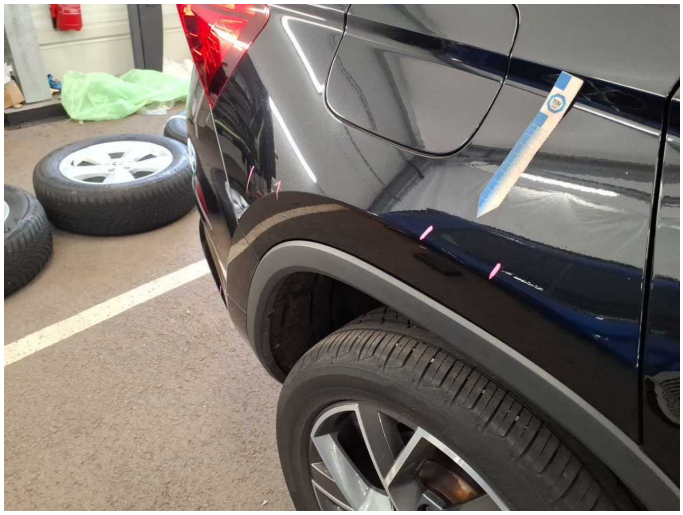
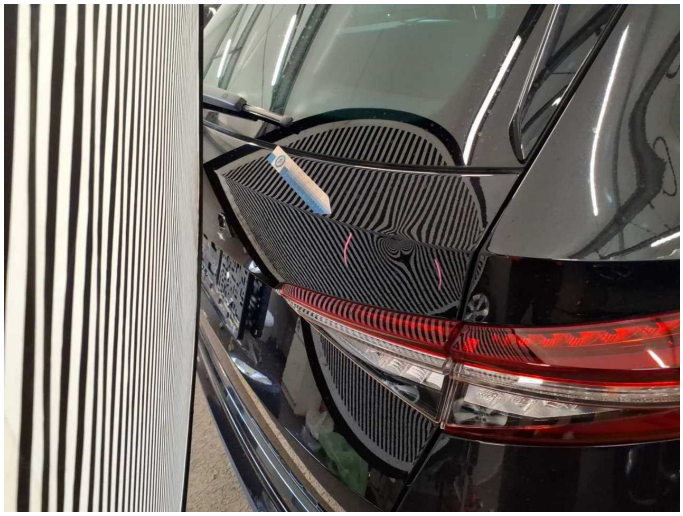
Damage 11: Side panel - rear right side: Side panel - Scratch(es) - Paint

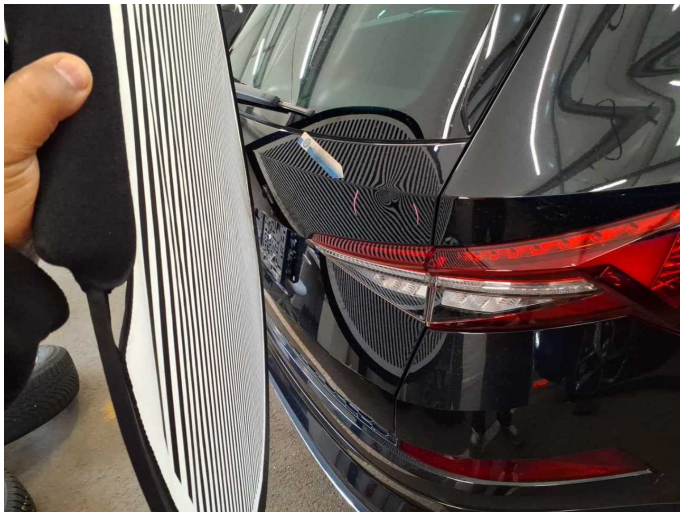
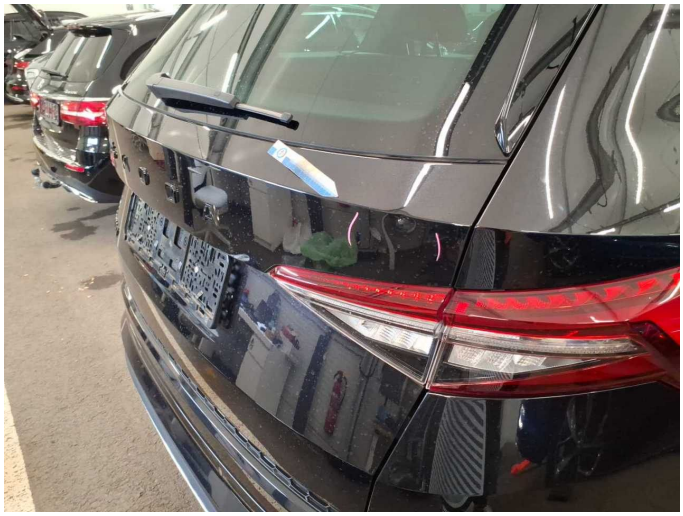
Damage 12: Boot lid / rear door: Boot lid - Dent / paintcoat damage - Repair and paint

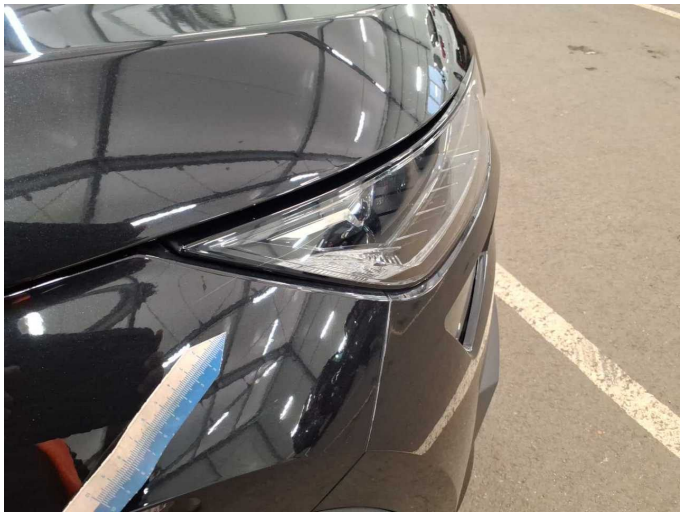
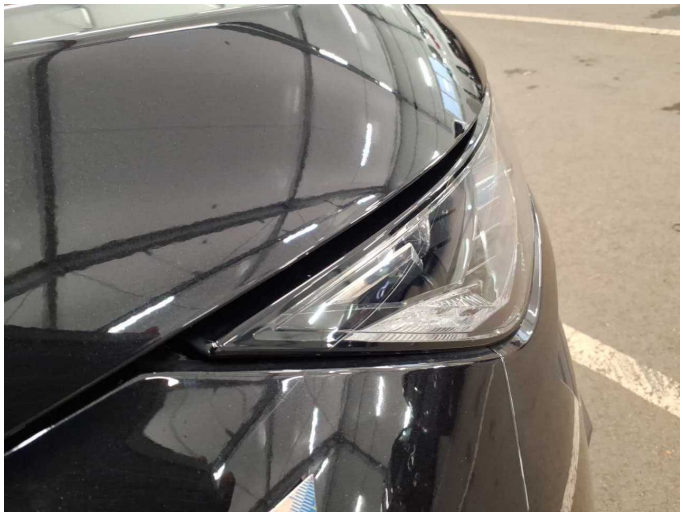
Damage 14: Headlight: Headlight - right side - Scratch(es) - Replace
