Expertise

Protocol number: 48349261
Order No. / Reference: 27177588
Inspection date: 27 Oct 2026

Manufacturer: Audi	Model: Q4 e-tron 40
VIN: WAUZZZFZ9PP073020

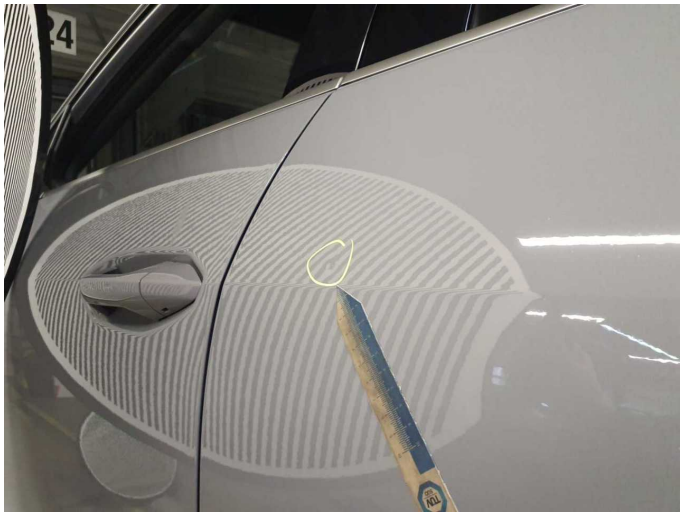
No.	Component group	Description
1	Door - rear left side	Door - dent(s) - Smooth repair work

Damage 1: Door - rear left side: Door - dent(s) - Smooth repair work
