PEUGEOT 508 SW

Vehicle information

Damage summary

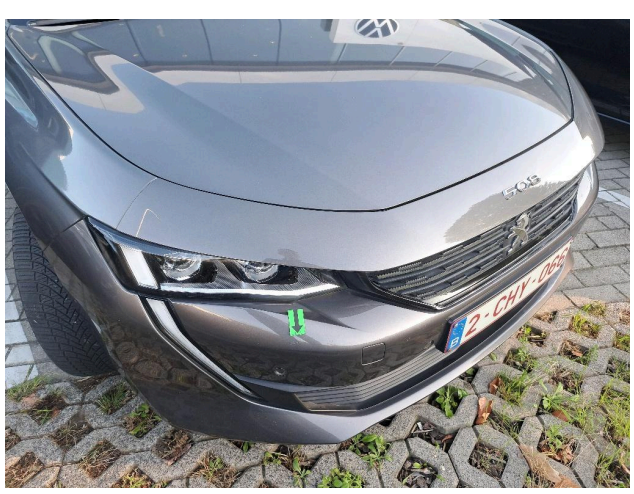
Bodywork
Damaged
Acceptable
Roof & others

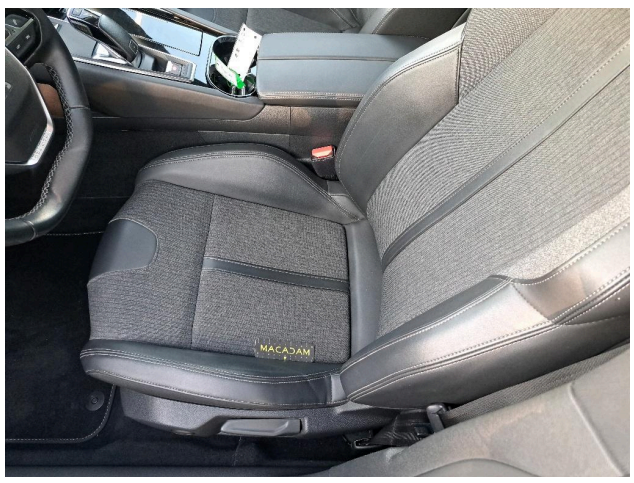
Seat cover FL
Worn
Check
Interior
