TÜV SÜD Auto Partner GmbH
Wiesenring 2
04159 Leipzig

Expertise

Protocol number: 48421463
Order No. / Reference: 27248350
Inspection date: 30 Oct 2026

Manufacturer: Mercedes-Benz	Model: 311 CDI Sprinter Kompakt VA
VIN: W1V9076311P218713

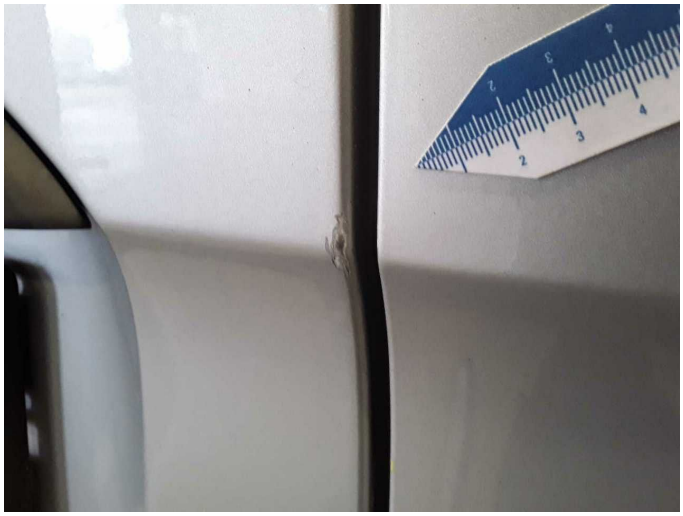
Damage 2: Door - front left side: Door edge - Scratch(es) - Smart repair

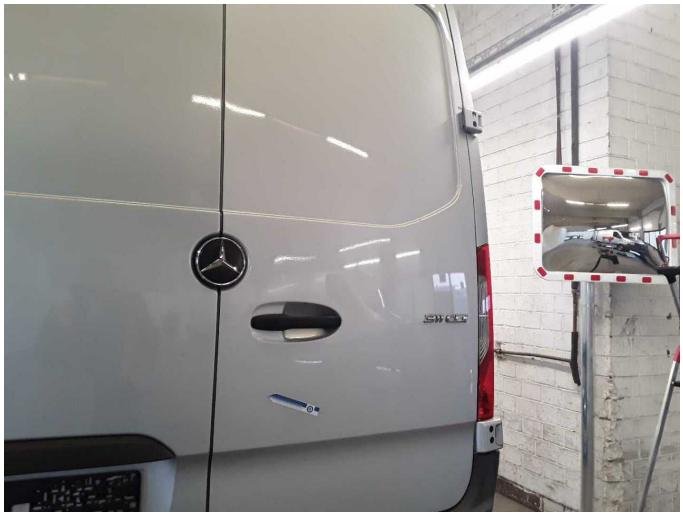
Damage 3: Boot lid / rear door: Rear door - left side - Scratch(es) - Smart repair

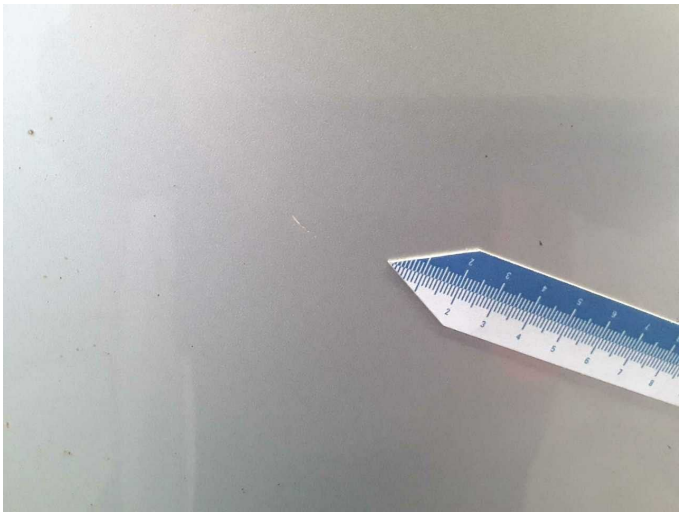
Damage 4: Boot lid / rear door: Rear door - right side - Scratch(es) - Loss in value

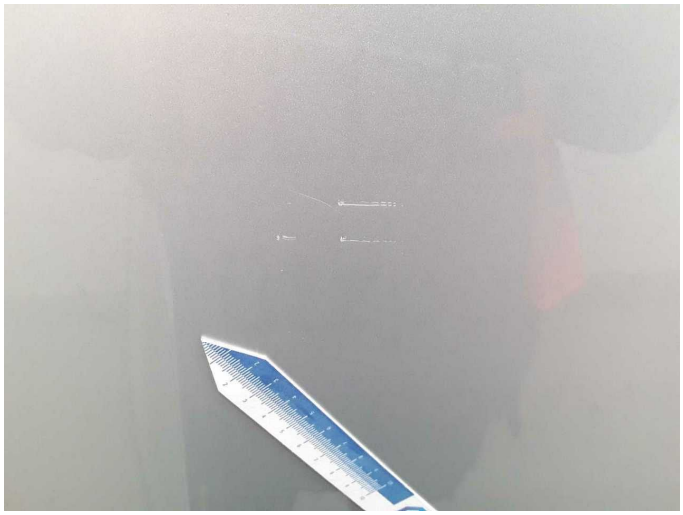
Damage 6: Door - front right side: Door - Scratch(es) - Loss in value

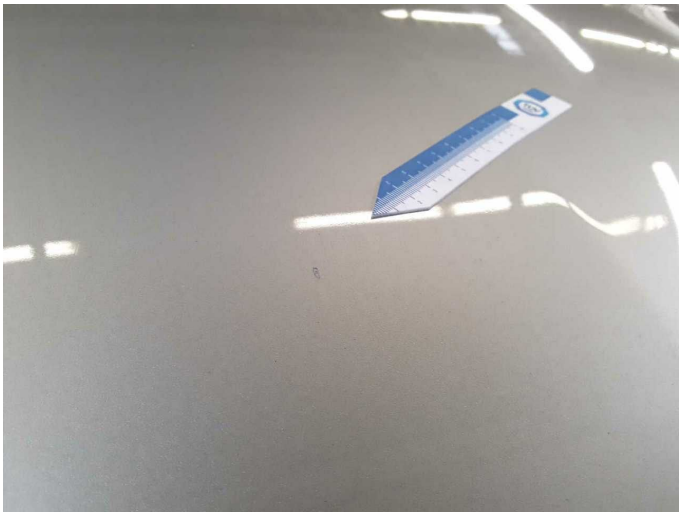
Wear and tear 4: Boot lid / rear door: Rear door - left side (Innen) - Dent / paintcoat damage - No deduction
