Expertise

Protocol number: 48028319
Order No. / Reference: 27061298
Inspection date: 8 Oct 2026

Manufacturer: Audi	Model: A3 35 TFSI Sportback S tronic advanced
VIN: WAUZZZGY3RA008207

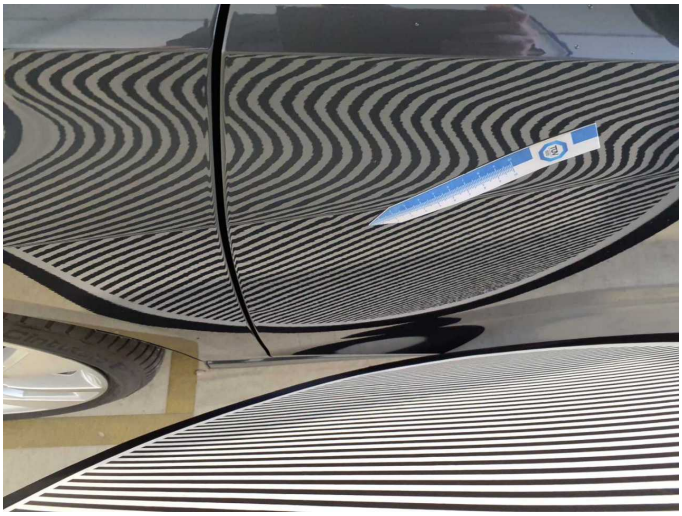
Damage 2: Door - front left side: Door - dent(s) - Smart repair

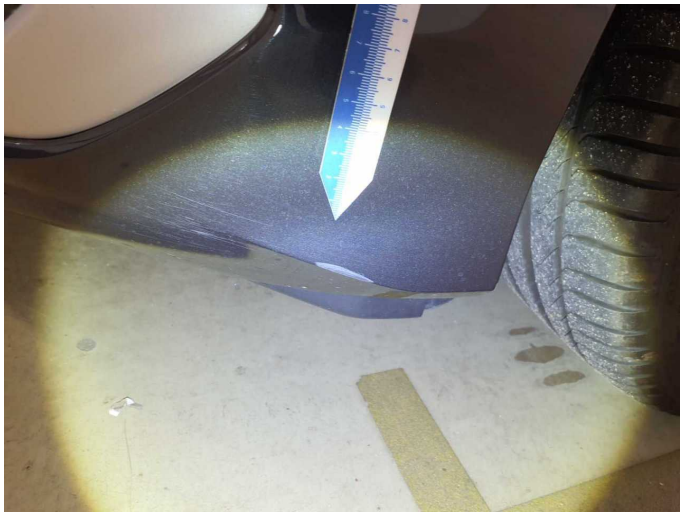
Damage 4: Front bumper: Front bumper - Scratch(es) - Smart repair

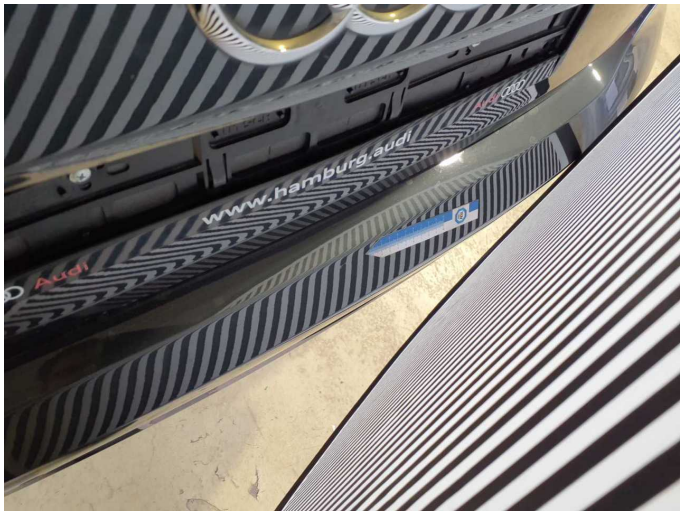
Damage 6: Rear bumper: Rear bumper - Dent / paintcoat damage - Paint
