Expertise

Protocol number: 47810065
Order No. / Reference: 27061047
Inspection date: 28 Sept 2026

Manufacturer: Seat	Model: Ateca 2.0 TDI DSG Style
VIN: VSSZZZ5FZN6516981

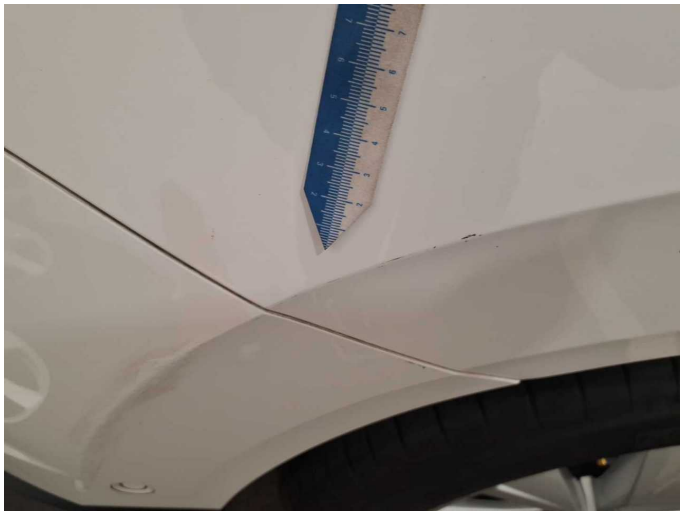
No.	Accident
1	Rear, Side right

Non-repaired previous damages were found at the vehicle. The necessary repair costs are listed in the expert report or if necessary, are listed in detail in a separately enclosed repair cost calculation.

Accident 1: Rear, Side right
