TÜV SÜD Auto Partner GmbH
Wiesenring 2
04159 Leipzig

Expertise

Protocol number: 48042190
Order No. / Reference: 27067491
Inspection date: 8 Oct 2026

Manufacturer: Volkswagen	Model: Passat Variant 2.0 TDI SCR DSG Business
VIN: WVWZZZ3CZPE076222

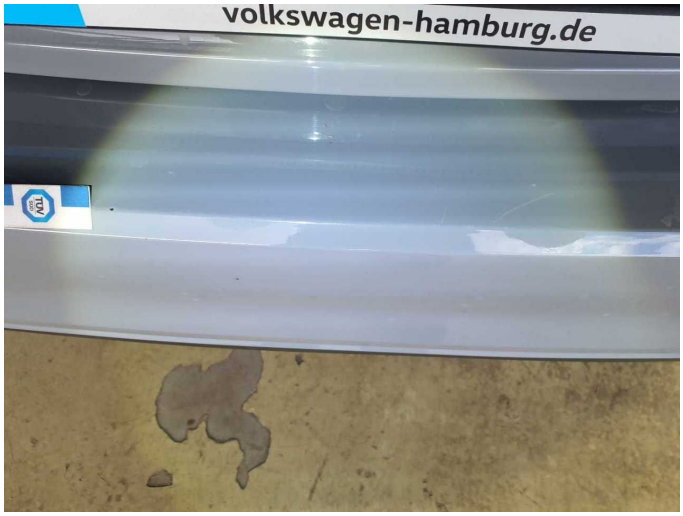
Damage 3: Rear bumper: Rear bumper - Scratch(es) - Smart repair

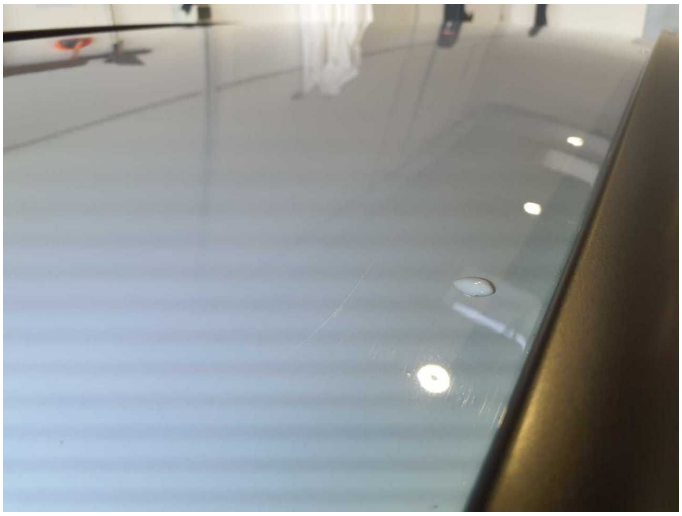
Damage 9: Roof: Roof - Scratch(es) - Loss in value

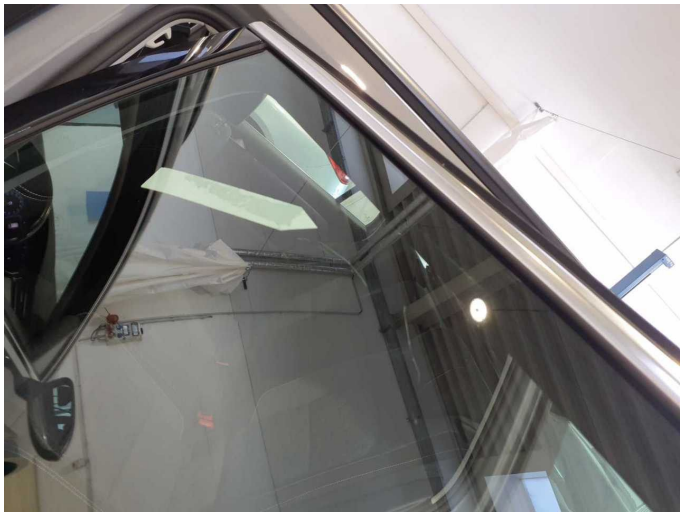
Damage 12: Vehicle glazing: Door glass - rear left side - Scratch(es) - Replace
